FARM ENVIRONMENT PLAN (FEP)
BRIEN FARM
140 MORRISON ROAD, PUKEKAWA

Version 1	Draft FEP prepared to determine likely information requirements and associated costs	August 2016

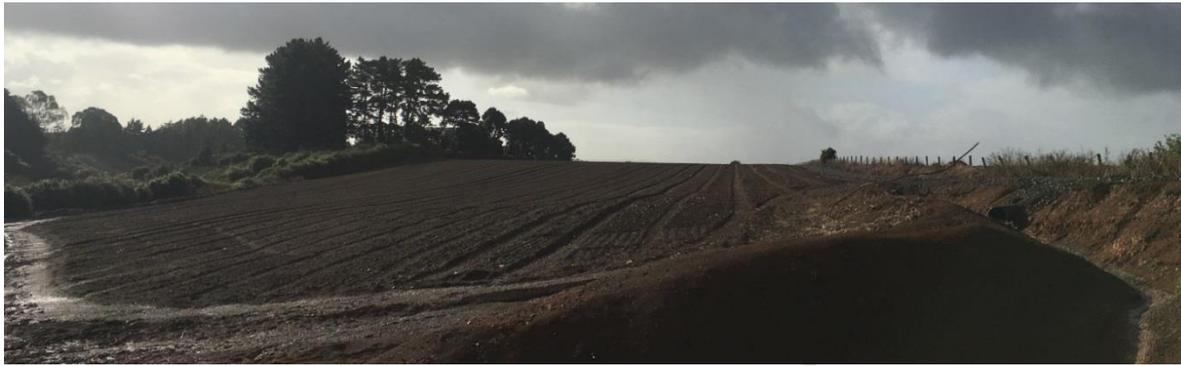
Figure 3. Paddock view of BRIE01

Priority	Time Frame	GPS Ordinates	Co-	Date Completed
Observation	Site is moderate in slope and appropriately contoured, with banded channels directing all runoff to a sediment trap at lowest point					
Recommendation	No recommendations for sediment control required.					
Observation	A stream runs to the north of this site, traversing retired pastoral land.					
Recommendation	It is recommended that if stock are to be grazed on the pastoral land to the north of this site, then the stream should be fenced off to prevent their access with a minimum 1m setback as slope is less than 15 degrees.	Low	If needed			
Observation	Existing vegetation in excess of 5m bounds stream to the north but is comprised of blackberry and long grasses.					
Recommendation	No recommendations

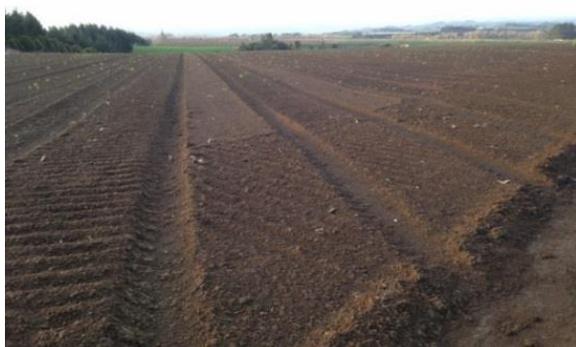
Figure 5. Paddock view of BRIE02 (above)

Observation	Priority	Time Frame	GPS Ordinates	Co-	Date Completed
LMU is moderately steep in grade 5-10°. Erosion and sediment controls are well positioned and maintained on site. There are currently nine sediment traps that exist on this site (refer to LMU Map). Excellent management of runoff.

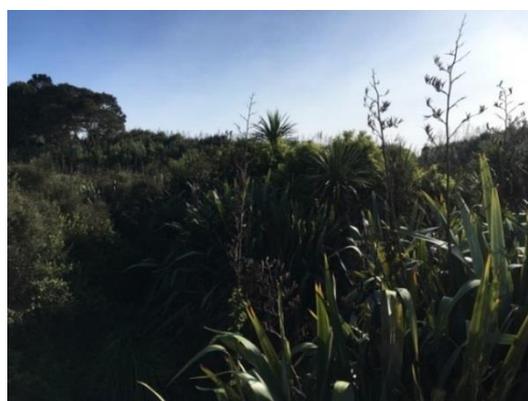
Figure 6. Established Riparian Vegetation on Southern Boundary (right)

Recommendation	No recommendations				
Observation	Extensive established riparian planting to the south of the LMU exists (>10ha). To the north of the site there is a small area of riparian planting between sediment traps G and J. The remainder of the northern boundary is in pasture, with eucalyptus trees planted along the boundary line.				
Recommendation					
Observation	Control of runoff to the west of the site exists, although disperses into paddock at lowest point. Runoff is derived from sediment trap P of MARS03 and also from site TOWN02.				
Recommendation	Sediment trap to be developed in north western corner of LMU BRIE02.	High			
Observation	Three minor breaches in the bund on the southern margin of the site were observed, please refer to LMU Map for locations.				
Recommendation	Recontour bund on southern margin to rectify breaches.	High			-37.322707, 175.005152

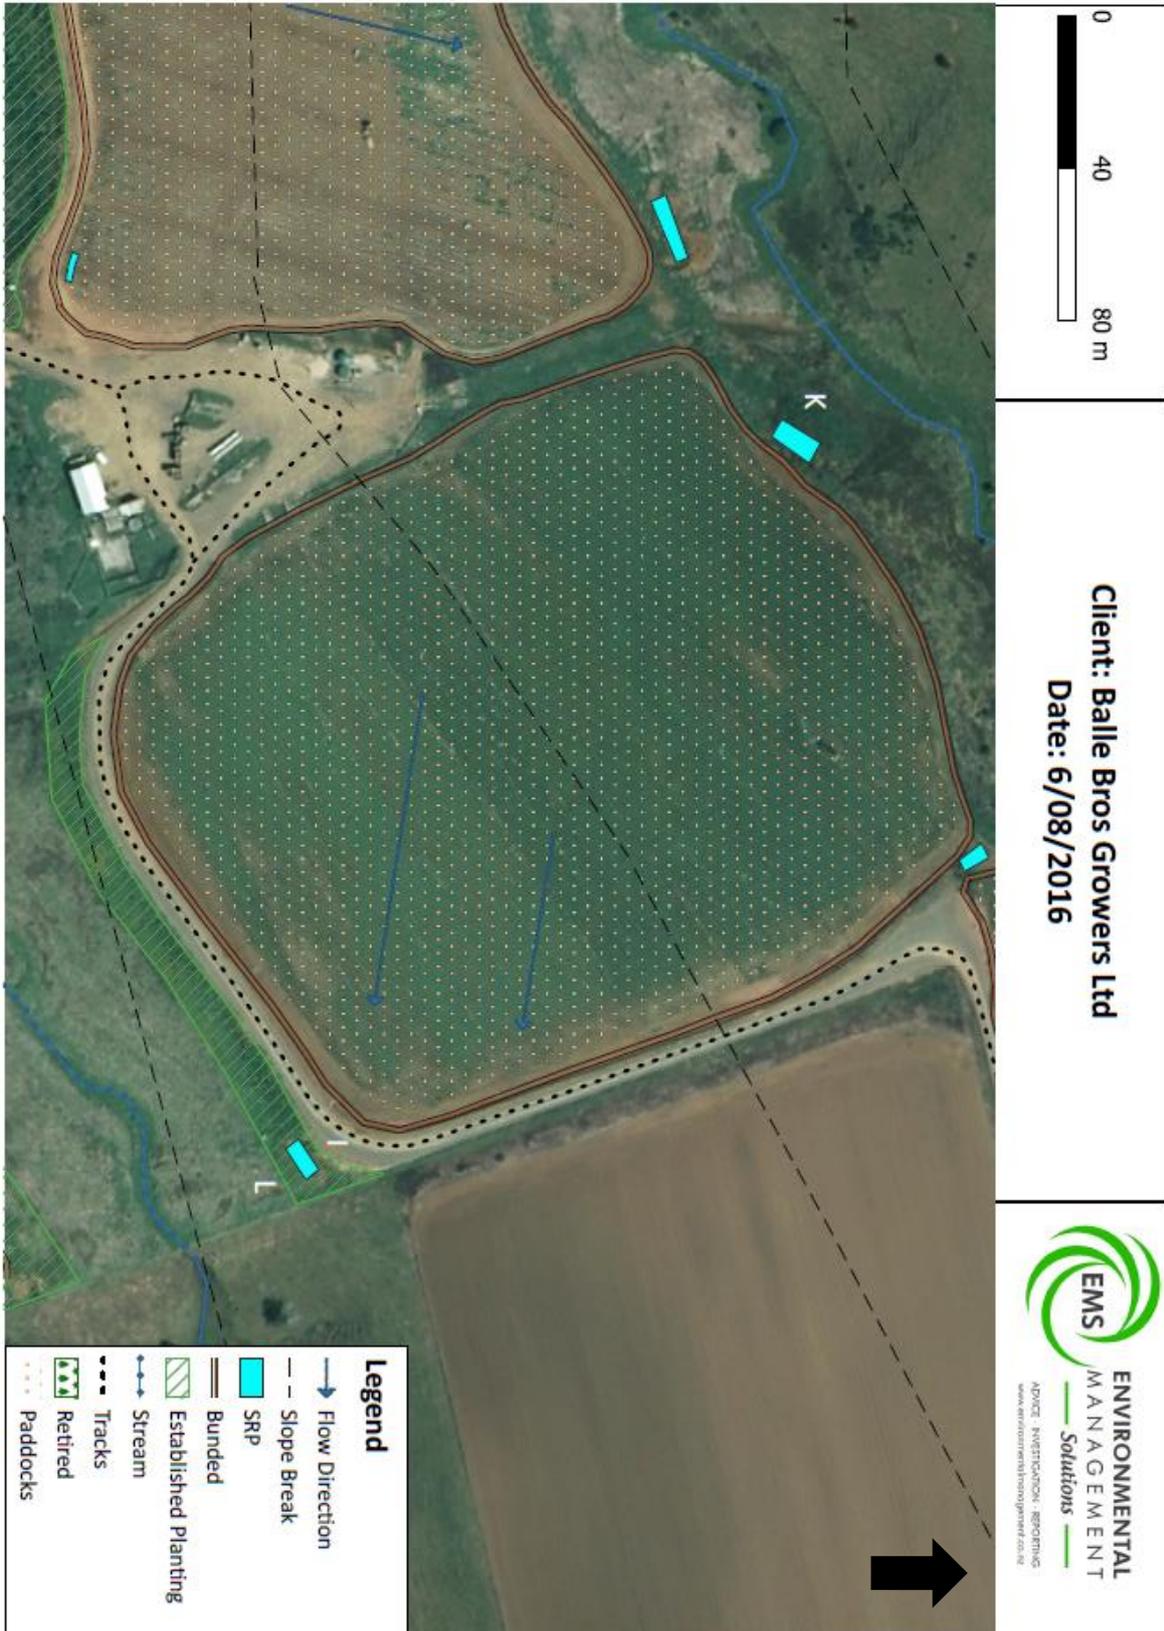
Figure 7. Map of LMU BRIE03

Priority	Time Frame	GPS Co-Ordinates
Observation	Paddock is moderate in slope with two sediment traps for catchment. Majority of site has good channelling, bunding and management of runoff to sediment traps. One breach noted on northern margin requiring repair as depicted on LMU map			
Recommendation	Breach in bund on northern margin requires repair to ensure that all runoff is channelled to sediment trap K. To achieve this, sediment trap K shall be extended 2m to the west.	High		-37.320532, 175.009954

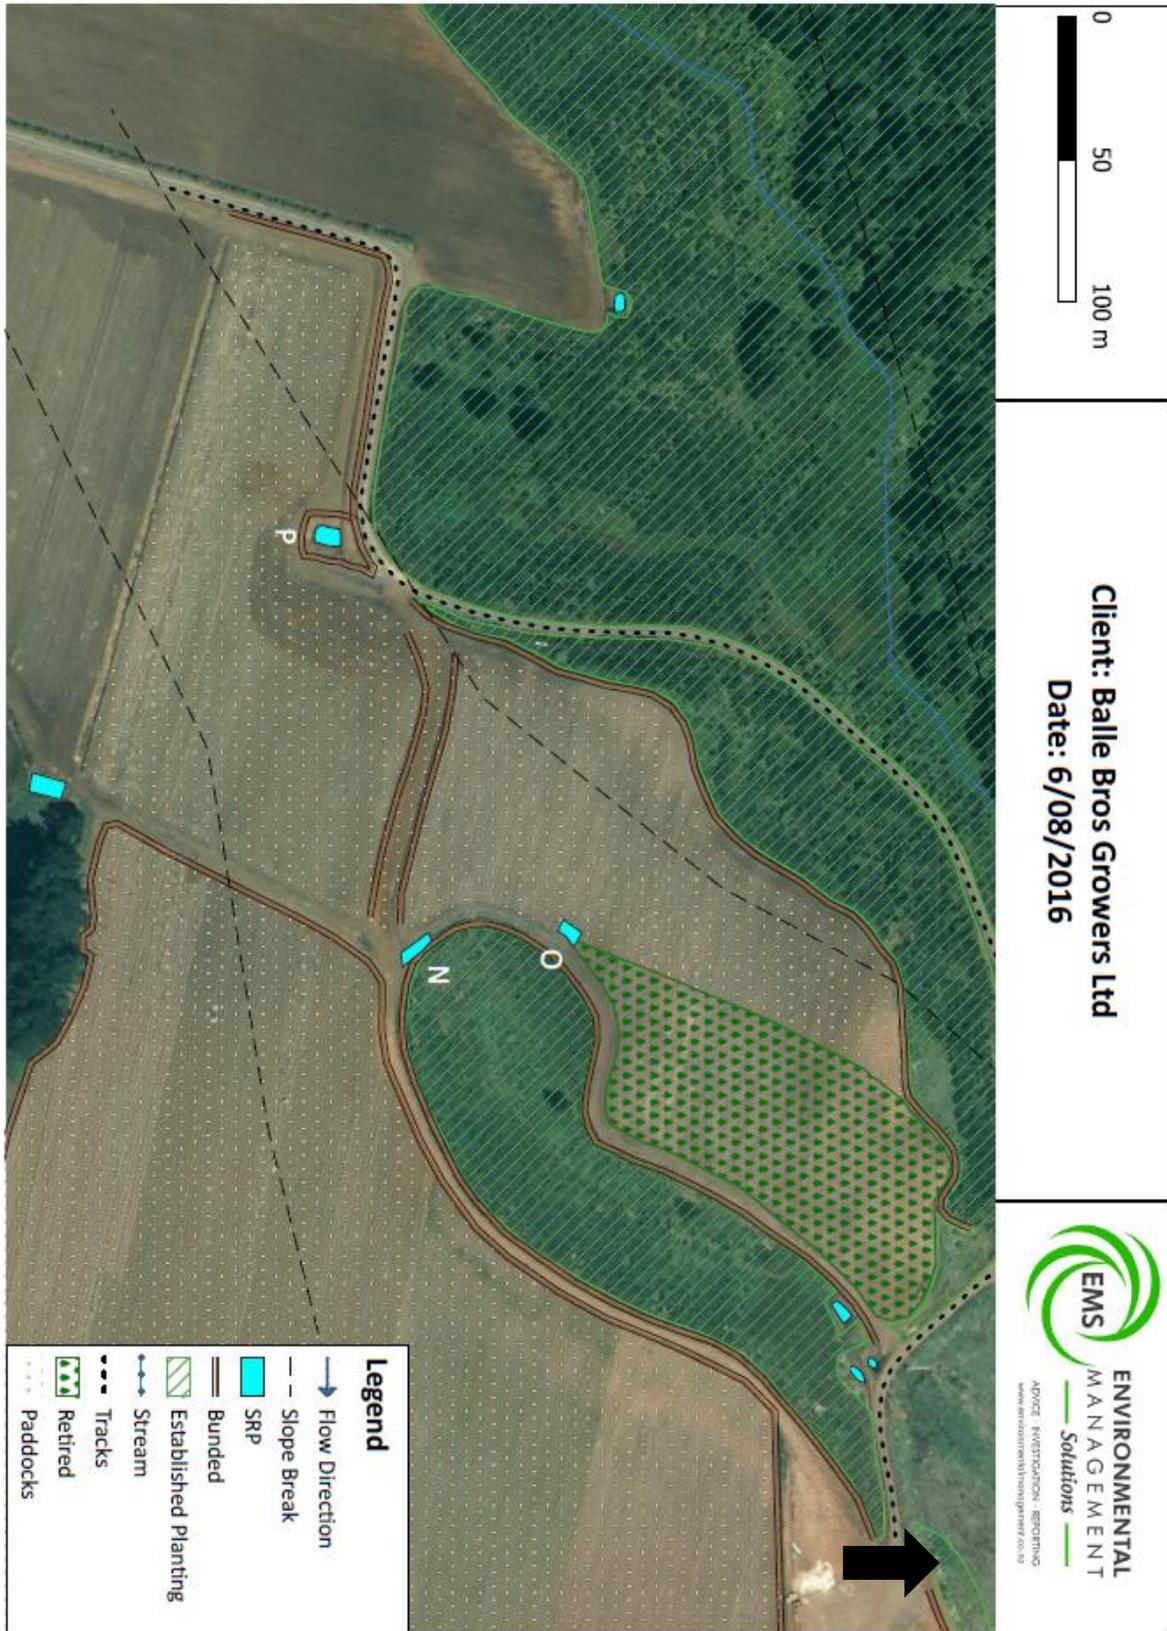
Figure 8. Map of LMU BRIE04

Priority	Time Frame	GPS Co-Ordinates	Date Completed
Observation	Slope at steep portion of site is in excess of 15° (clinometer assessed to be 20°). This area has been retired. The remainder of the site is low gradient around 2-3° and is suitable for productive use.				
Recommendation	No recommendations

Observation	Erosion and sediment controls are well positioned and maintained. Three large sediment traps are located at the base of the paddock. All runoff channelled, banded and directed to sediment traps.				
Recommendation	No further recommendations for erosion and sediment control beyond routine maintenance.				
Observation	Existing well established riparian planting in excess of 5m on the eastern margin protecting adjoining watercourse (See Figure 11).				
Recommendation	No recommendations.

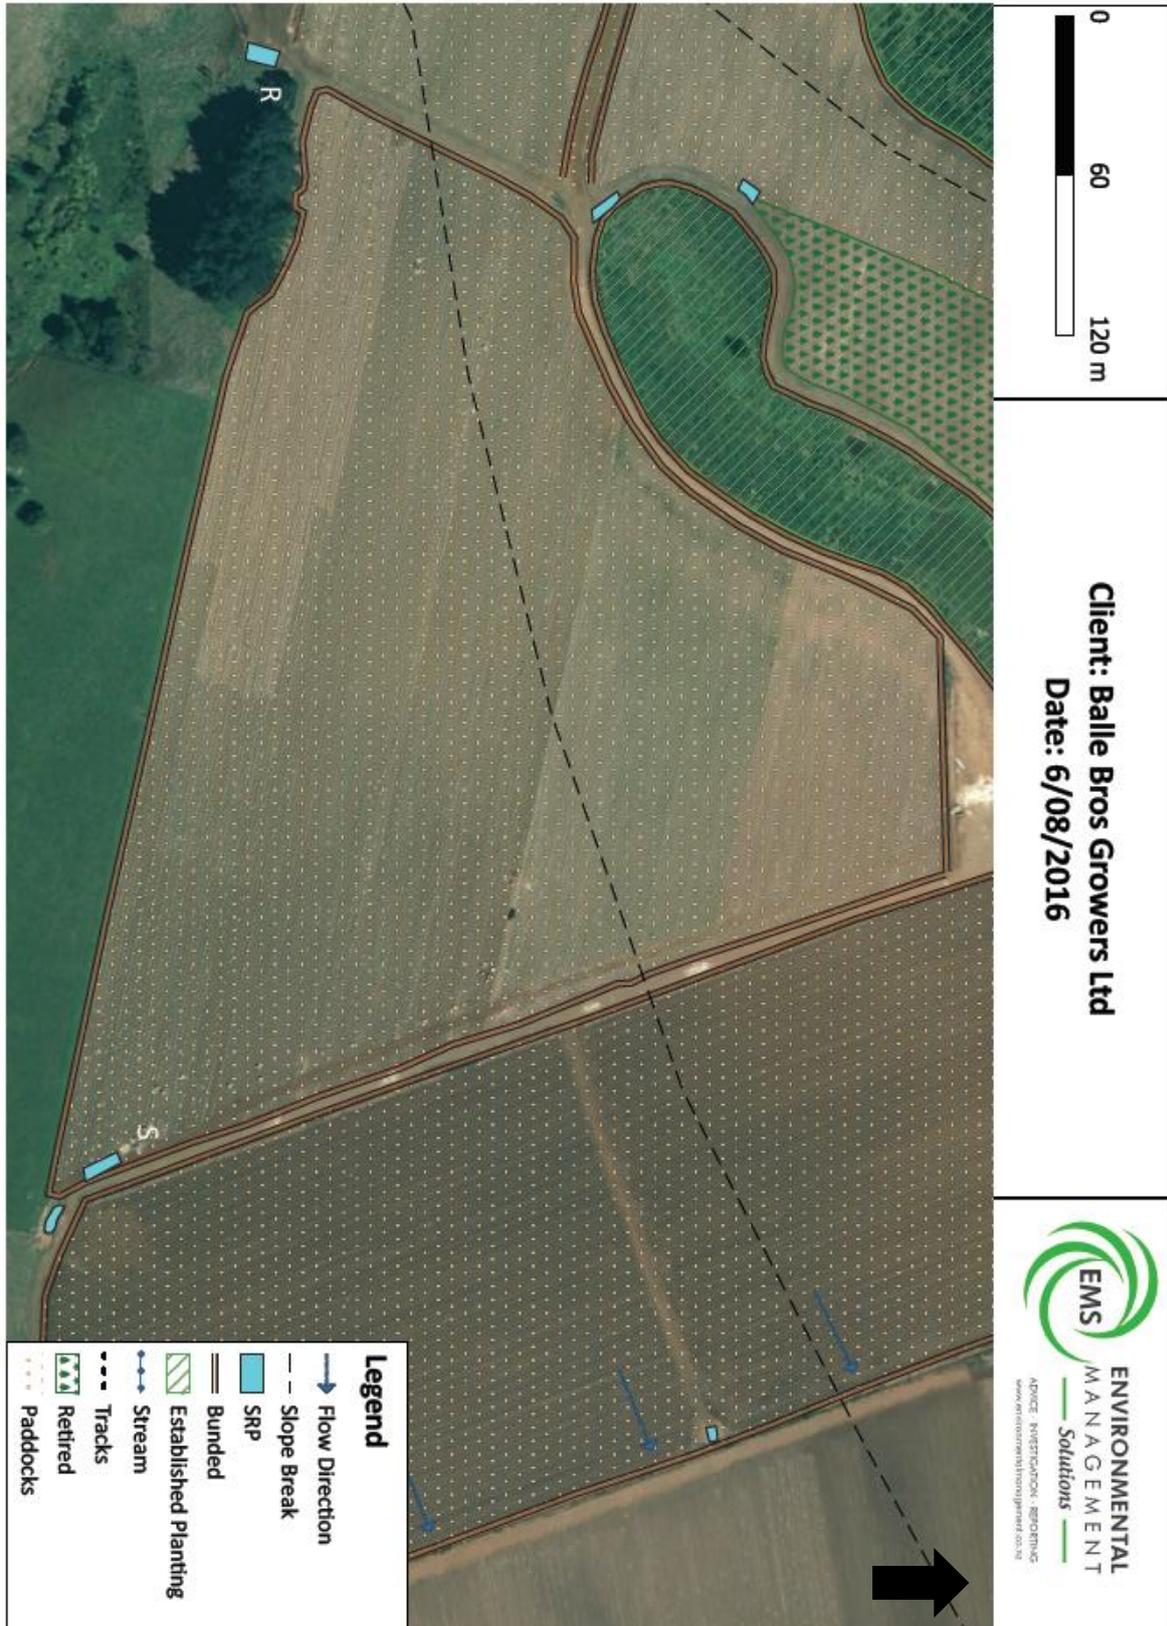
Figure 9. Map of LMU BRIE05

Priority	Time Frame	GPS Co-Ordinates	Date Completed
Observation	Slope of paddock is moderate to flat. Bunding and channels provide well defined route for directing runoff. Bunding adjoining the northern margin has several minor breaches leading into gully containing sediment traps. Remainder of site has excellent sediment controls in place.				
Recommendation	Recontour bund to remove minor breaches.	Low

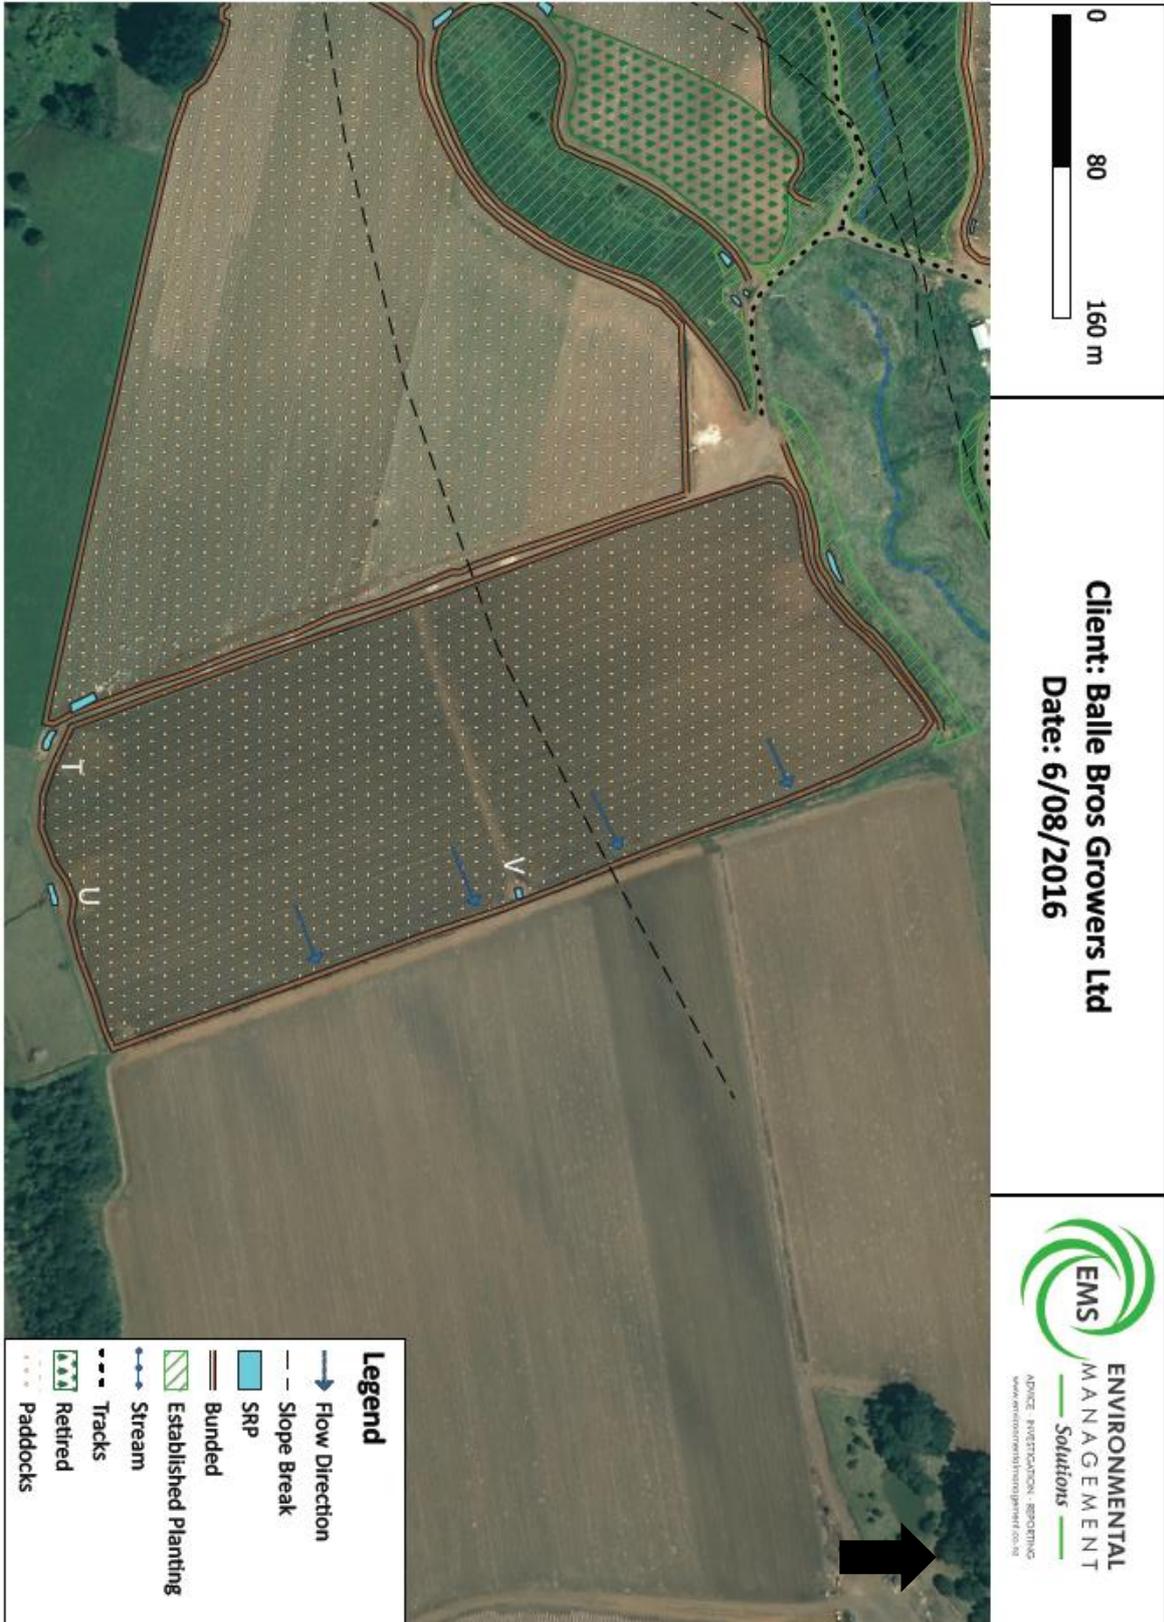
Figure 10. Map of LMU BRIE06

Priority	Time Frame	GPS Co-Ordinates	Date Completed
Observation	Moderate slope on property (refer Figure 15 above). Excellent sediment controls in place, contouring and bunding channels all runoff to a number of sediment traps on site (refer below for summary of sediment traps). Effective bunding and channelling through the middle of the paddock (towards the east) as shown in Figure 16 and table below.				
Recommendation	No recommendations				
Observation	The northern margin of the property has been extensively planted with native riparian vegetation in excess of 5m. A small area (15m) is yet to be planted.				
Recommendation	Remaining area to be planted	Low
