**Analysis of  
Degradation**

**Waikato River**

**Karapiro to  
Ngaruawahia**

For Environment Waikato  
P.O. Box 4010, Hamilton East  
August 2005

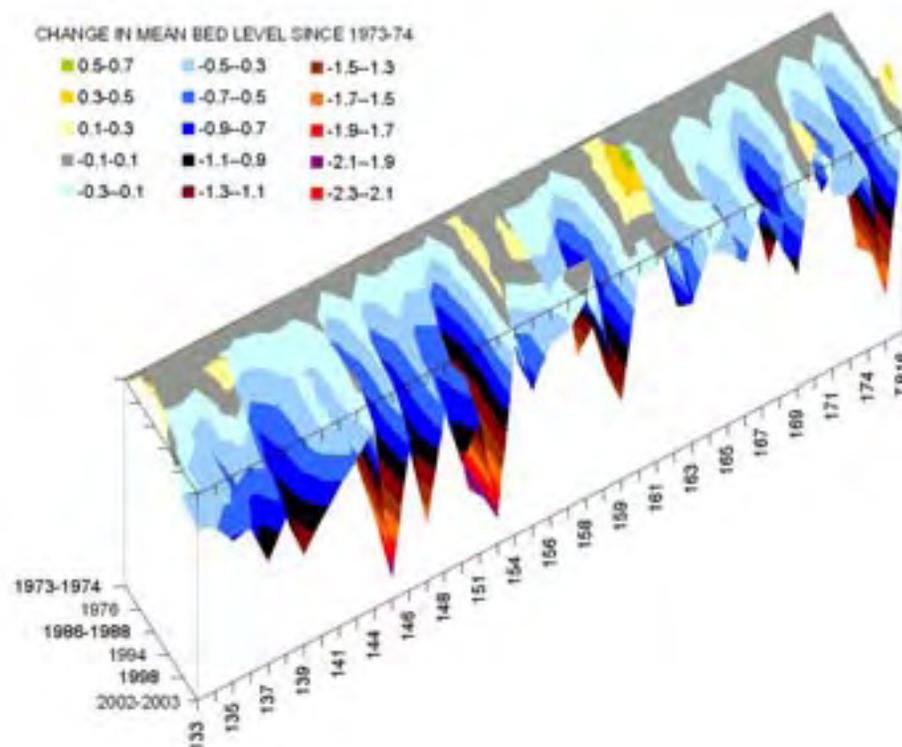
An indication of the problem is given in Figure 1 which shows changes in mean bed level at a series of cross sections monitored by Environment Waikato. Areas shown in grey have not changed in level since 1973.

**Figure 1 Changes in mean bed level since 1973, shown in metres, from Section 133 (near Ngaruawahia) to Section TB16 (near Karapiro Dam).**

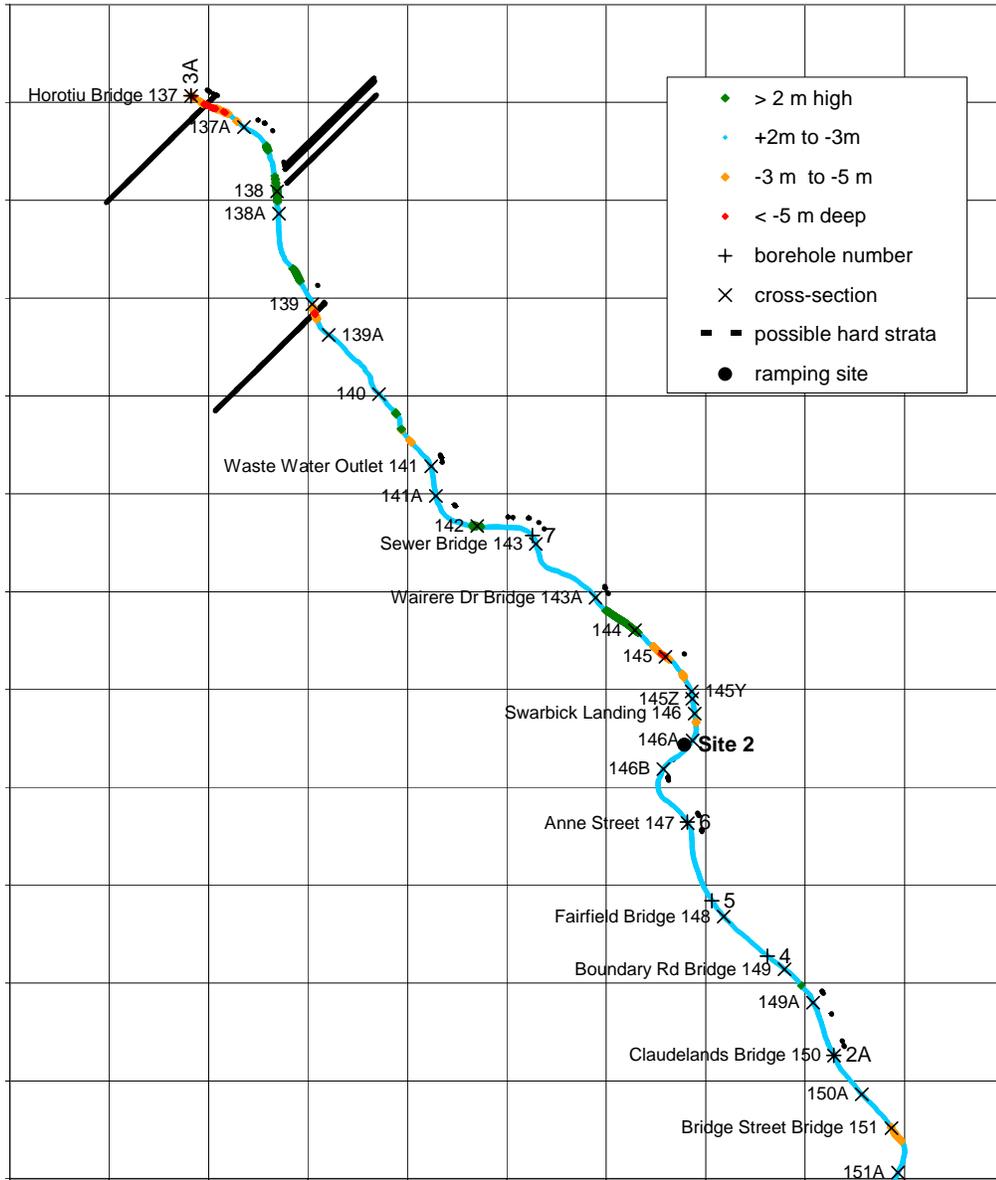
**Figure 2 Bed levels of Northern Hamilton reaches, indicated by deviation of the thalweg elevation from its linear trend line. Possible hard strata, cross-sections and borehole measurement locations are shown. Grid size is 1km.**

In these figures, dark green points show where the thalweg lies over 2 metres above the trend line. Such high points are potential hard sills in the bed. Black dots alongside the river right bank show where the seismic survey indicated

Four locations where high points correspond to potential hard strata are marked on the figures by diagonal lines rising to the right of the river. These are located 1.25 km and 1.43 km upstream of Horotiu Bridge on Fig. 2 and between 0.45 km and 2.53 km downstream of the Narrows Bridge on Fig.3. There are three high areas (shown in green) in the central Hamilton region. These are located halfway between sections 153A and 153Z on Fig. 3, and on Fig. 2 between Boundary Rd Bridge and section 149A and from section 144 downstream. None of these correspond to locations of hard strata indicated by the seismic survey. In Hamilton the thalweg is quite flat from just below Bridge St to the golf course just upstream of Swarbick Landing on Fig. 2. The flat bed could indicate an alluvial substrate with no hard sills.

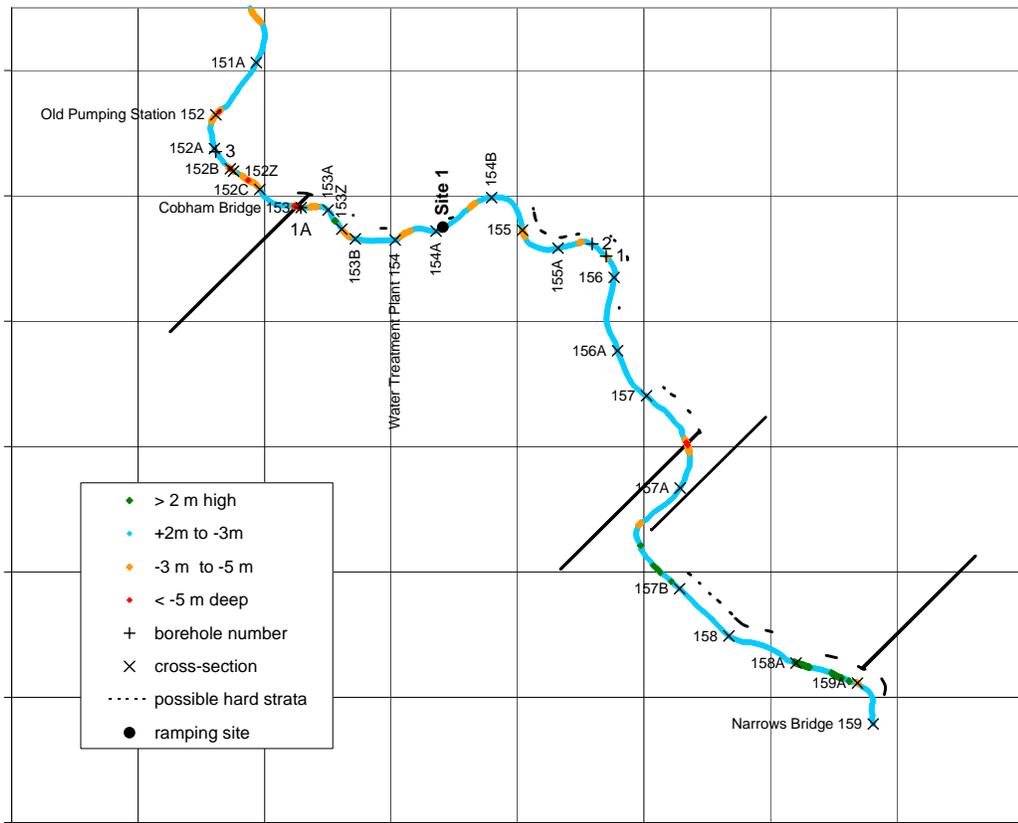
**Figure 3 Bed levels of Southern Hamilton reaches, indicated by deviation of the thalweg elevation from its linear trend line. Possible hard strata, cross-sections and borehole measurement locations are shown. Grid size is 1km.**

Low points in the thalweg are shown on Fig. 2 and Fig. 3 in orange and very low points are shown in red. Four locations where very low points correspond with indications of potential hard strata are shown by diagonal lines to the left

of the river. These are at 180 m upstream of Horotiu Bridge (where the bed is only 0.39 m above sea level datum), 2.77 km upstream of Horotiu Bridge (bed level is 1.01 m above datum), 30 m downstream of Cobham Bridge (bed level is 1.08 m above datum) and around half way between cross sections 157 and 157A north of the city (bed level is 2.52 m above datum). There is a notable low section downstream of the golf course, near section 145 where the bed level falls to 1.43 m above datum and no hard strata were indicated. Low points in a thalweg are typically found on the outside of river bends (see orange and red reaches on Figs 2 and 3). While this explains many of the low points between the Narrows and the Golf Course, downstream of Swarbick Landing there are deep sections in straight reaches.

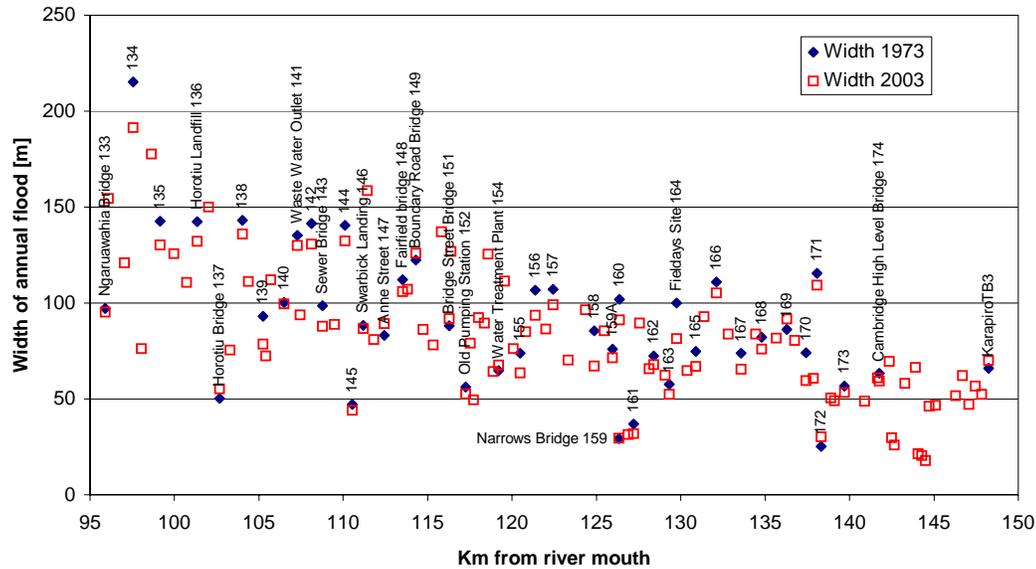
**Figure 4 Profile of flood widths from Ngaruawahia to Karapiro in 1973 and 2003.**

The flood widths narrow from over 150m near Ngaruawahia to less than 50m near Karapiro. At most sections, the width of the mean annual flood has narrowed over a 30 year period (blue diamonds lie above the red squares on Fig. 4). Summary statistics on annual flood width in the Hamilton region are given in Table 1. The apparent increase in mean width between 1991 and 1998 is mainly because the average width of an additional 25 cross-sections included in the 1998 and 2003 surveys was greater than the average width of the earlier sections.

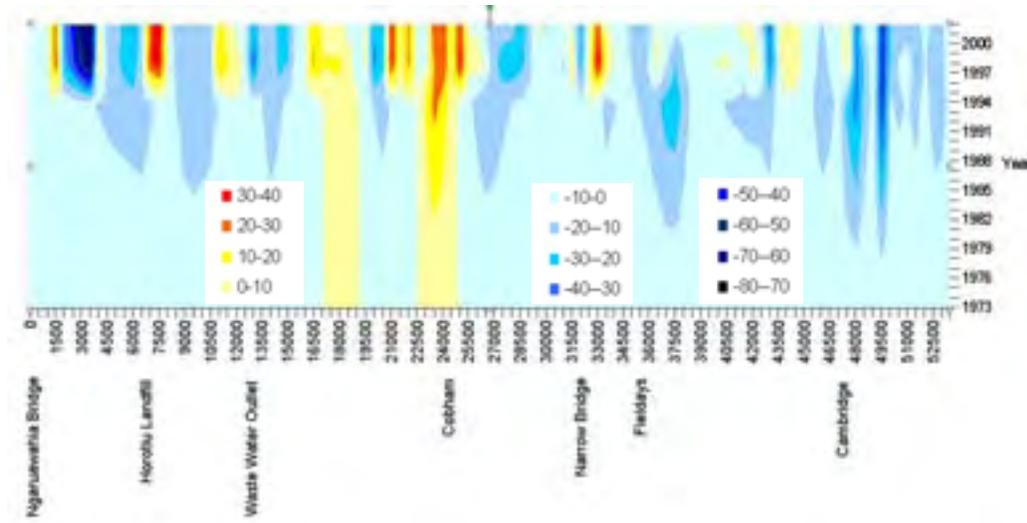
**Figure 5. Changes in width of an average annual flood from Ngaruawhia Bridge to Karapiro between 1973 and 2003 (yellow, orange and red indicate widening up to 40 m, darker blue regions show narrowing of up to 80m). Ref. EWDOCS-#923799.**

The greatest increases in width occur just upstream of Horotiu Landfill and close to the city centre (from the Water Treatment Plant to Anne Street).

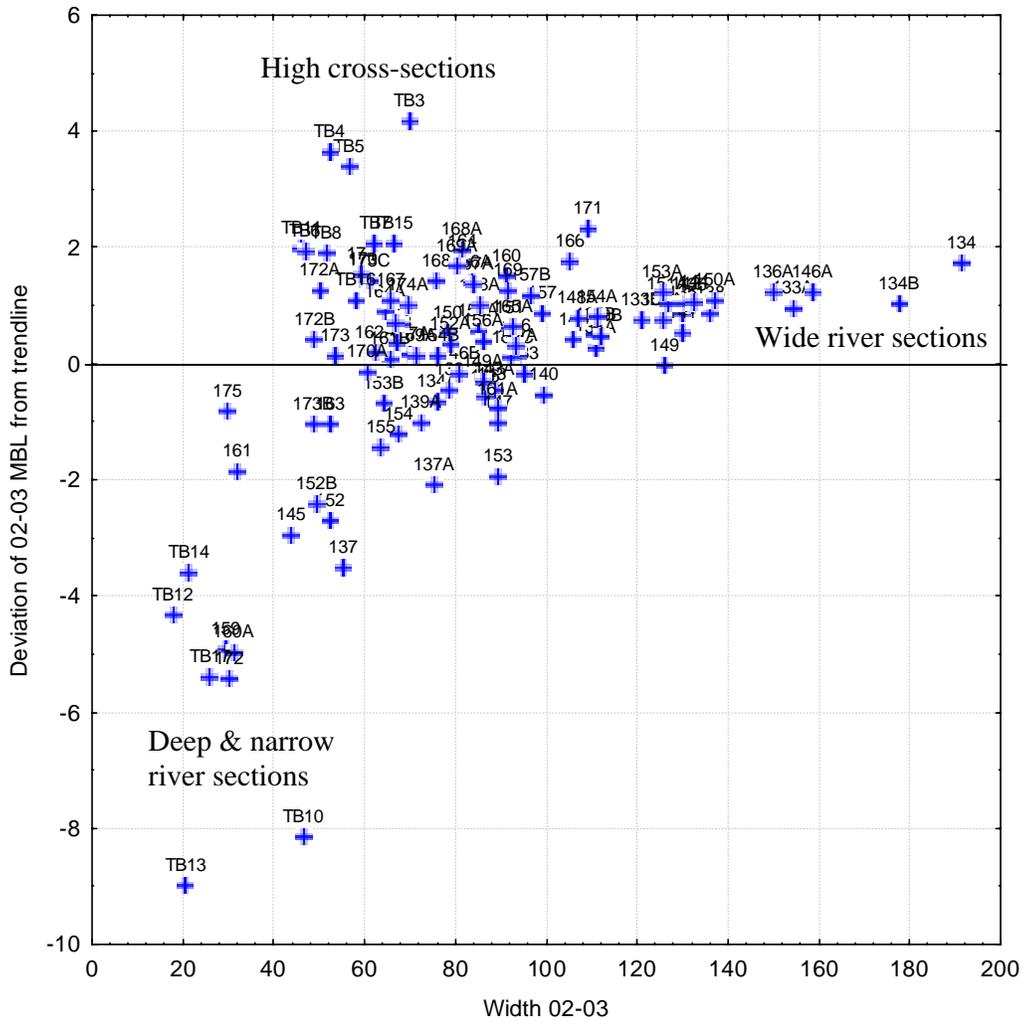
Fig 6 shows deviation of the MBL from its trend line and the annual flood reference widths for the 2003 survey. This figure demonstrates that wider cross sections deviate very little from the trend line (reaches of 80 m width or greater are generally within 2m of the trend line). The two widest sections lie downstream of Horotiu.

The deepest reaches (relative to the trend line) are also narrow and lie close to Karapiro Dam (TB section numbers on Fig. 6). The highest reaches (relative to the trend line) have moderate widths and also lie close to Karapiro Dam. It is understood that these very high reaches are situated on bedrock. When these reaches are excluded a clearer pattern is evident as shown in Fig. 7 which shows the same data for reaches between Horotiu Landfill and Narrows Bridge.

**Figure 6 Deviation of Mean Bed Level from its trendline and flood width for the 2003 survey data, Ngaruawahia to Karapiro.**

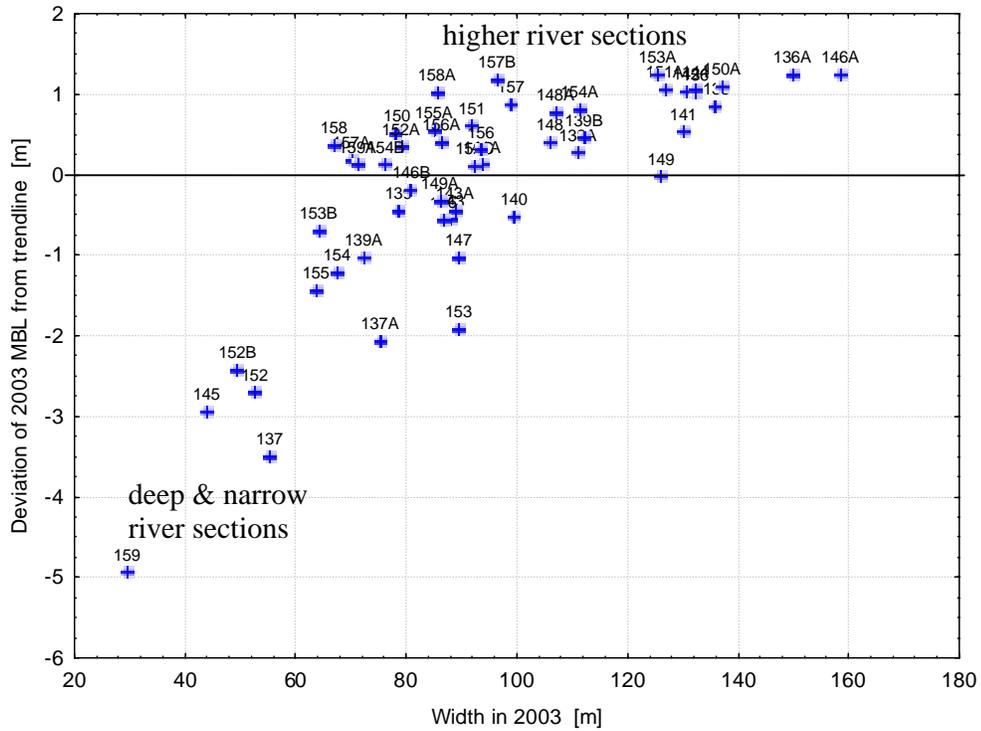
**Figure 7 Deviation of mean bed level from its trend line and flood width for the 2003 survey data, Horotiu Landfill to Narrows Bridge cross sections.**

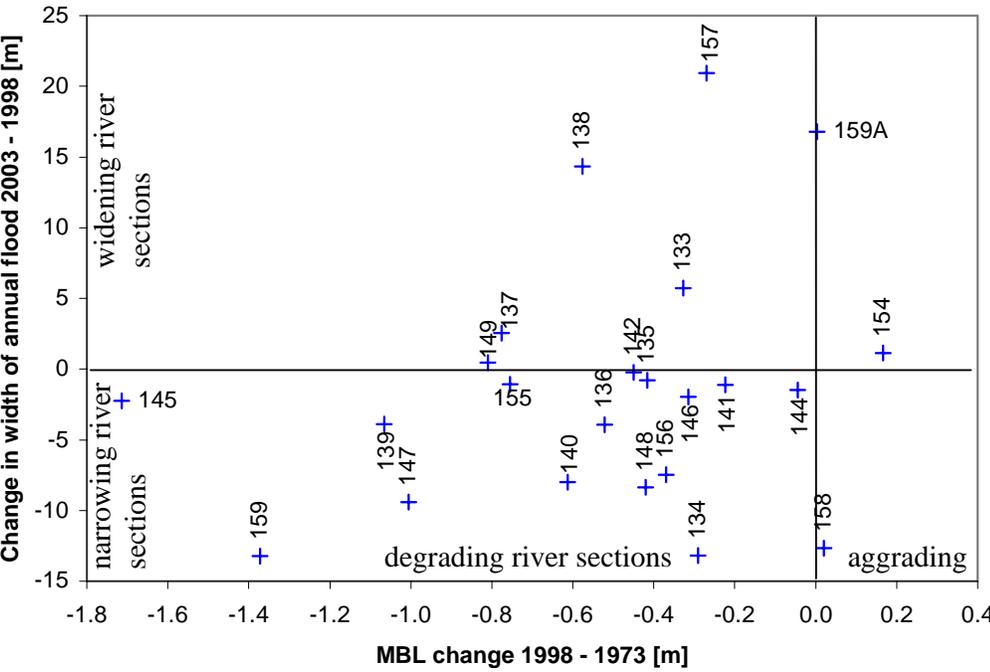
To investigate evidence of degradation heralding bank erosion, changes in MBL between 1973 and 1998 were compared with changes in flood width between 1998 and 2003. This is shown in Fig. 8 but no trend is evident which could indicate that sections which degraded prior to 1998 then widened post 1998. It is therefore concluded that the modelling reveals no evidence that a general switch from deepening to widening has occurred.

**Figure 8 Changes in mean bed level between 1973 and 1998 and changes in annual flood width between 1998 and 2003 for sections between Ngarauwahia and the Narrows.**

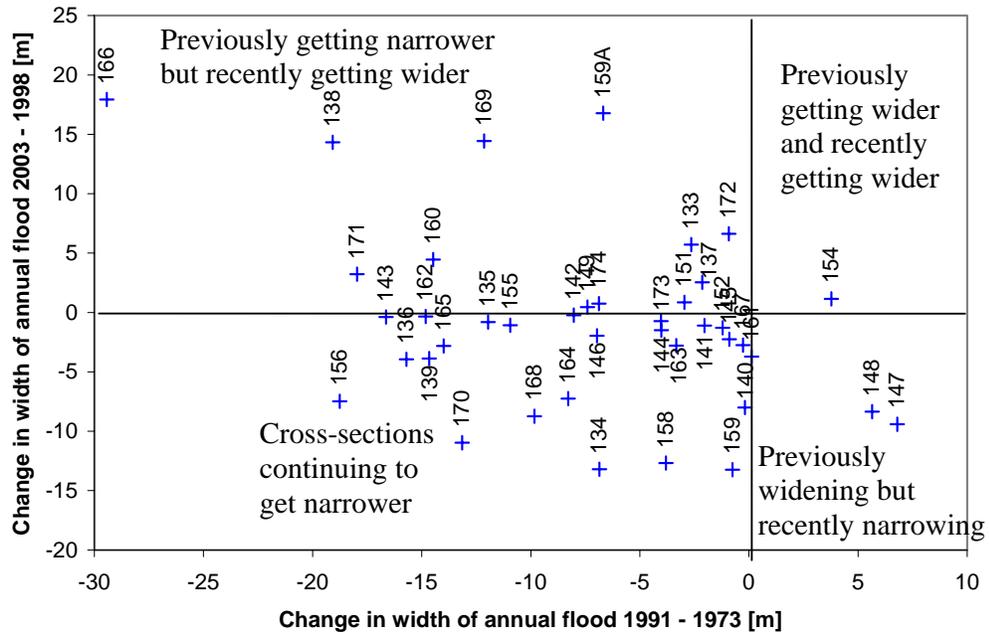
Fig. 9 shows the changes in width between the 1998 and 2003 surveys compared with the changes in width between the 1973 and 1991 surveys. Negative changes indicate that the channel is narrowing with time.

**Figure 9 Comparison of recent width changes with past width changes.**

This figure clearly indicates the dynamic nature of the degradation process with channels that were narrowing now widening and channels that were widening now narrowing. Within a 1m tolerance, there are no channels which were getting wider in the period prior to 1991 that are continuing to get wider post the 1998 survey.

As continued degradation must eventually lead to bank collapse, a continuation of the bathymetric surveys and LiDAR monitoring of banks every 5 – 10 years is recommended.

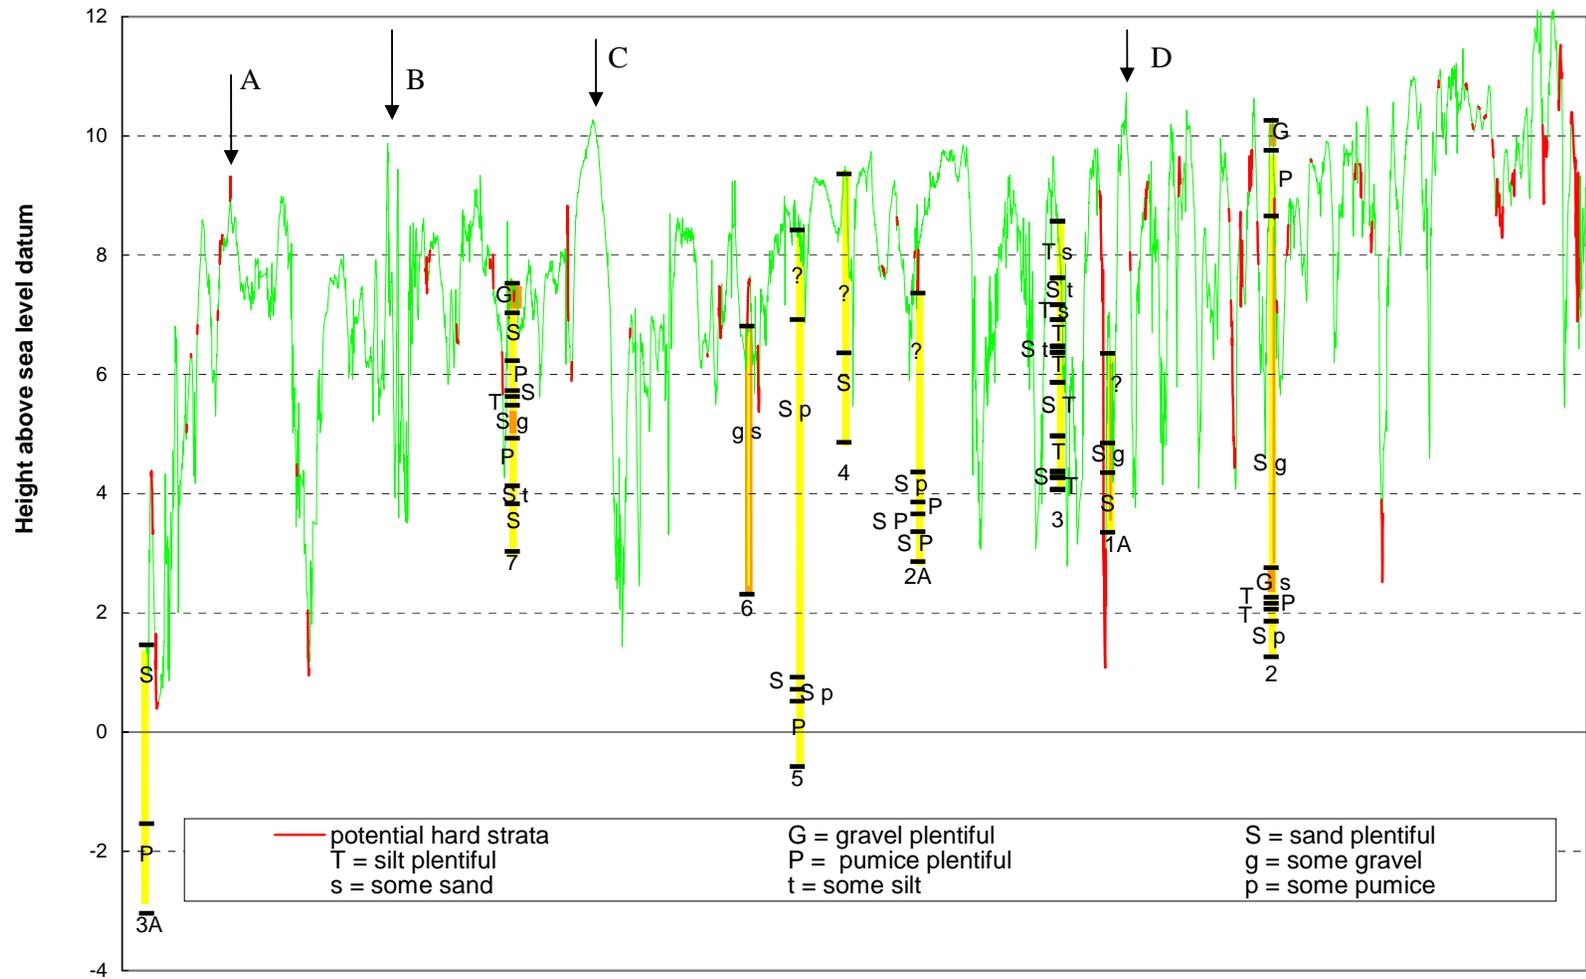
**Figure 10** Thalweg (green) between Horotiu and the Narrows showing initial borehole logs relative to potential hard strata (red). Borehole numbers are below the holes. Yellow strata are easily erodable, orange contain gravel. High sills are indicated by arrows.

Sills which presently appear to be controlling water levels are marked by arrows A – D on Fig. 10. It is suggested that further boreholes be drilled at these sites to investigate whether hard sills exist. Information from these bores will be invaluable if it becomes necessary to construct bed stabilisation sills at some stage in the future. It is also suggested that a further borehole be drilled at the location of ramping measurement site 2 as discussed in section 6. The recommended locations for supplementary boreholes are given in table 2.
