In the matter of: Clause of Schedule 1 – Resource Management Act - Submission on publicly notified plan change – Proposed Waikato Regional Plan Change 1 – Waikato and Waipa River Catchments (PC1)

And: **Hill Country Farmers Group (HCFG)**

Water monitoring information relating to the Waerenga, Whangamarino at Jefferies Road Bridge, Matahuru and Mangapiko Sub-Catchments as identified in the Waikato Regional Council Healthy Rivers Proposed Plan Change 1 (PC1)

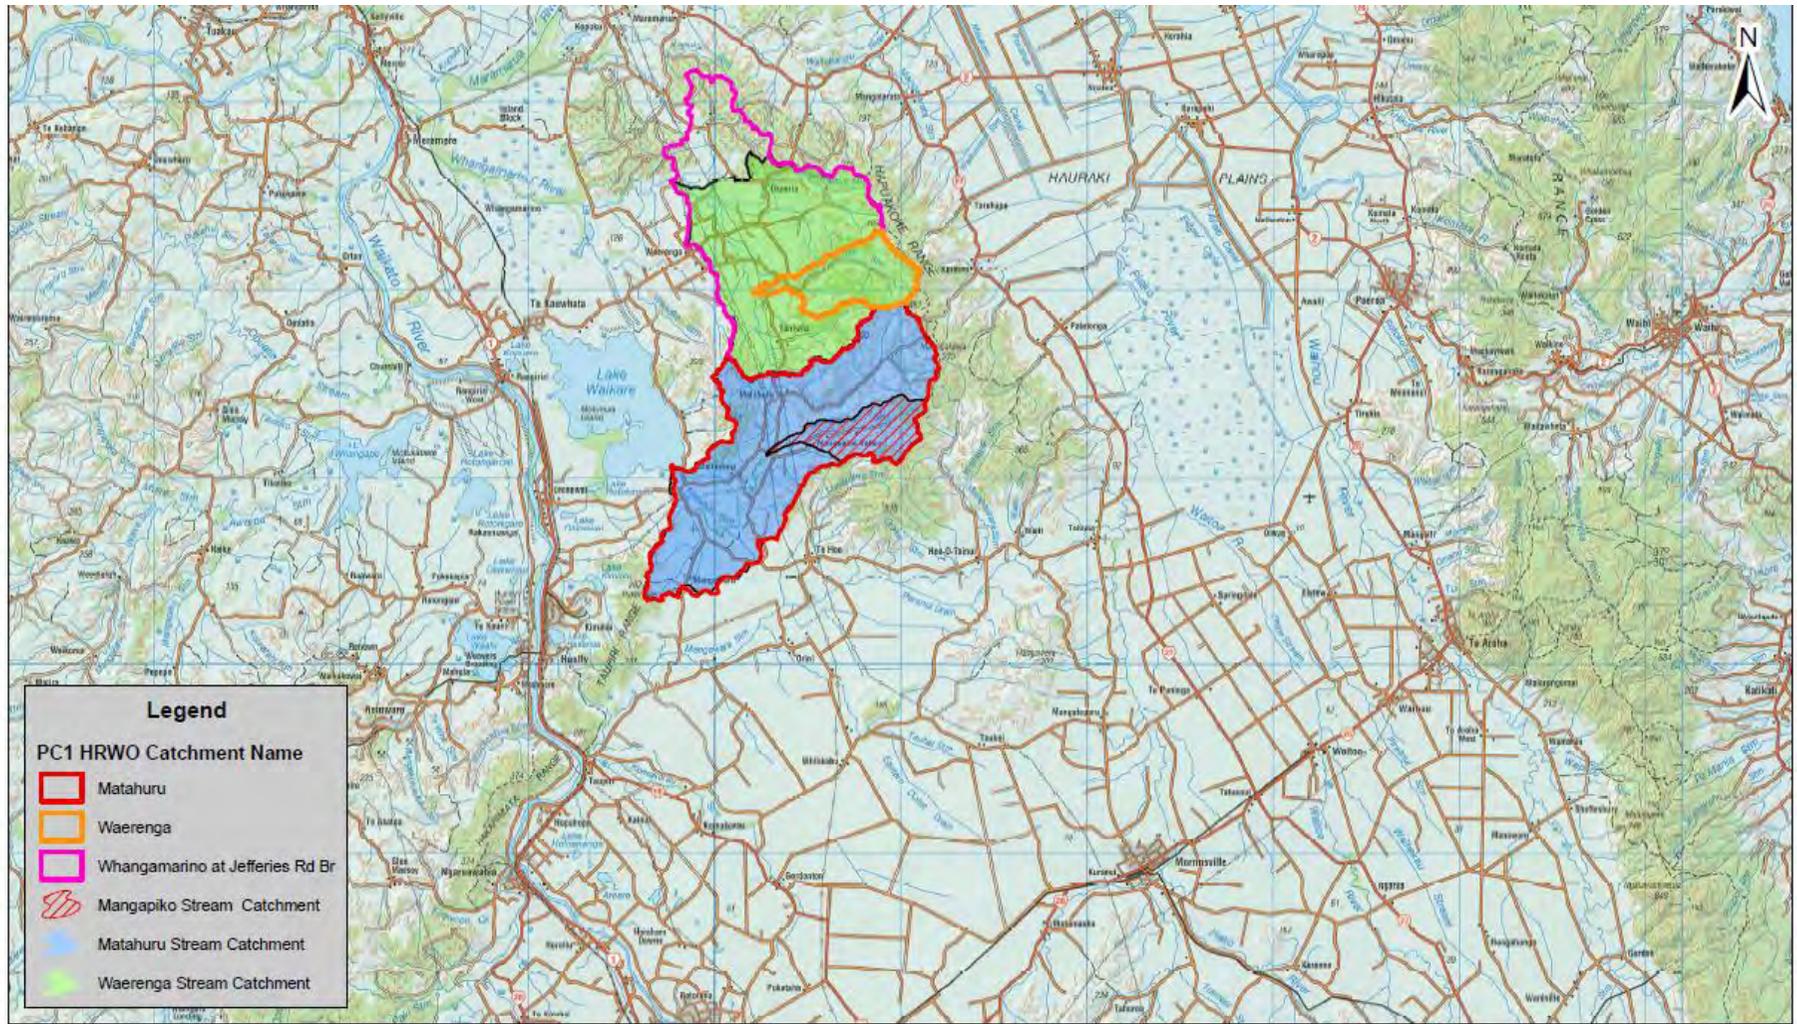
Figure 1 Stream catchments and PC1 sub-catchment boundaries of investigation area

3. This specific analysis was undertaken to determine relevant sampling locations and available water quality information held by WRC for the Waerenga, Whangamarino at Jefferies Road Bridge, Matahuru (including Mangapiko) sub-catchments, refer Figure 1 for stream catchments and PC1 adopted sub-catchment locations that form the basis of this investigation.

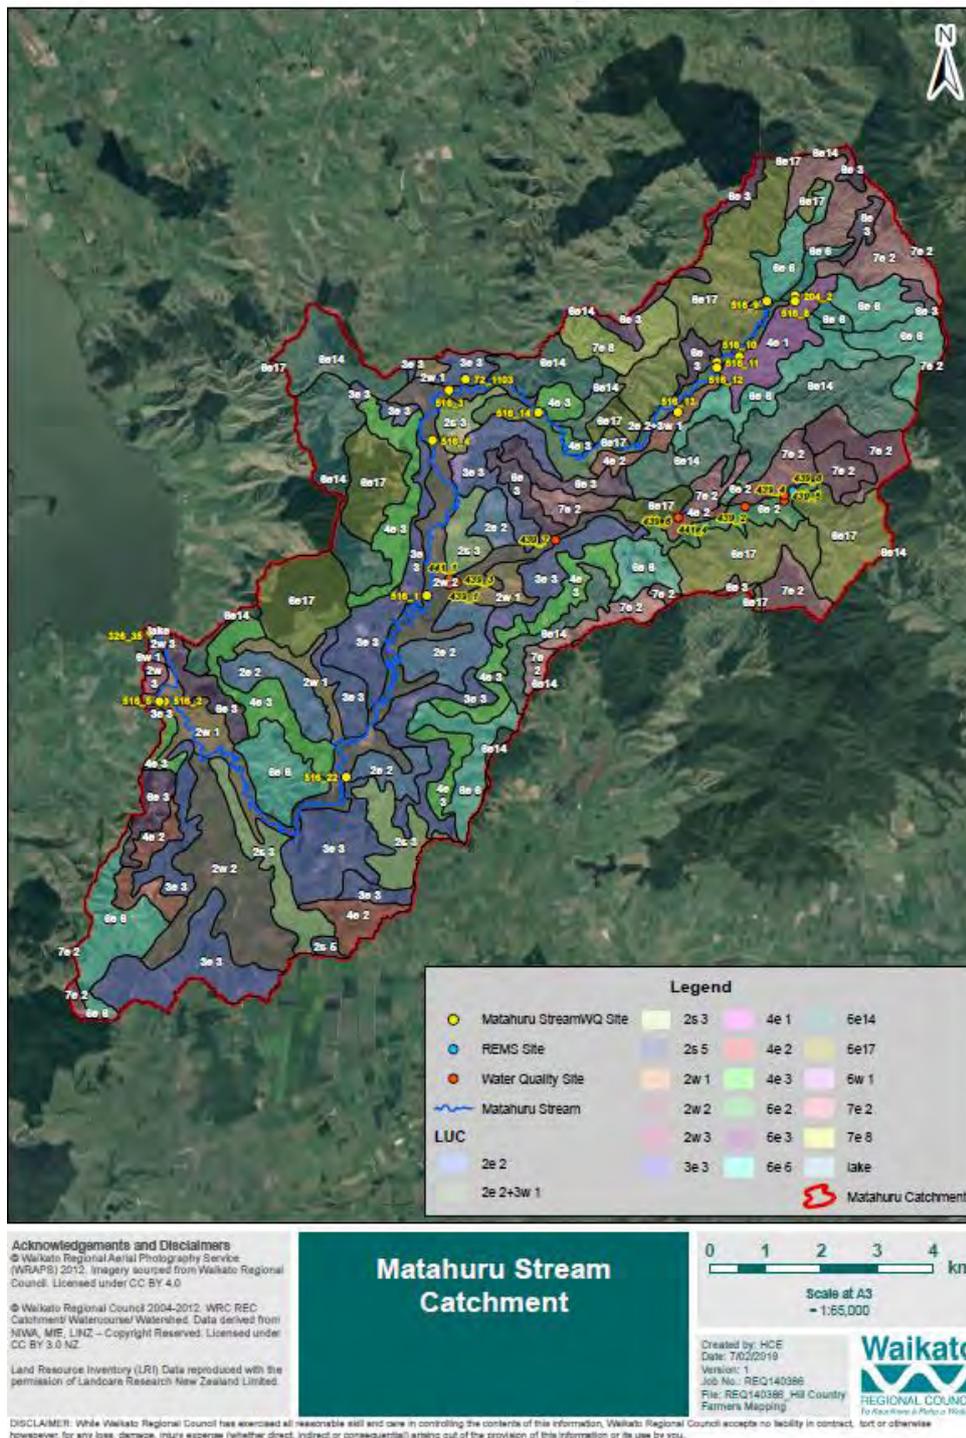
4. Figure 2 shows the Matahuru Stream (running north to south west) and Mangapiko Stream (running east to west/south west) catchments, both located within the Matahuru sub-catchment defined by PC1. Water quality sampling locations are identified along each of these streams, as provided by Waikato Regional Council (WRC). Of the 16 sampling locations shown along the Matahuru Stream, none have sampling data available. There is one sample location for water quality located on the margin of Lake Waikare to the north west, outside of the sub-catchment area. There are no Regional Ecological Monitoring Sites (REMS) on this stream.

Figure 2 Matahuru Stream Catchment and Freshwater Management Unit

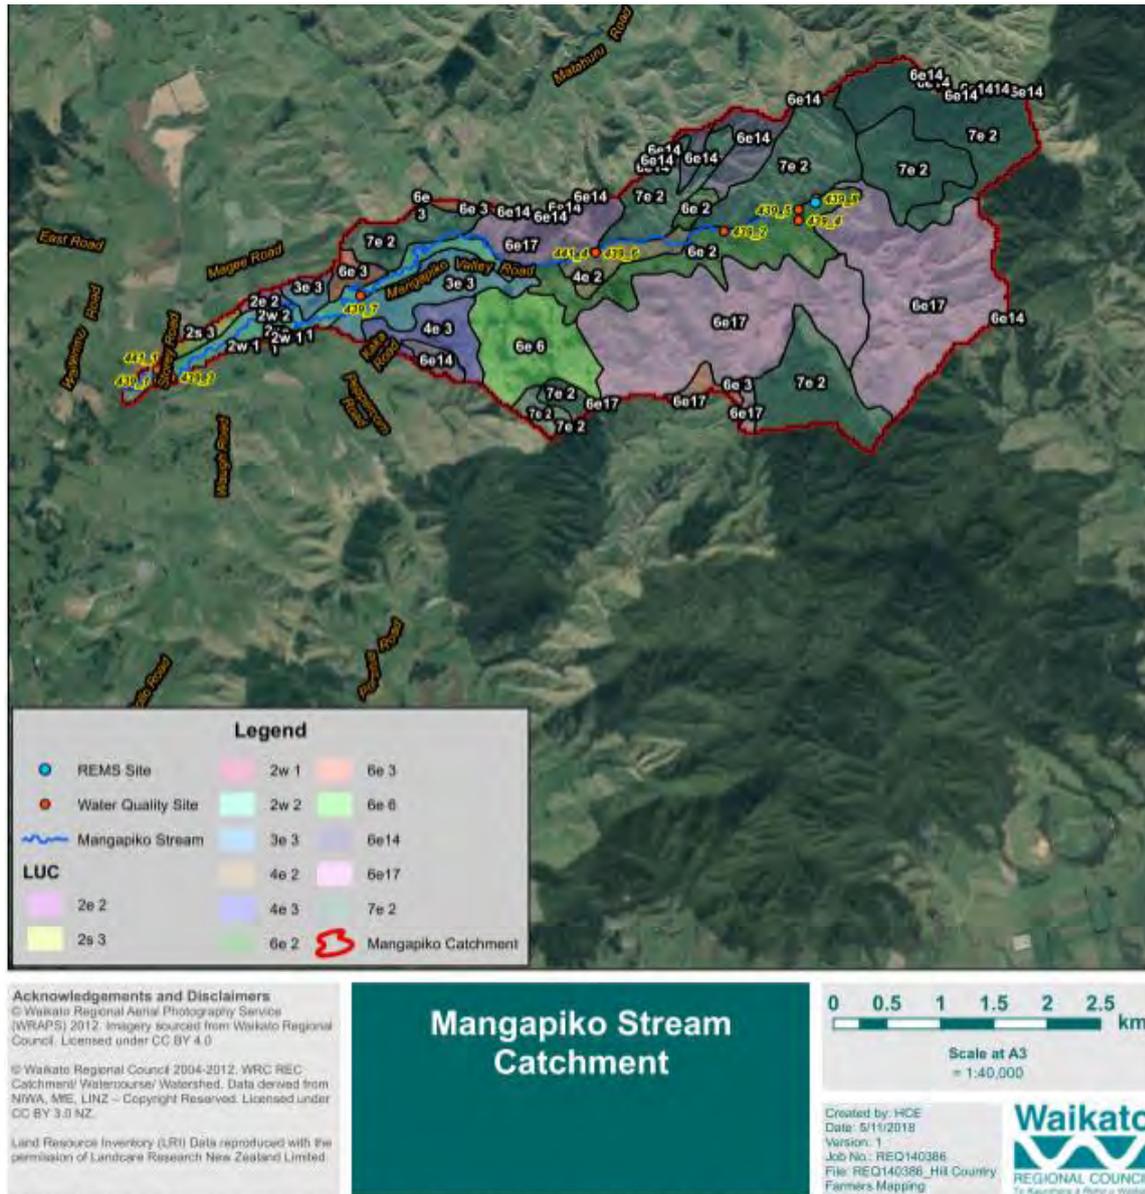
- The Mangapiko Stream, identified in Figure 3, is a soft bottomed stream that runs through a variety of land uses and topography including forestry (7e2); Hill Country Sheep and Beef (7e2; 6e17; 6e14; 6e3; 6e2); dairy farming (including extensive areas of maize within operations) (4e3; 4e2; 3e3; 2w2; 2e2; 2w1; 2s3) (some ground truthing occurred in gathering this information). This stream has ten sampling locations identified by WRC along its length. It was considered that any sampling location with more than five years data would be useful in interpreting trends in a particular location. Only one sample location had sufficient data (please refer to Table 1 and Figure 4 below). This sampling location was a Regional Ecological Monitoring Site (REMS) at the bottom of the Mangapiko stream catchment where sampling for macroinvertebrate populations is undertaken in accordance with protocol P2 of Stark et al. 2001¹.

Figure 3 Mangapiko Stream Catchment, contained within the Matahuru Freshwater Management Unit

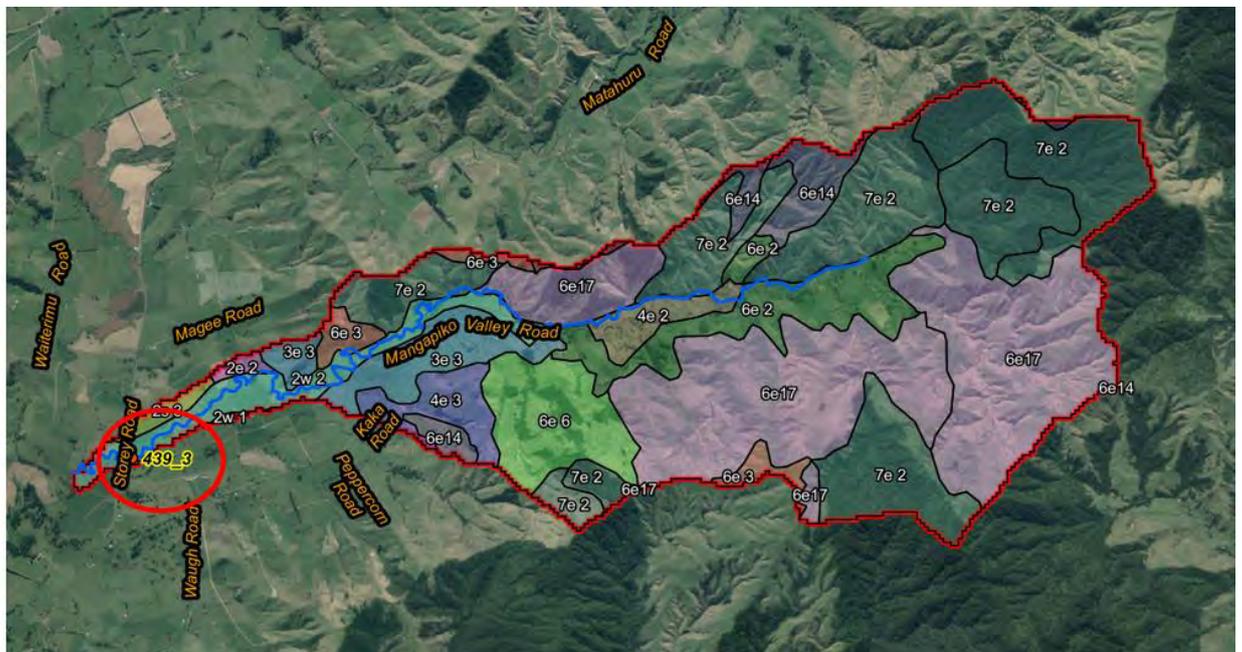
Figure 4 Location of sampling point 439_3 in Mangapiko Stream, at bottom of sub-catchment

- Seventy per cent of Mangapiko Stream sampling locations had a single sample undertaken (or less) with no follow up sampling carried out. Only one sample location, 439_3, had over five years of data collected. This is a Regional Ecological Monitoring Site (REMS), addressing MCI. This site is located at the bottom of the sub catchment, adjoining a road, surrounded by dairy farming and maize, with minimal riparian vegetation (refer Figures 4 and 5 below).

7. The sampling undertaken in this location may provide an indication as to the state of water leaving this sub-catchment, however, it is considered that this particular location is likely to be heavily influenced by local factors.

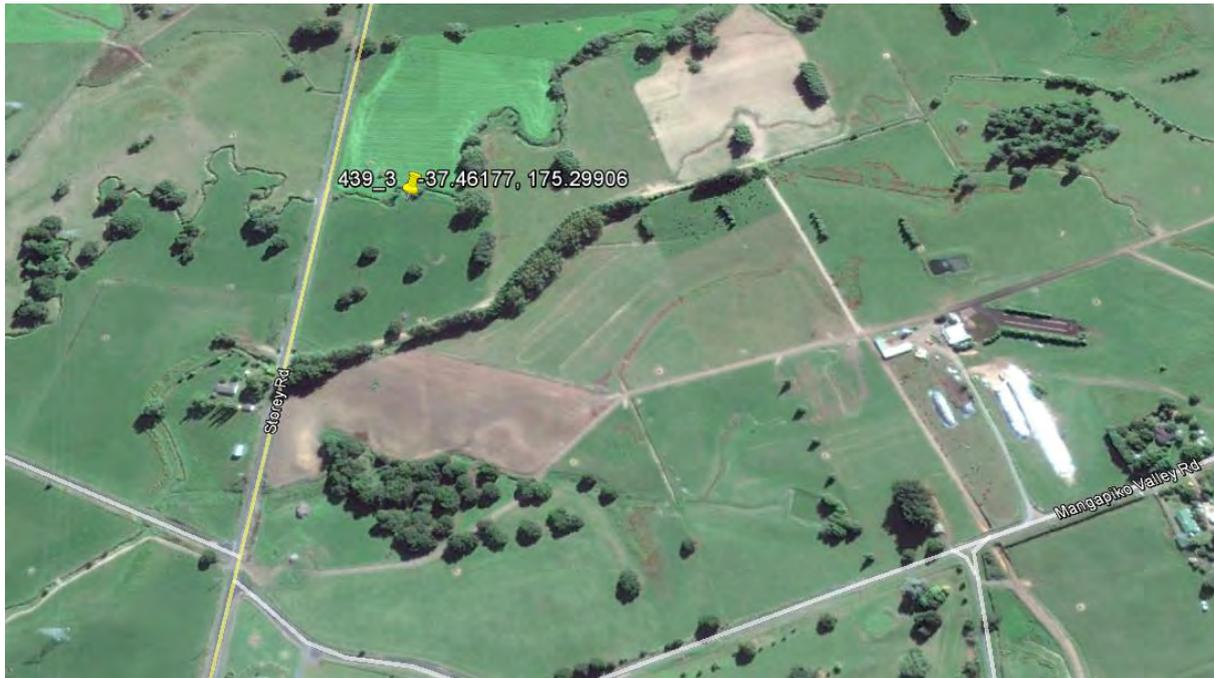
Figure 5 Location of sampling point 439_3 on the Mangapiko Stream, image courtesy of Google Earth

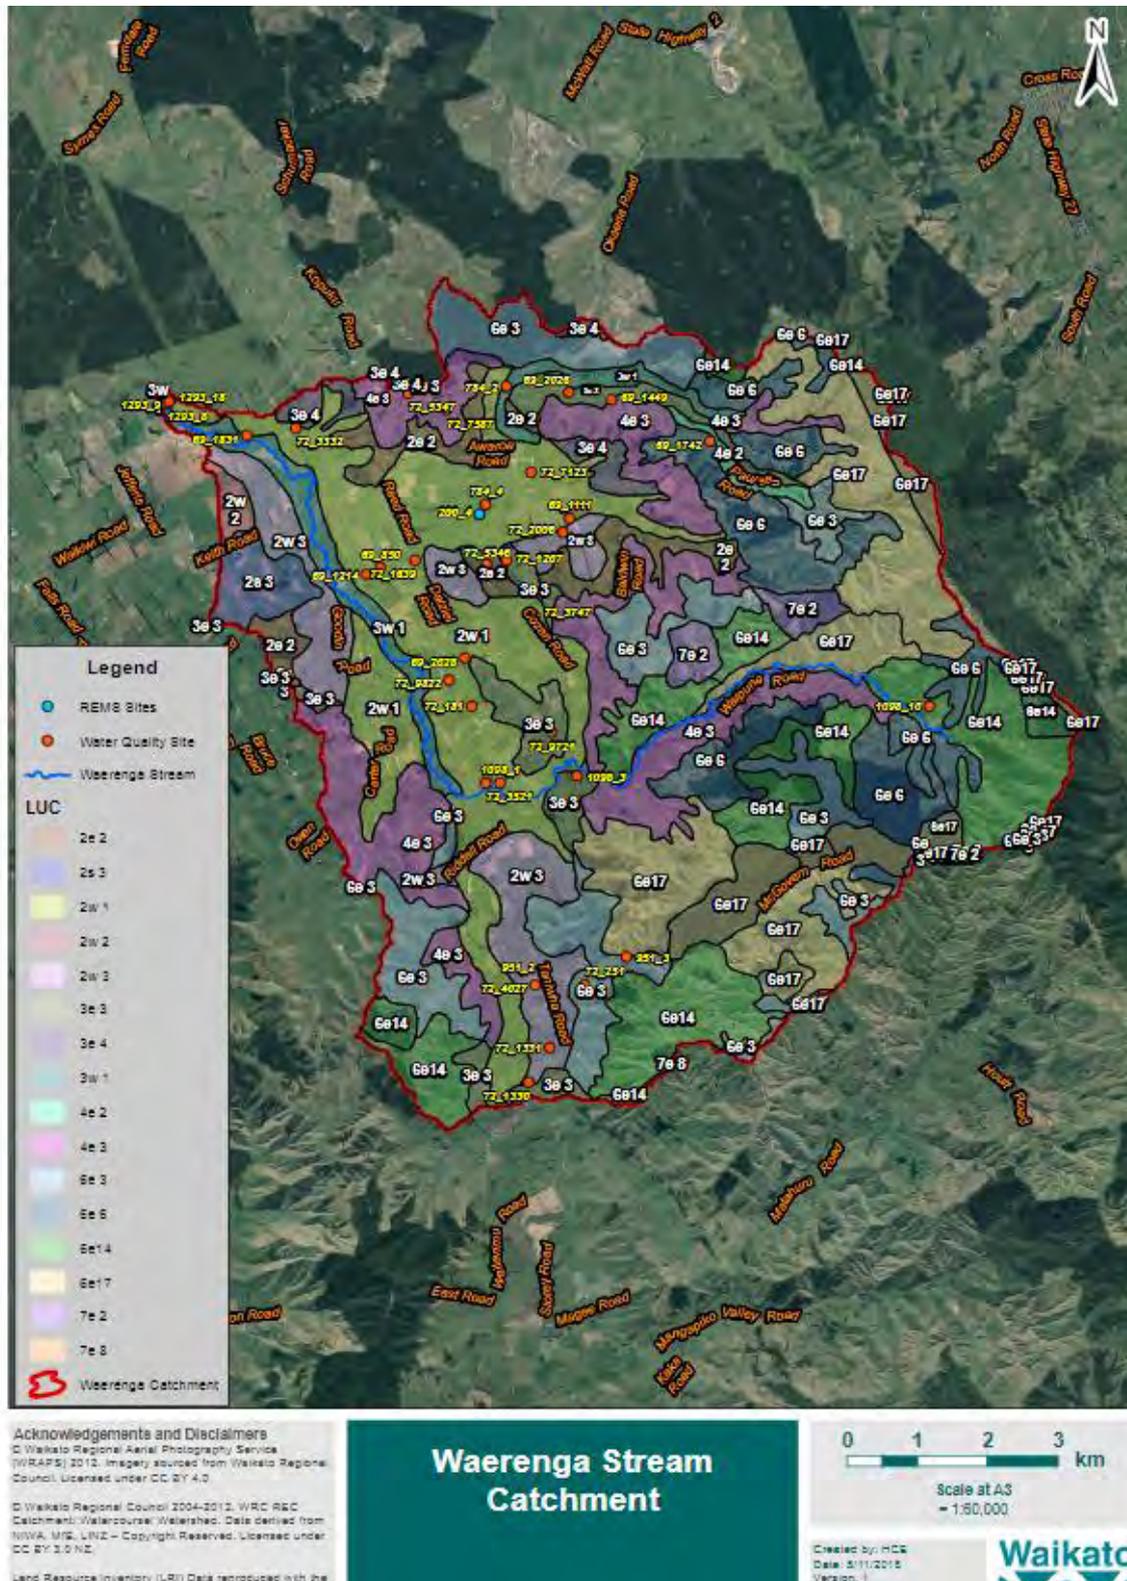
Figure 6 Waerenga Stream Catchment showing all WRC identified sampling locations

- The Waerenga Stream catchment includes both the Waerenga and Whangamarino at Jefferies Road Bridge sub-catchments, as depicted in PC1. This area is located directly north of, and adjoining, the Matahuru sub-catchment. Please refer to Figure 1 for location map and to Figure 6 for a map of the Waerenga Stream Catchment showing all WRC sampling locations.

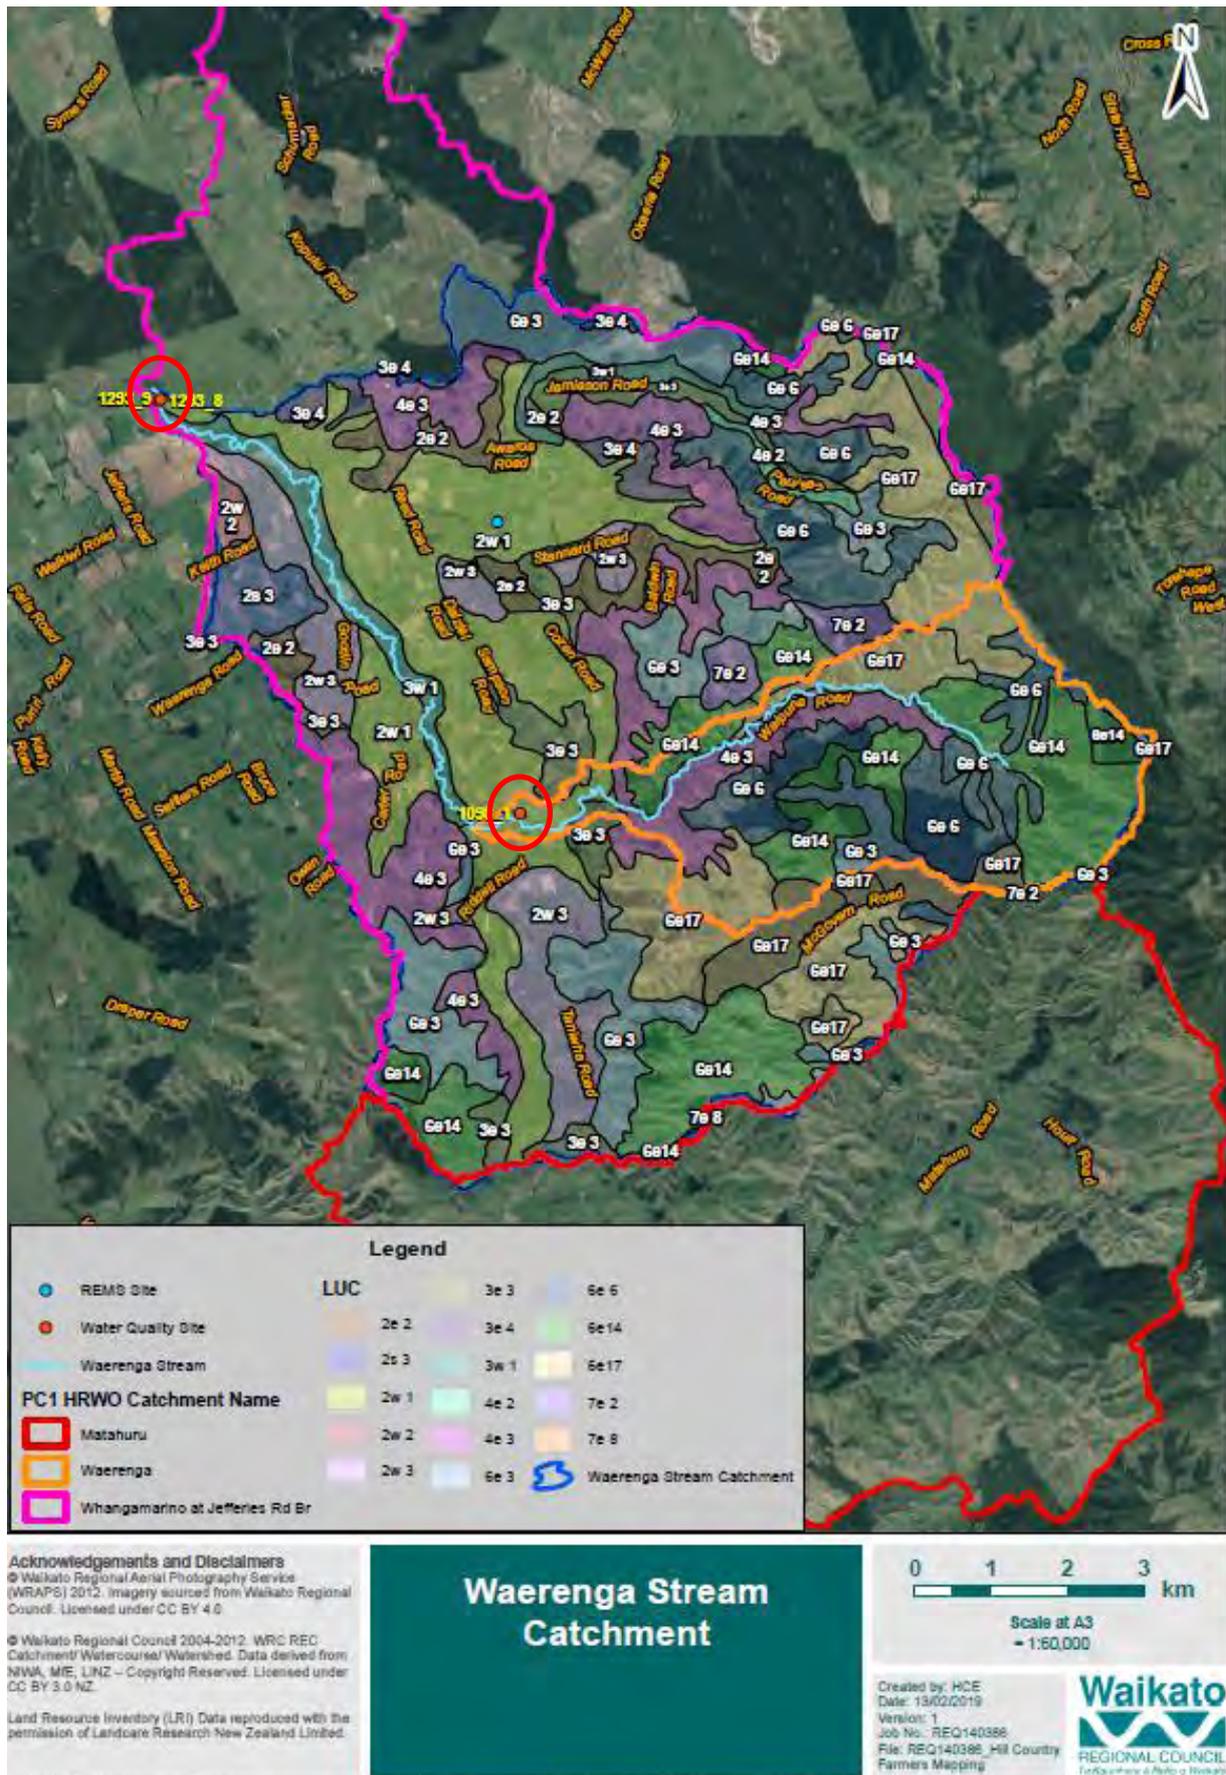
Figure 7 Sampling locations with over five years data available within the Waerenga Stream Catchment.

9. The Waerenga Stream catchment has 36 Sampling Locations recorded by WRC along this stream. Three of these sampling locations have over five years data. All are located on class 2 or 3 land in the lowest reaches of their relevant sub-catchment and are surrounded by dairy farming. Refer Table 2 and Figure 7 below.

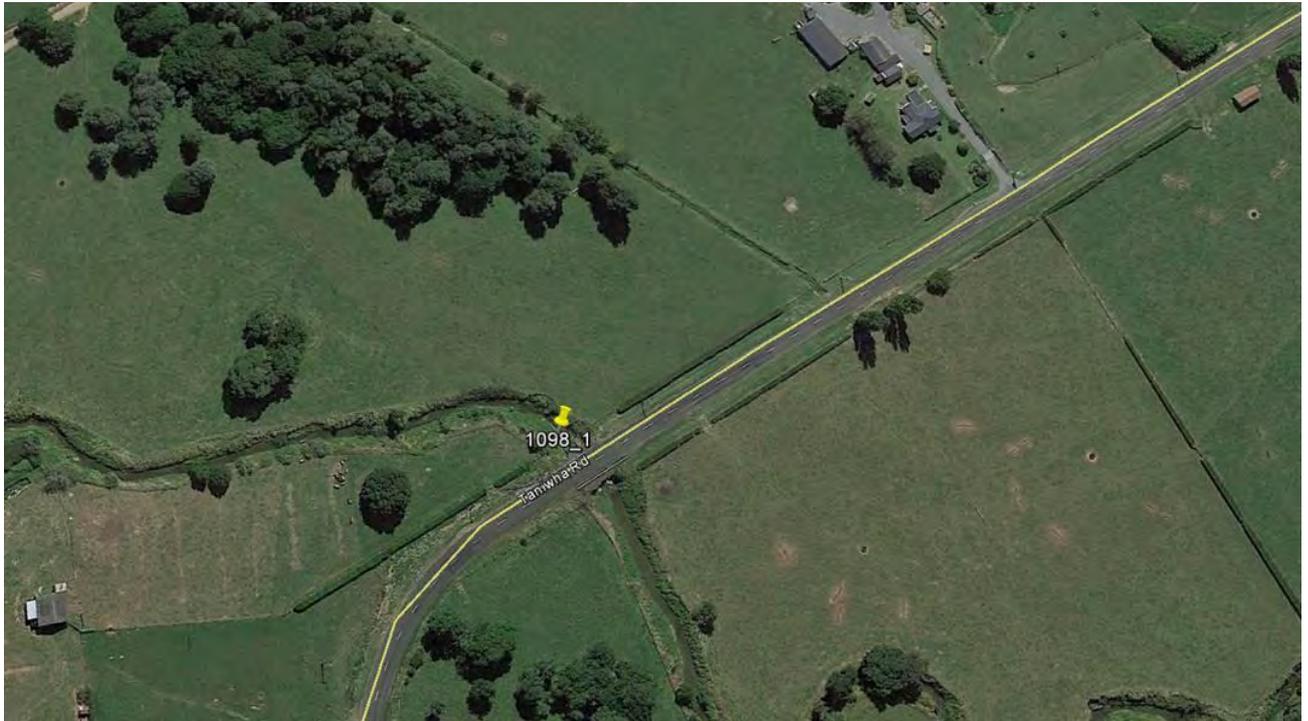
10. Sampling point 1098_1 is located on the Waerenga Stream at Taniwha Road. The location traverses Class 2 land, is surrounded by dairy farming with minimal riparian vegetation and is located at the bottom of the Waerenga sub-catchment as defined in PC1, bounding the Whangamarino at Jefferies Road Bridge sub-catchment (refer Figure 8 below).

Figure 8 Taniwha Road sampling location, sample reference 1098_1

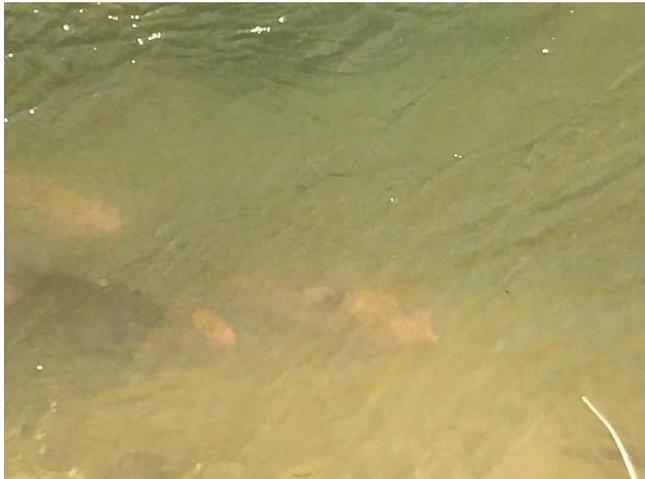
Photograph 1 Numerous Koi Carp visible in stream in close proximity to Taniwha Road sampling location, 1098_1

11. Water quality in this location meets the attribute threshold in PC1 for annual median Ammonia (short and long term) and no significant trend was detected for ammonia 1993-2017 in this location². Technical Report 2018/30 identified no significant trend for E.coli in this location. Turbidity and visual water clarity results however, both displayed a significant deterioration over time².
12. Ground truthing undertaken in relation to sampling point 1098_1 identified Koi Carp (*Cyprinus carpio*) on both sides of the stream surrounding the testing location. The landowner who bounds the stream indicated that Koi Carp have continued to erode the banks at the stream edge leading to significant slumping and sediment in the water column. He advised that his fencing was previously 1m from the stream edge, it is now only approximately half a metre (refer Photographs 1, 2, 3 below).

13. On average a female Koi Carp can produce 300,000 – 400,000 eggs during spawning and as they gather for spawning or feeding in the shallow margins of the Waikato river and tributaries, Koi biomass can reach 4000 kg/ha³. A study by Waikato University undertaken in October 2015 concluded that a biomass of 374 kg/ha of Koi Carp, could suspend 14.5 tonnes of sediment per day⁴. Research has confirmed that deposited fine sediment strongly affects river ecosystem health and it is considered likely that Koi Carp in these lower tributaries is a major contributor to the decline in visual clarity and turbidity.

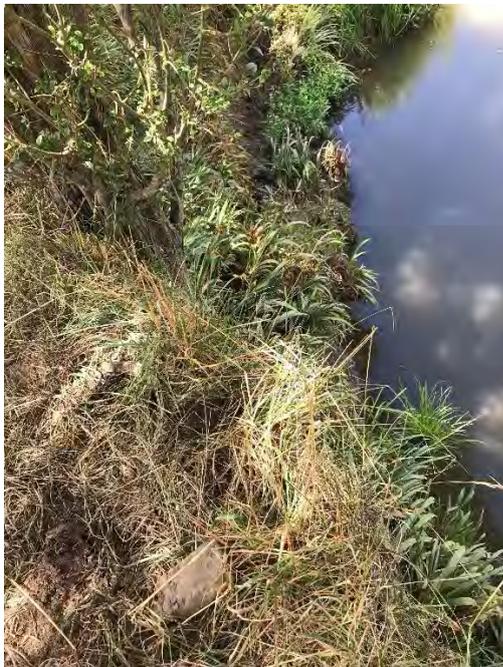
Photograph 2 Stream bank slumping reported by landowner to be caused by Koi Carp eroding the sediment beneath

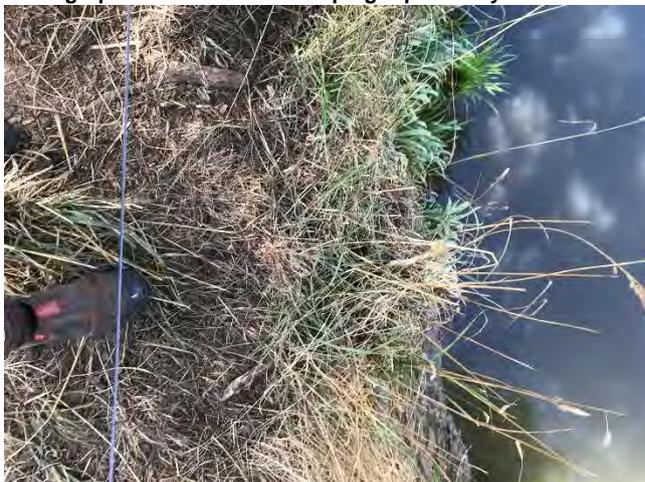
Photograph 3 Severely eroded stream bank location in relation to existing fence

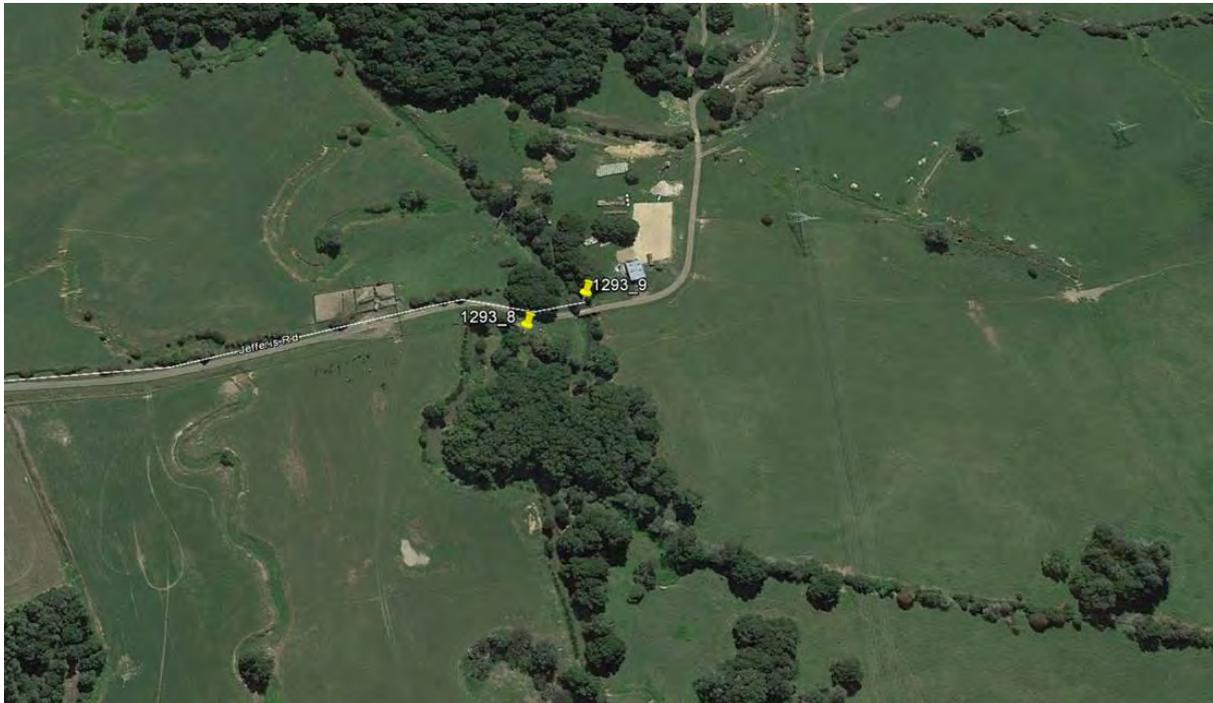
14. 1293_8 is REMS data (MCI) taken on a tributary on private land at Jefferies Road Bridge and again is at the bottom of the sub-catchment, surrounded by dairy farming. The location has minimal riparian vegetation (refer Figure 9).

15. 1293_9 is taken in the same location at 1293_8 and is surface water quality monitoring (refer Figure 9).

Figure 9 Whangamarino at Jefferies Road Bridge sampling locations, 1293_8 and 129 3_9

16. Water quality in this location showed significant improvement in Ammonia 1993-2017 (Technical Report 2018/30). No trend was reported in relation to E.coli⁵. Turbidity and visual clarity in this location both showed significant deterioration over time⁴.
17. These sampling locations are again likely to be affected by local influences. There are significant numbers of koi carp noted in this location.

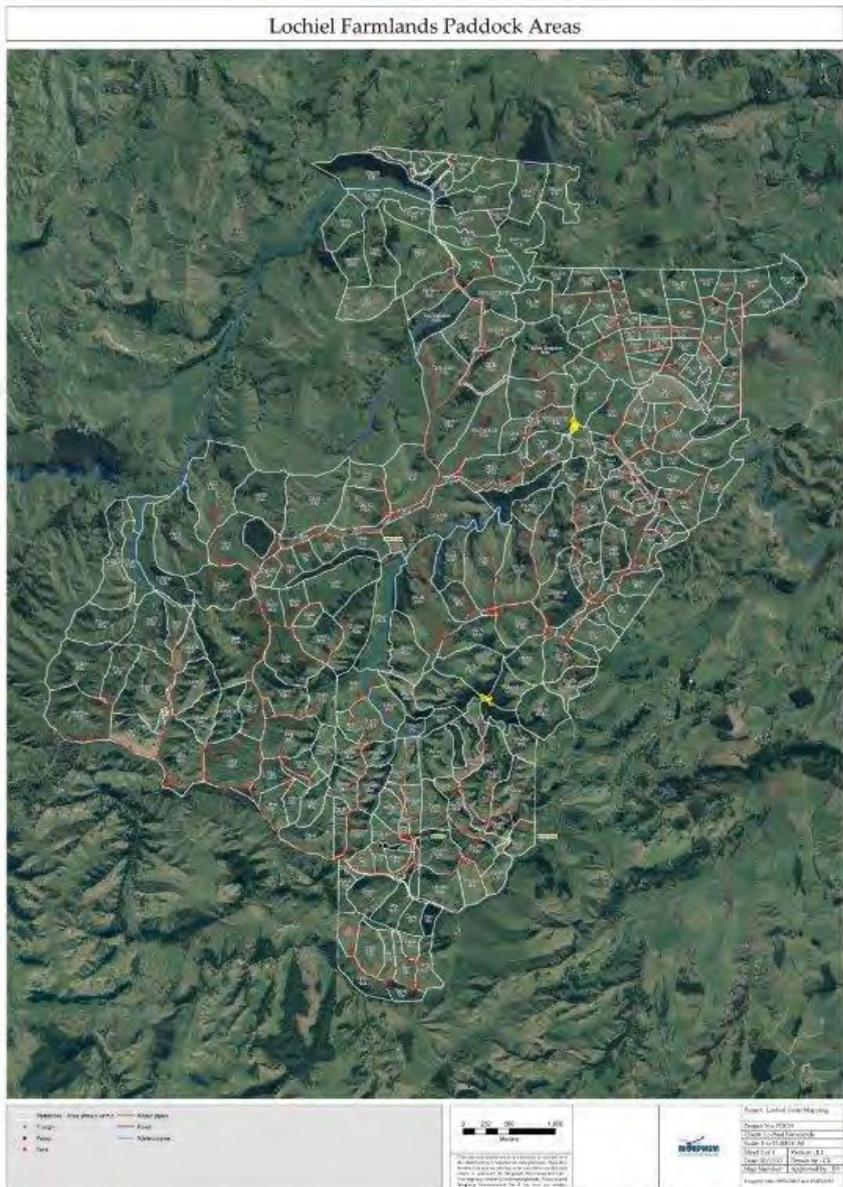
20. Since 2007 22, surface water samples have been taken from an upstream and a downstream location on the station. One at the stream's source within the property and the other on the property's northern boundary where the Mangatia meets the Opuatia Stream which drains into the Waikato River (refer Figure 10).

Figure 10 Map of Lochiel Station, yellow dots indicate sampling locations

21. Data while preliminary only, meet short term and long-term attribute levels in PC1 for Phosphorous; show no notable difference between upstream and downstream data over a ten year period (2007-2017) and do not increase over time.

22. Nitrate levels on Lochiel Station meet PC1 short- and long-term targets and excluding one outlier, show no difference in concentration upstream vs downstream over time.
