Report

2012 Waikato River Bed Degradation Analysis

4 MARCH 2013

Prepared for
Mighty River Power
160 Peachgrove Rd
P O Box 445
Hamilton
3240
42189500

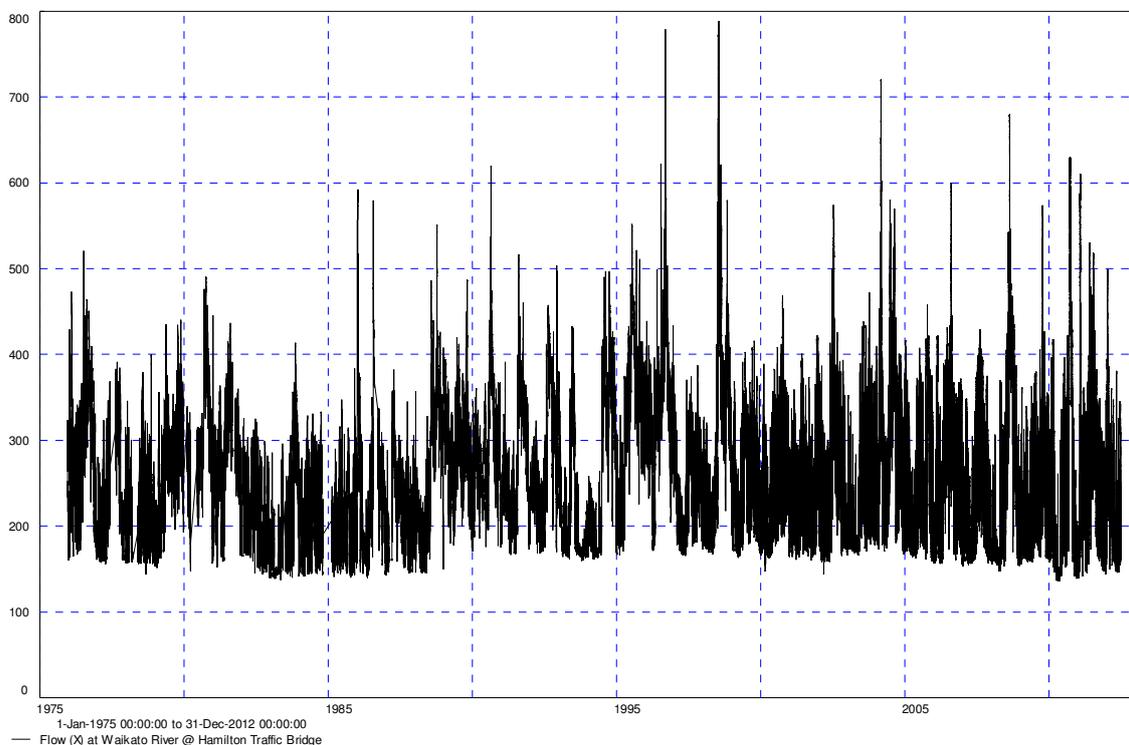
Figure 1-1 Waikato River flow (m³/s) at Hamilton Traffic bridge, 1975 - 2012

Figure 1-1 shows the flow regime 1975 – 2012, and an increase in baseflow is evident from the late 1980s. At this scale there is no obvious difference in flow regime since the mid-late 1990s. However, there are some subtle changes as discussed below.

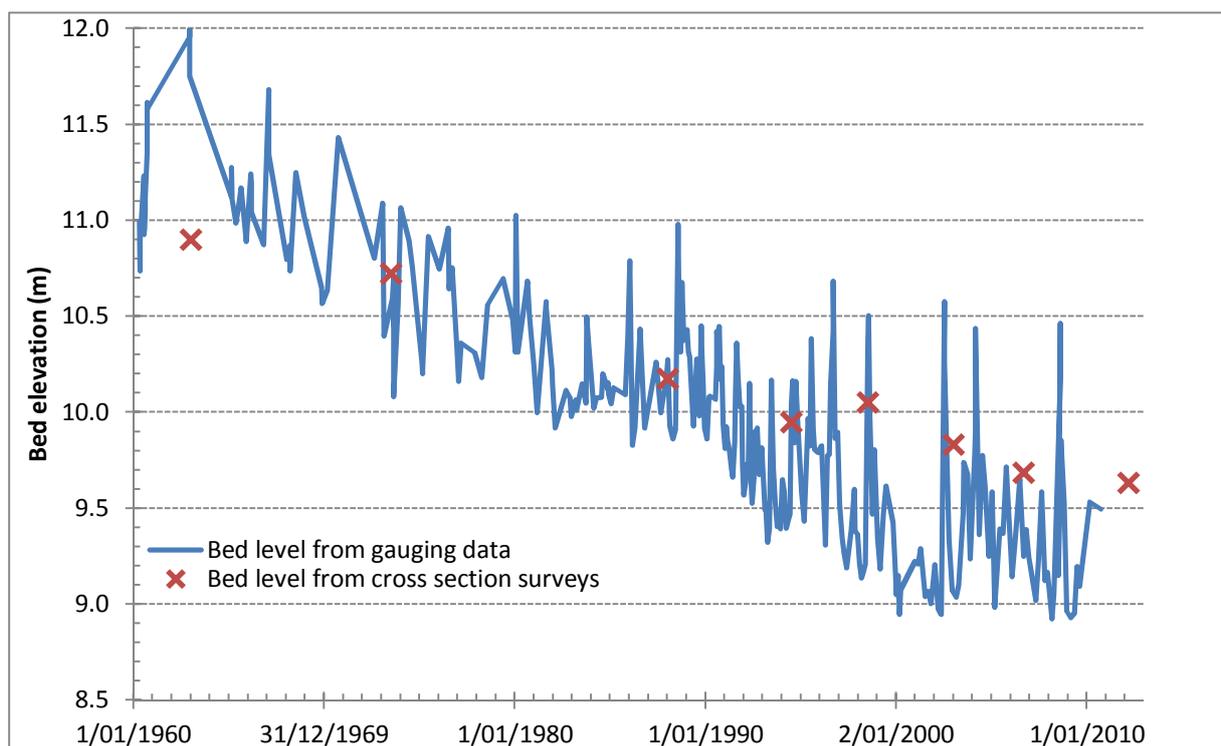
Figure 4-4 Waikato River mean bed levels at Hamilton Traffic bridge (xs 151), 1960 - 2012

Several periods are evident in the long term decline. From 1960 to 1981 the bed declined at ~42 mm/yr, while between 1982 and 1990 the degradation trend reversed, and the bed rose at 14 mm/yr.

Degradation resumed from 1991 until 2000 when the bed lowered at 56 mm/yr, the fastest rate over the period of record. From 2001 until 2010 bed degradation slowed to ~2 mm/yr. This reduced rate of bed lowering adds further weight to the above interpretation that degradation here is not currently threatening the stability of this bridge.

Figure 4-4 also shows the bed levels measured in the eight bed level surveys carried out at the bridge. It can be seen that these points form a different trend to the more frequently surveyed gauging data. For these the overall rate of degradation is 27 mm/yr.

Figure 4-1 shows this much longer and more complete record of bed level changes at the Hamilton Traffic Bridge up to late 2010⁹. This shows a long-term decline of bed level at the bridge, with a fall of ~2 m since 1960. The long-term trend¹⁰ was 44 mm/yr. However, it also shows there can be large short-term changes in bed elevation of up to one metre, presumably as mobile sediment bed forms pass the bridge. The short-term variability (about ±500 mm) is more than ten times greater than the calculated trend.

These observations have potentially important ramifications for interpretation of the five-yearly bed degradation data. If the bed is generally as mobile as these data suggest, changes determined from the infrequent 5-yearly surveys could be giving an incorrect impression of the overall pattern of bed degradation.

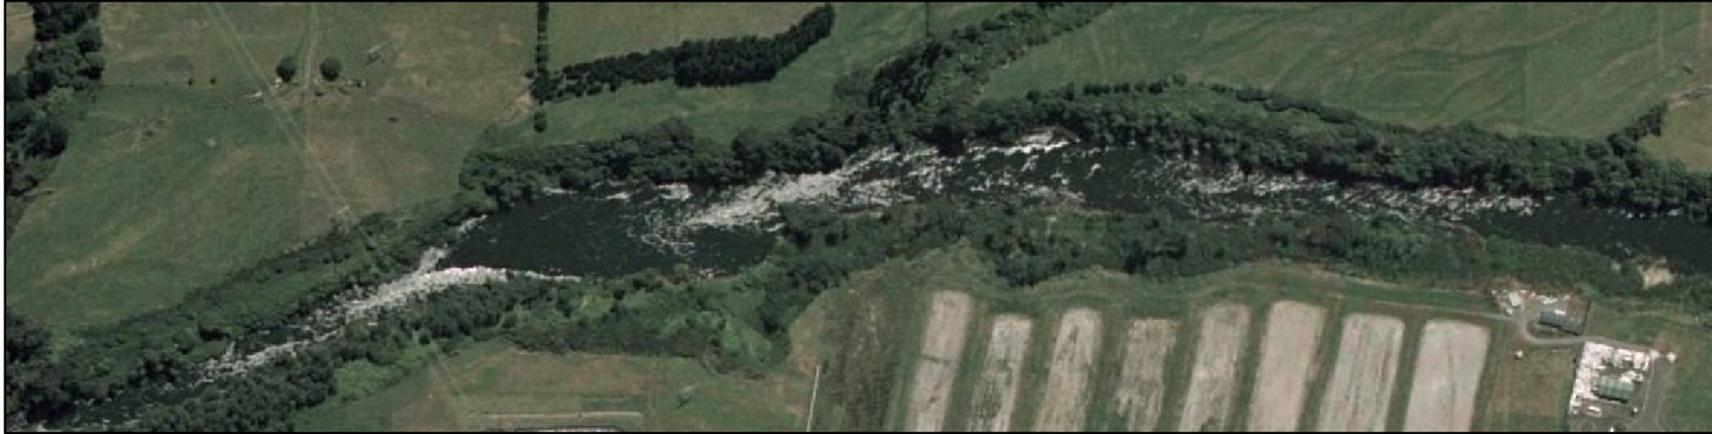
Figure D1:
10m+ deep hole at
chainage 139.01km
(140m upstream of
section 172A)

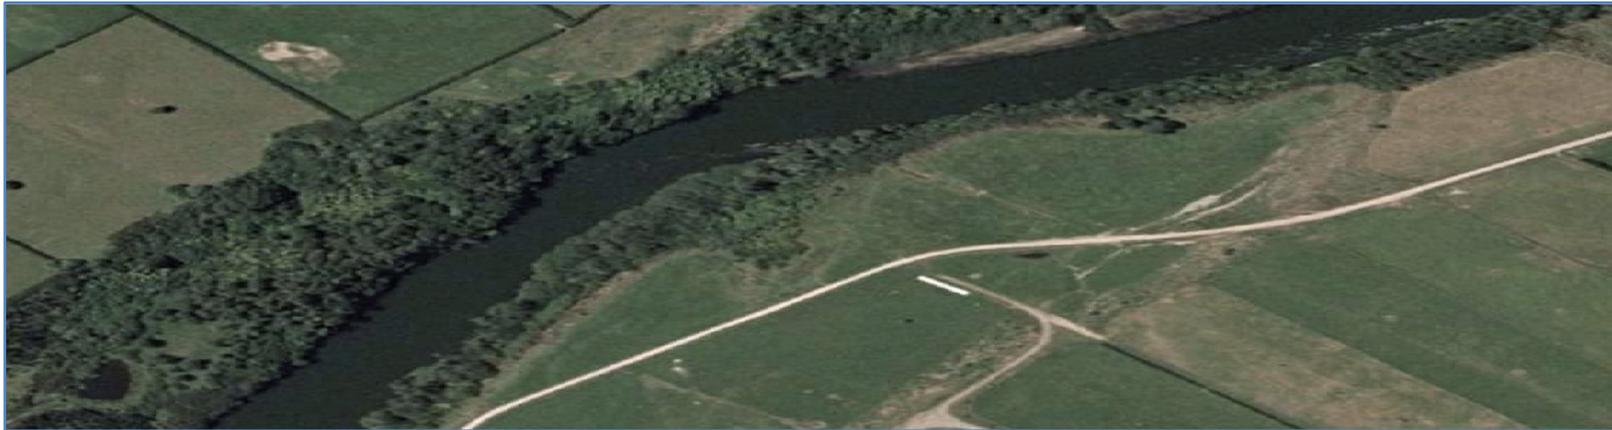
Figure D2: Example of bed hole on outside of bend. Located at chainage 136.13km (160m downstream of section 169) Approximately 5 metres deep

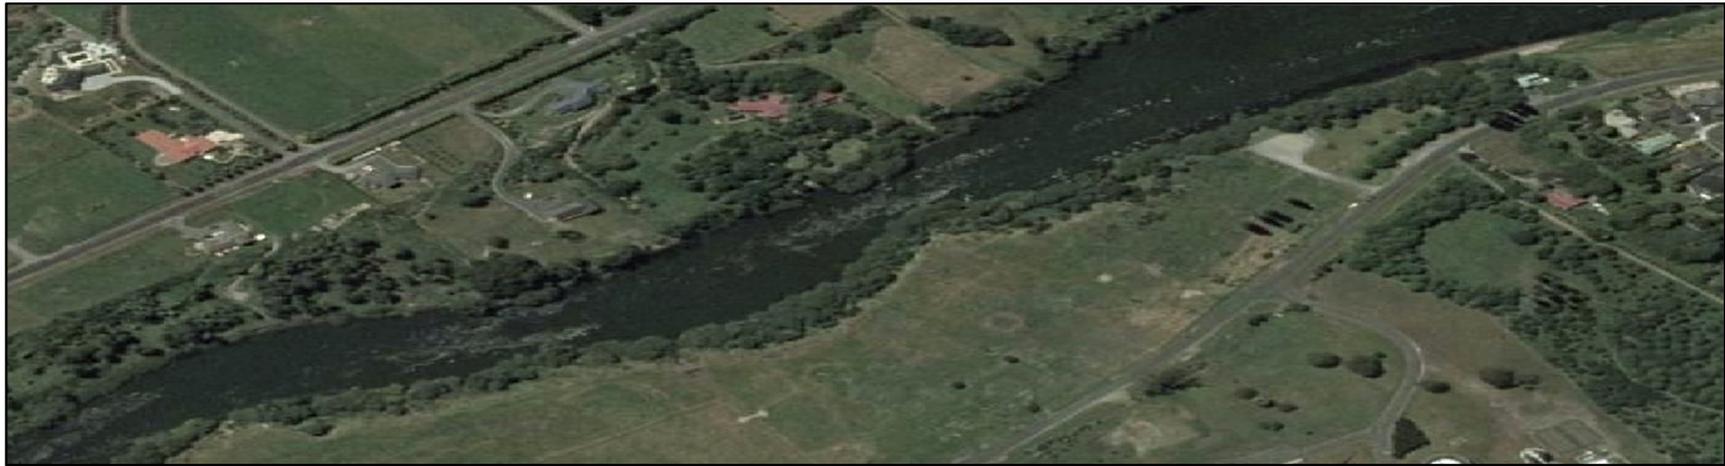
Figure D3: Example of a long hole. Located at chainage 107km (from 220-340m downstream of Section 141). Hole is over 7m deep

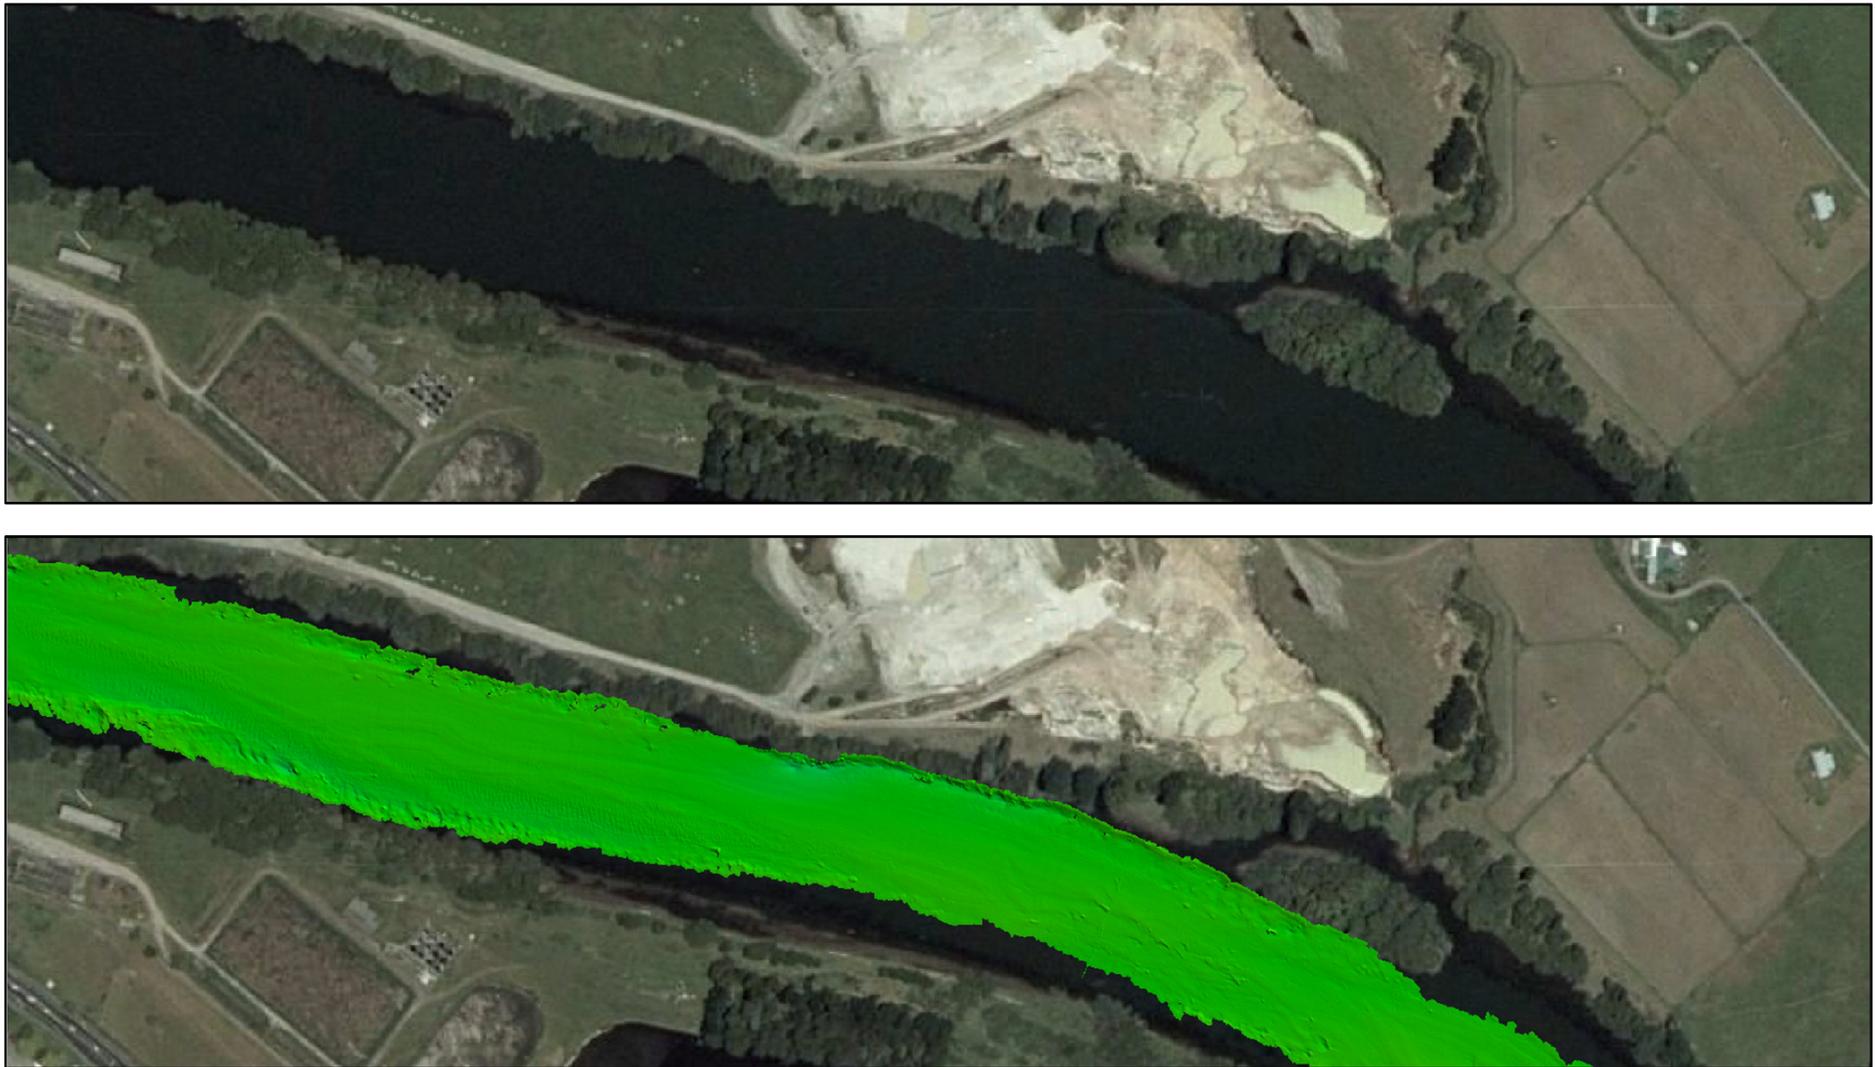
Figure D4: Example of a planar bed. Section is located at approximate chainage 101.5km (between sections 136 and 136A).

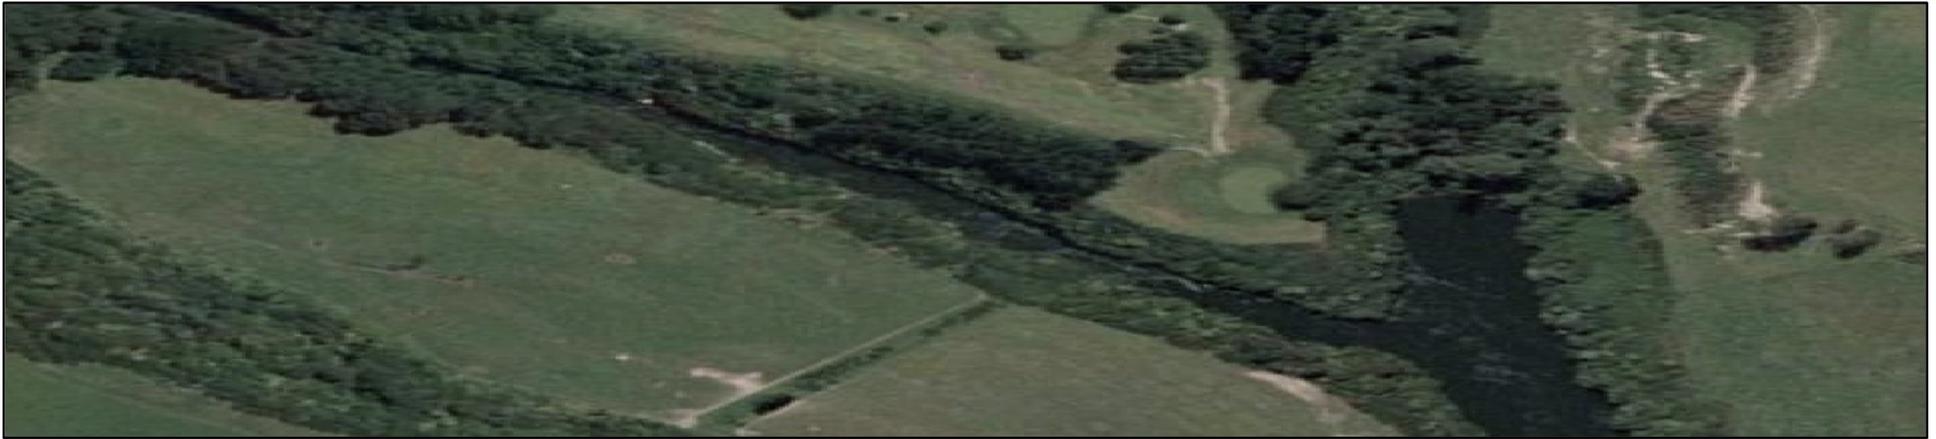
Figure D5: Example of a fault forming a sill. Located at chainage 144.65. The bed level drops by 8m, with individual holes a further 1.5 metres deep.
