Short term field investigations of groundwater resources in Waipa River Catchment - January to April 2015

Prepared by:
Zara Rawlinson, Kolja Schaller, Marc Andri Riedi, Molla Bekele
(GNS Science Consultancy)

For:
Waikato Regional Council
Private Bag 3038
Waikato Mail Centre
HAMILTON 3240

Rawlinson, Z.; Riedi, M.; Schaller, K.; Bekele, M. 2015. Short term field investigation of groundwater resources in the Waipa River Catchment: January – April 2015, *GNS Science Consultancy Report 2015/54*. 195 p.

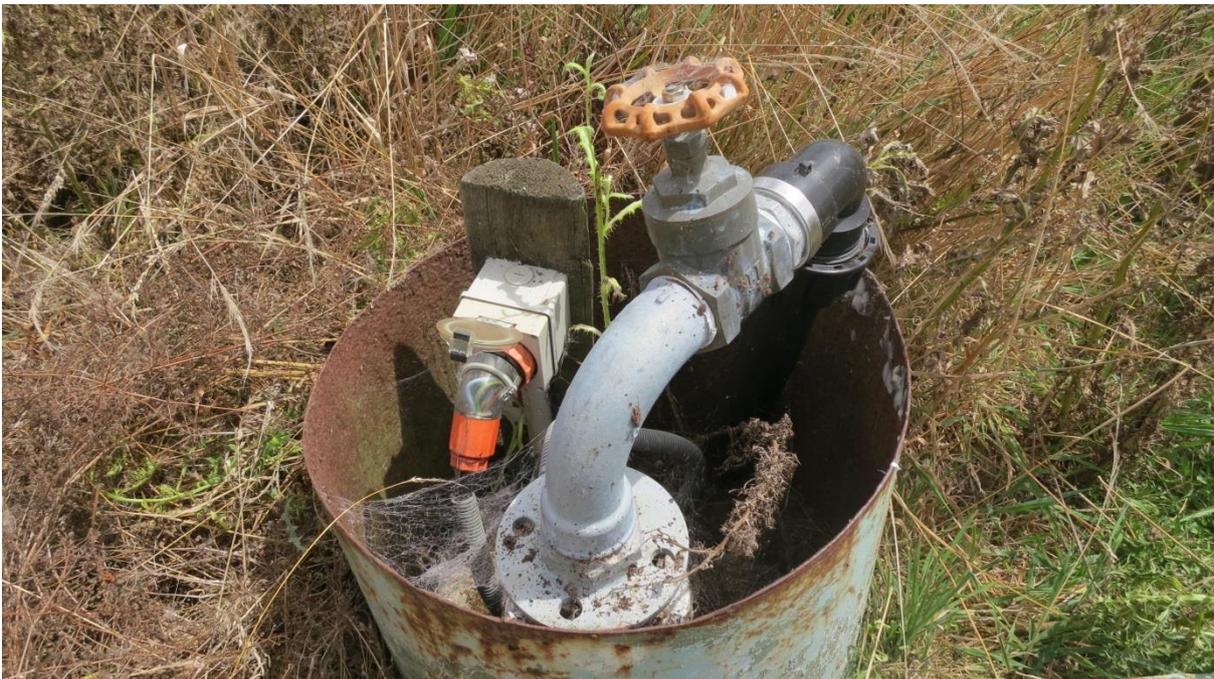
Figure A 1.10 Well 72_4070.

Pump comments: Submersible that pumps water into concrete tank nearby.

Sampling comments: Water quality sample taken where water feeds into concrete tank. Assumed to be well purged prior to sampling. Pump cannot be forced to run unless farm workers turn on the wash down hoses in the cowshed. Difficult bore to sample since float switch cannot be bypassed. Alistair Hogg is very interested in water quality results.

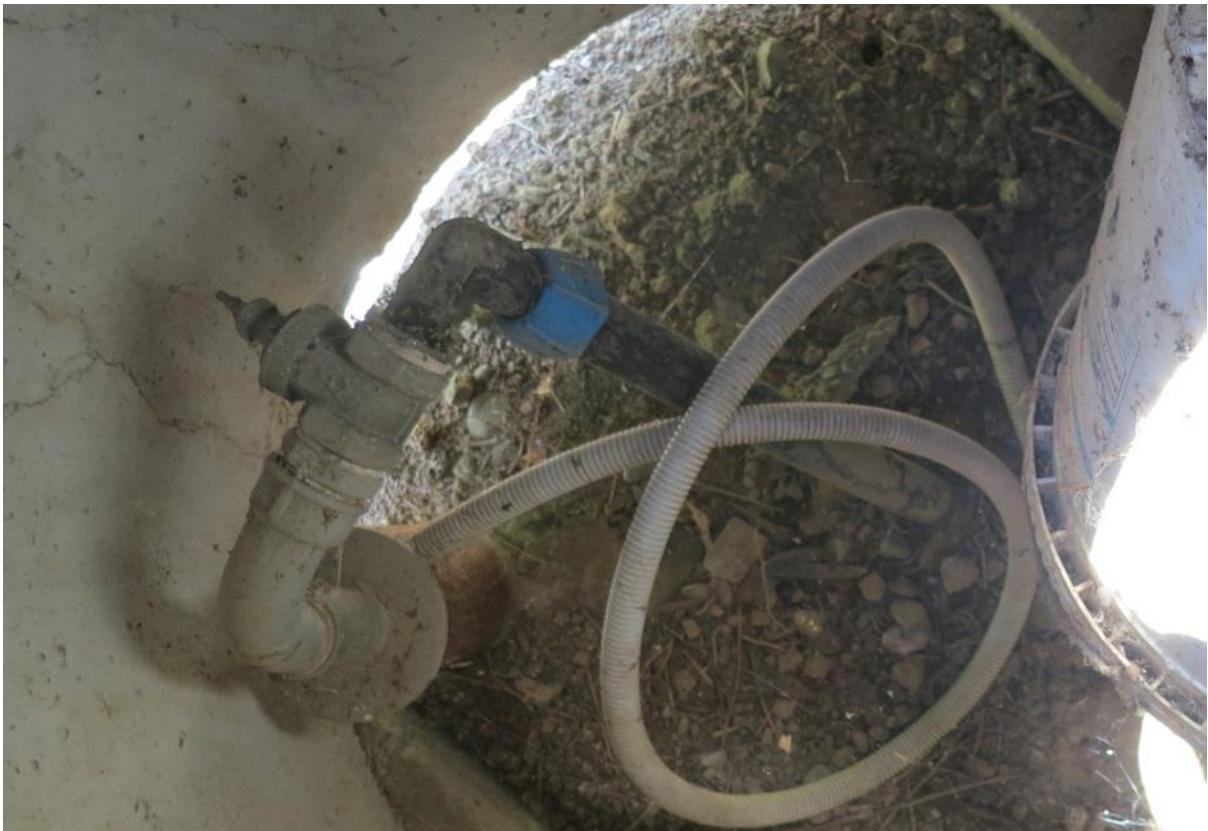
Figure A 1.12 Well 72_4820.

Pump comments: Submersible that pumps water into concrete storage tank nearby. Pump hidden under massive concrete tub that cannot be moved making access to the bore very difficult.

Sampling comments: Water quality sample was taken where it enters the concrete tank 5 m next to the bore. Assumed to be well purged prior to sampling.

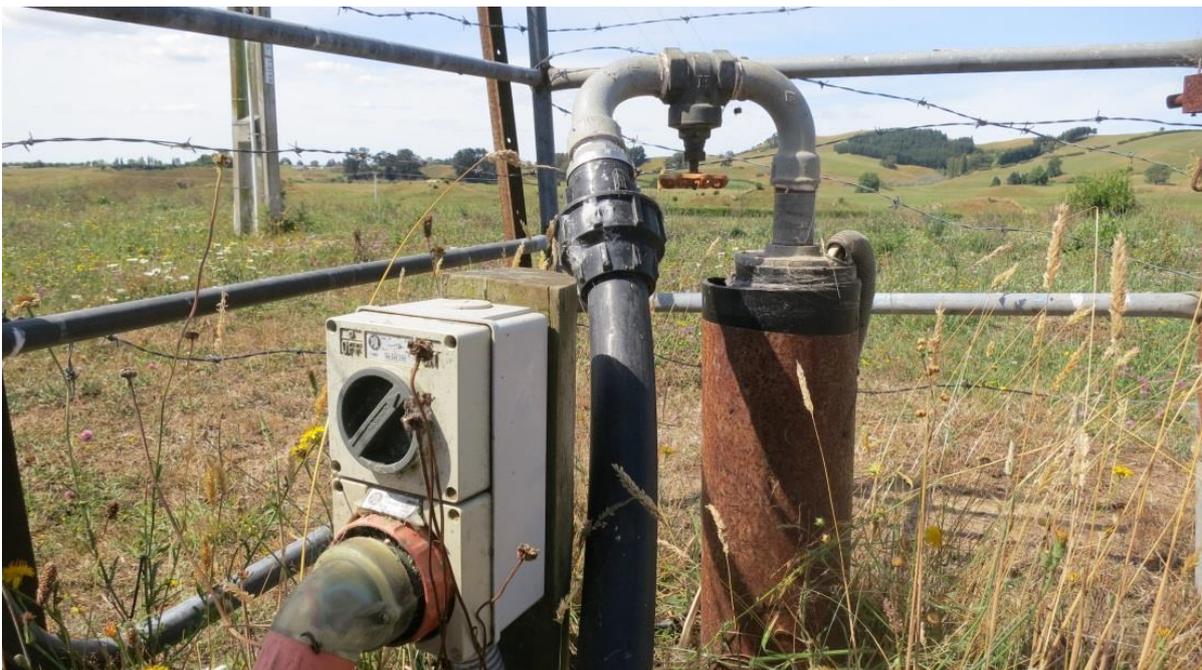
Figure A 1.16 Well 72_5053.

Pump comments: Submersible that pumps water into a plastic storage tank next to the cowshed.

Sampling comments: Water quality sample was taken where pipe feeds water into the plastic storage tank next to the cowshed. Assumed to be well purged prior to sampling.

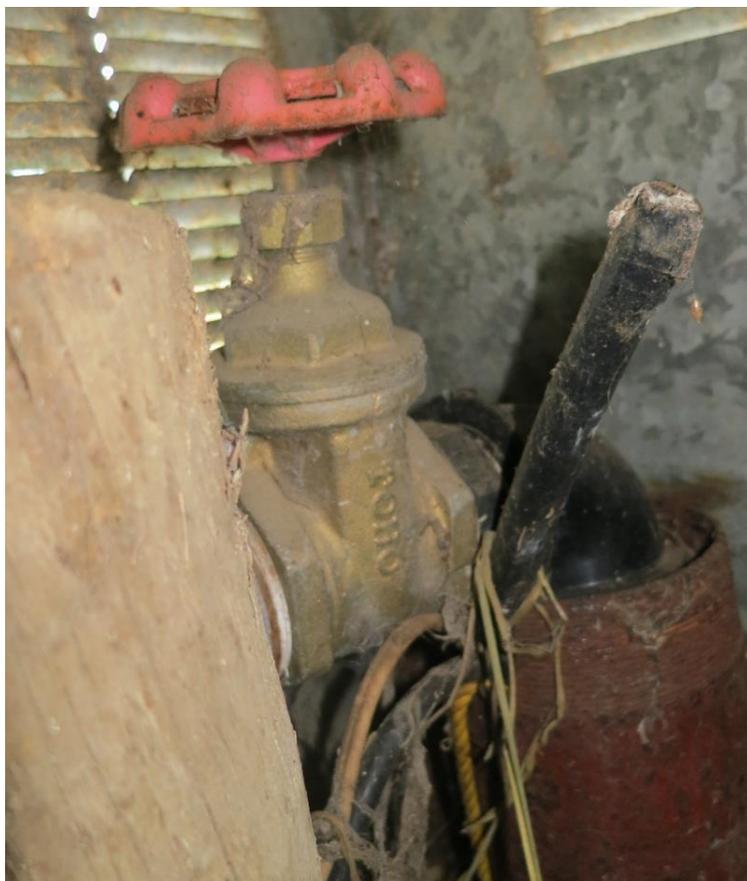
Figure A 1.18 Well 72_524.

Sampling comments: Water quality sample was taken by opening tap right at the pressure tank in the pump shed. Bore is pumped every day for the farm. Assumed to be well purged prior to sampling. Bore is under a steel cover that is difficult to take off.

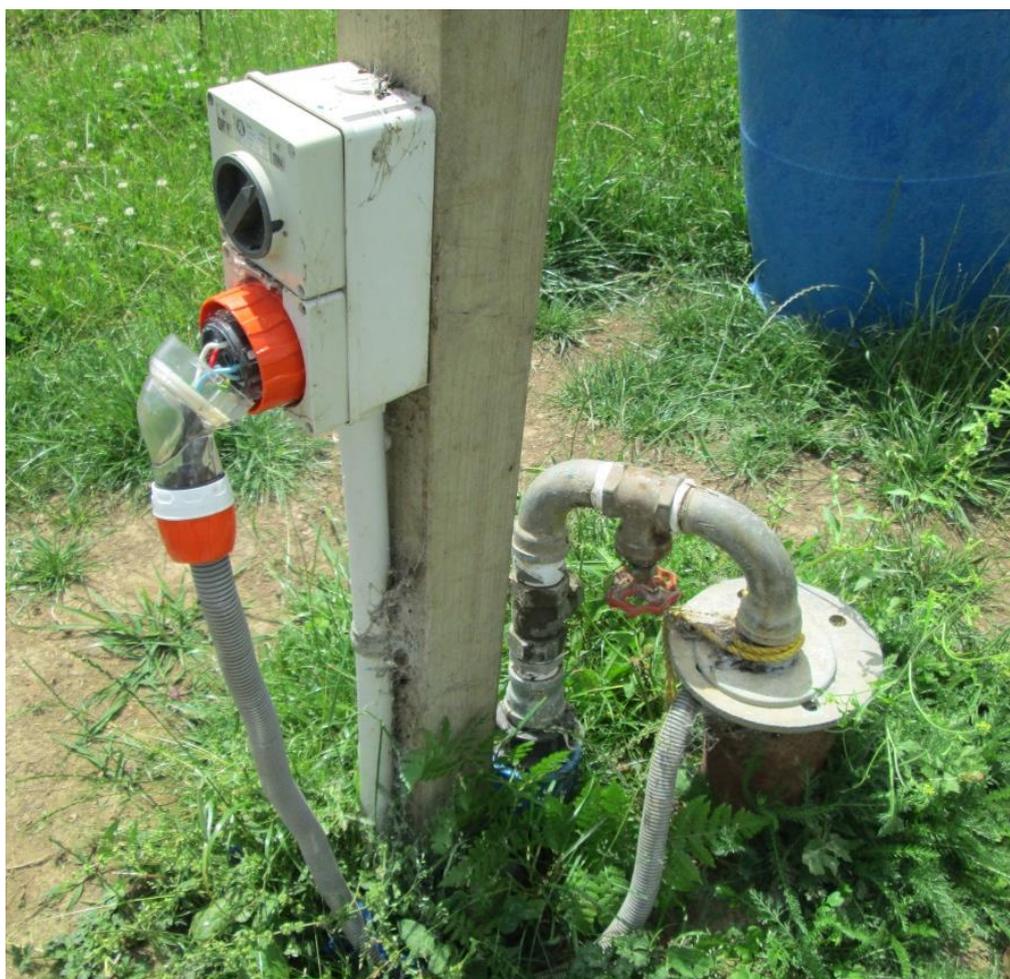
Figure A 1.20 Well 72_5253.

Pump comments: Submersible that pumps water into concrete storage tank next to shed.

Sampling comments: Water quality sample was taken where pipe feeds water into concrete storage tank. Assumed to be well purged prior to sampling.

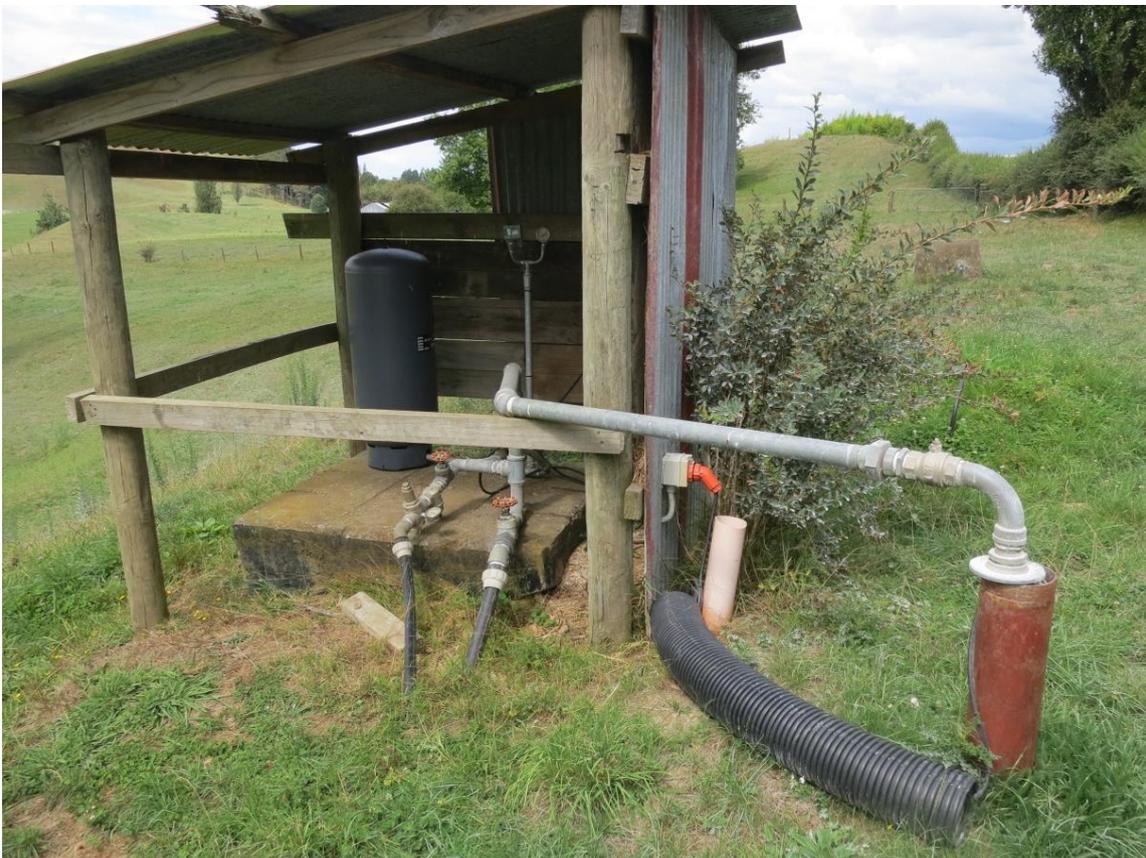
Figure A 1.28 Well 72_4742.

Sampling comments: Water quality sample was taken right at the bore by unscrewing a tap. Assumed to be well purged prior to sampling.

Additional comments: Big gap to get equipment down the bore. Really fast recovery of water table.

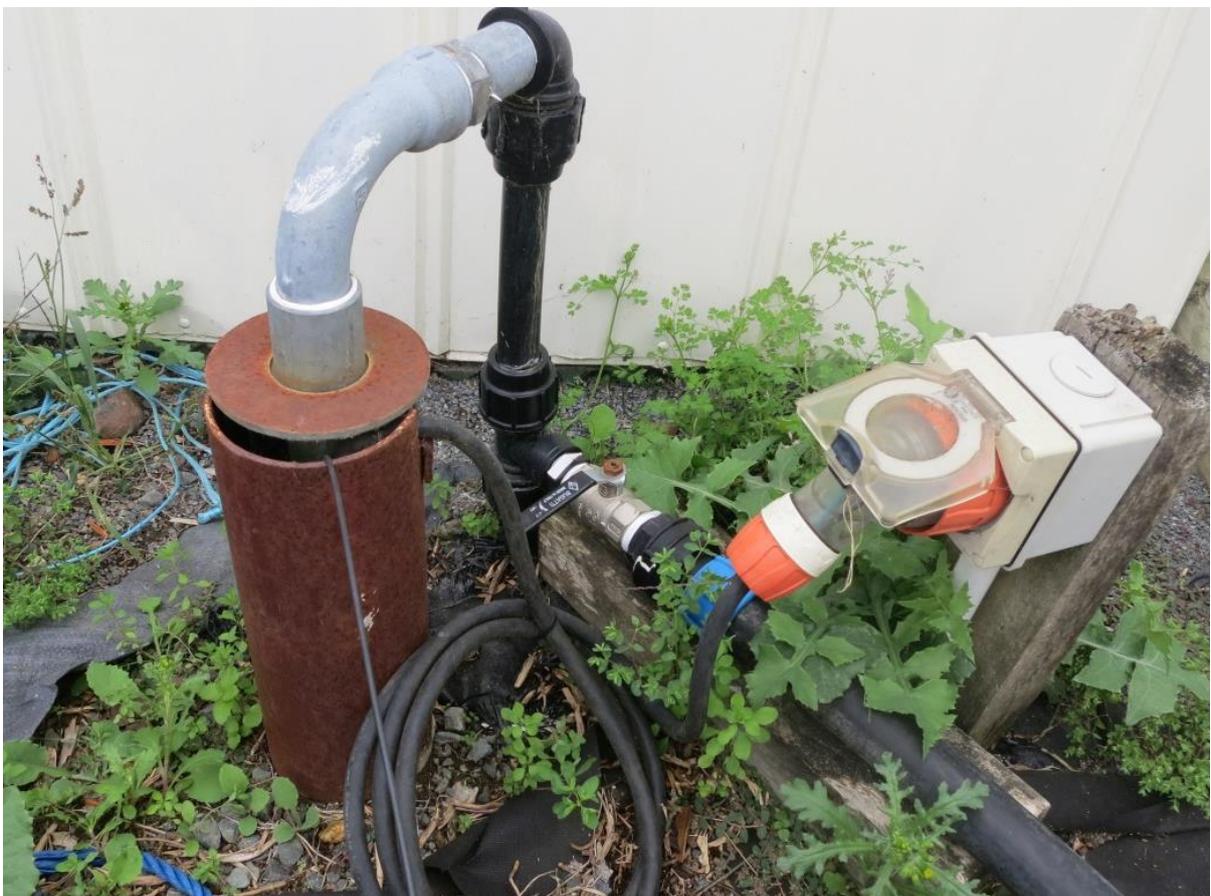
Figure A 1.32 Well 72_4998.

Pump comments: Submersible pump that feeds water into house and also through a pipe onto driveway.

Sampling comments: Water quality sample was taken about 10 m distance from bore at the open ending of the pipe on their driveway. Assumed to be well purged prior to sampling.

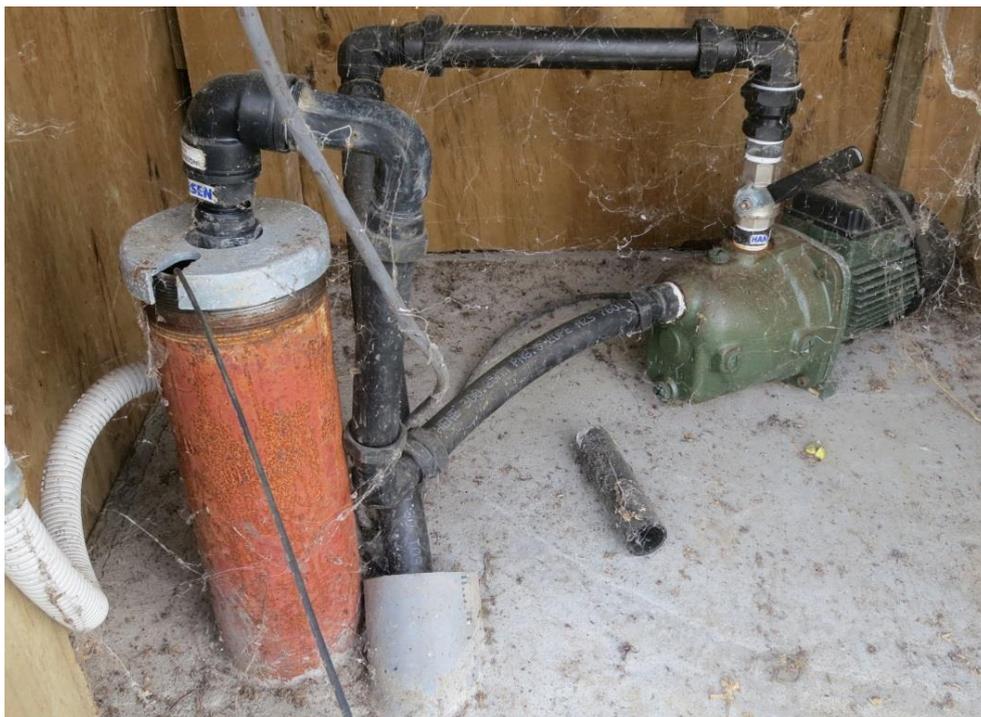
Figure A 1.34 Well 72_3706.

Pump comments: Submersible pump that feeds water to storage tank but also to a tap at 5 m distance from bore.

Sampling comments: Water quality sample was taken at about 5 m distance from bore at a tap. Assumed to be well purged prior to sampling.

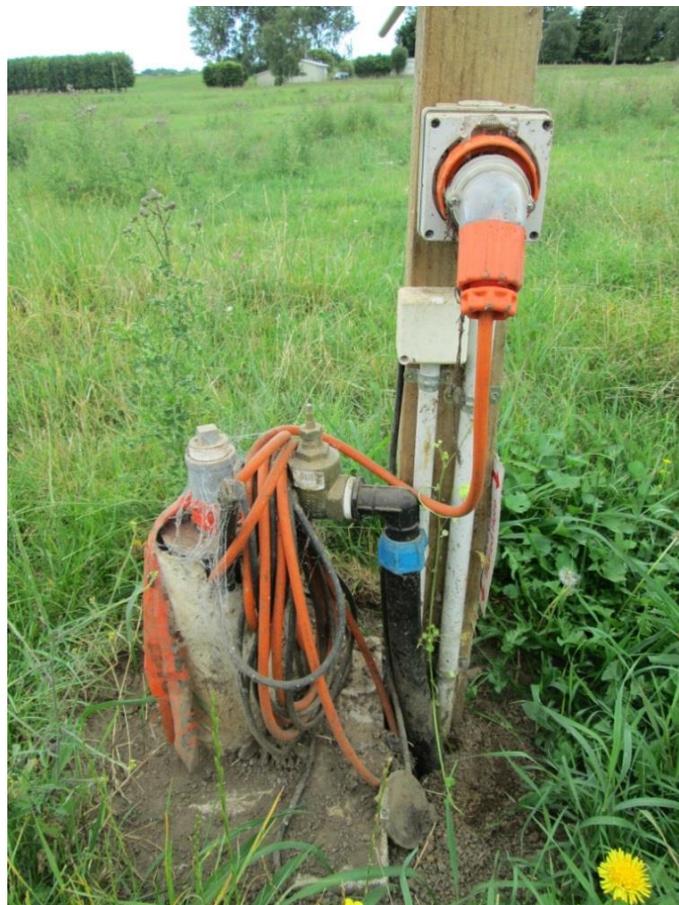
Figure A 1.38 Well 72_4320.

Sampling comments: Water quality sample taken where water feeds into concrete storage tank. Assumed to be well purged prior to sampling.

Additional comments: Small pipe that may be used for water level measurements going down bore shaft. Owner confirmed that this is most likely the correct bore. But since coordinates in the WRC database do not make sense it could also be 72_4369.

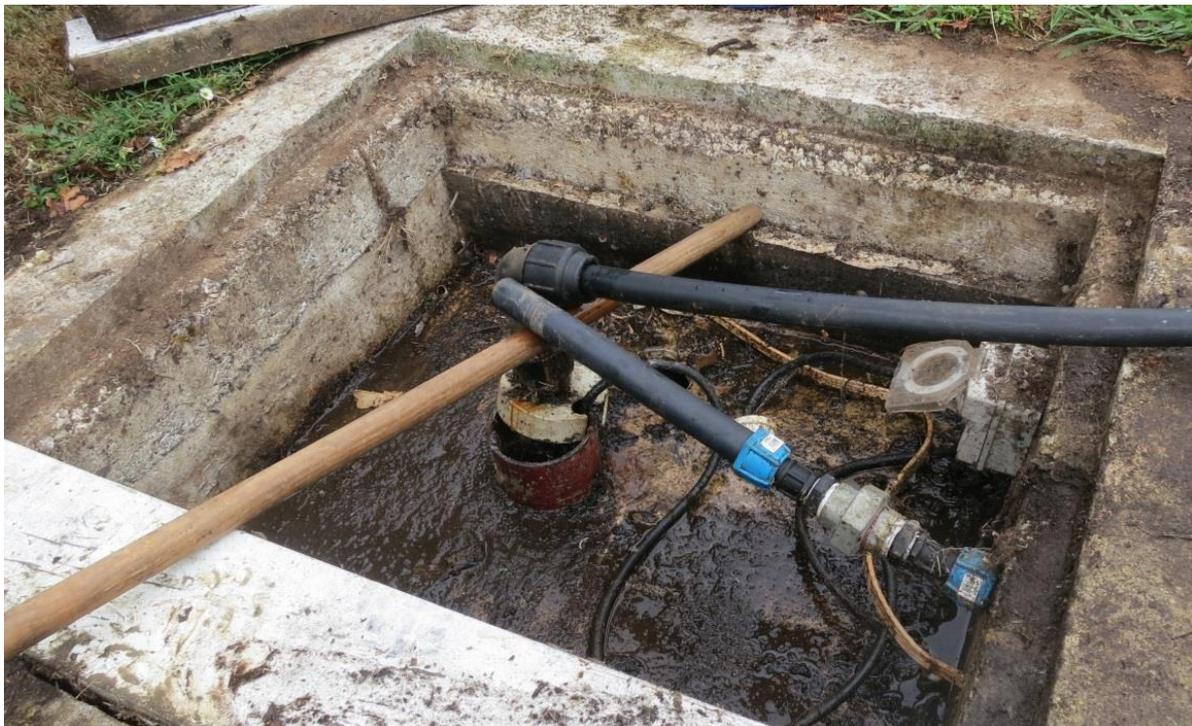
Figure A 1.40 Well 72_4805.

Sampling comments: Water quality sample taken right at bore after detaching pipe. Assumed to be well purged prior to sampling.

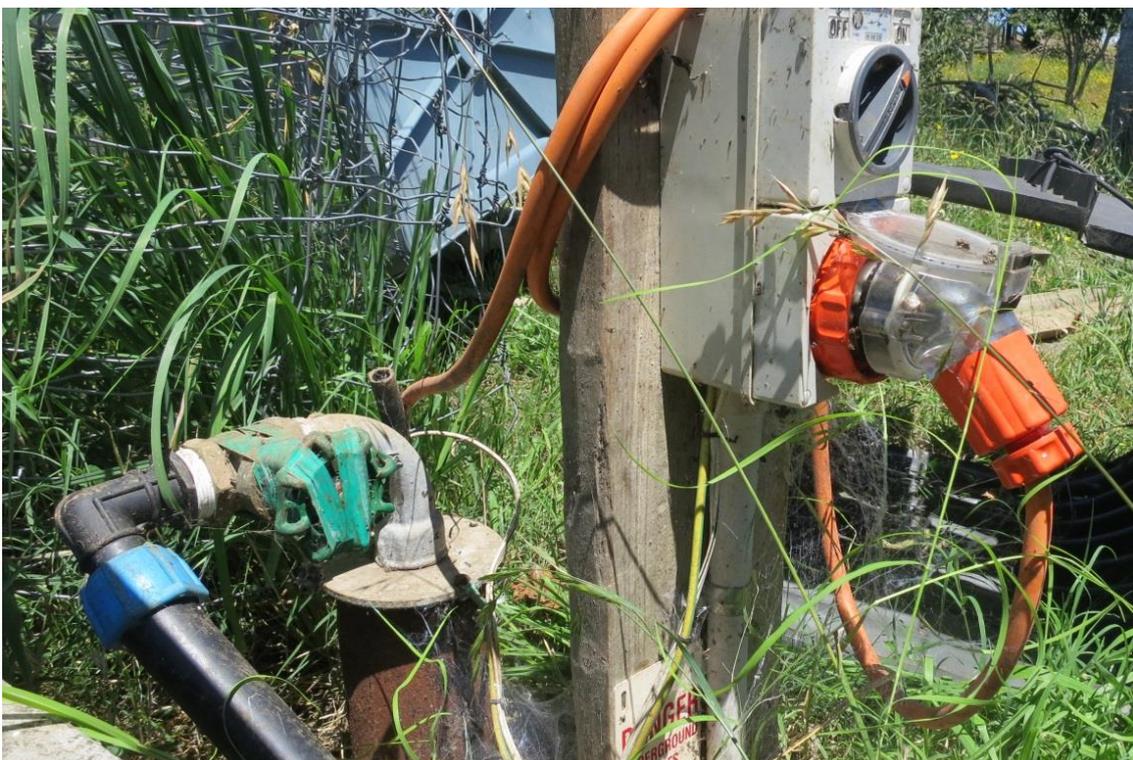
Figure A 1.44 Well 72_5042.

Pump comments: Submersible that pumps water into a concrete storage tank. Pump rate is roughly 660 L/h.

Sampling comments: Water quality sample taken right at the bore after detaching the pipe. Only one purge completed before sampling since it was too time consuming due to the low flow rate, but pump was running earlier the same day and parameters (pH, conductivity, temperature) stayed constant after one hour so it should be well purged.

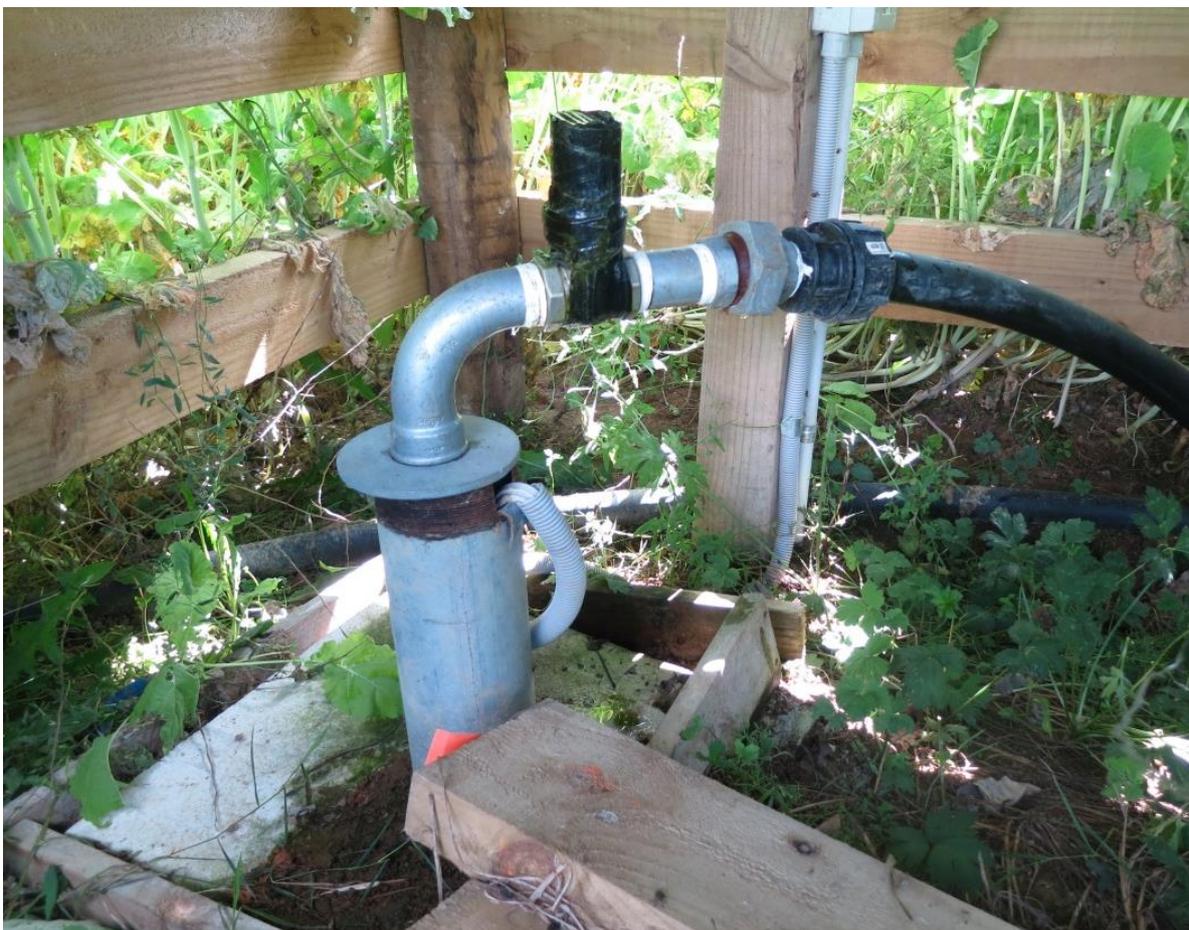
Figure A 1.50 Well 72_7107.

Pump comments: Submersible that pumps water into plastic storage tank next to the cowshed.

Sampling comments: Water quality sample was taken where the pipe feeds water into a plastic storage tank. Assumed to be well purged prior to sampling. Float switch can easily be forced down in order to start the pump running. Bore hidden under wooden box.

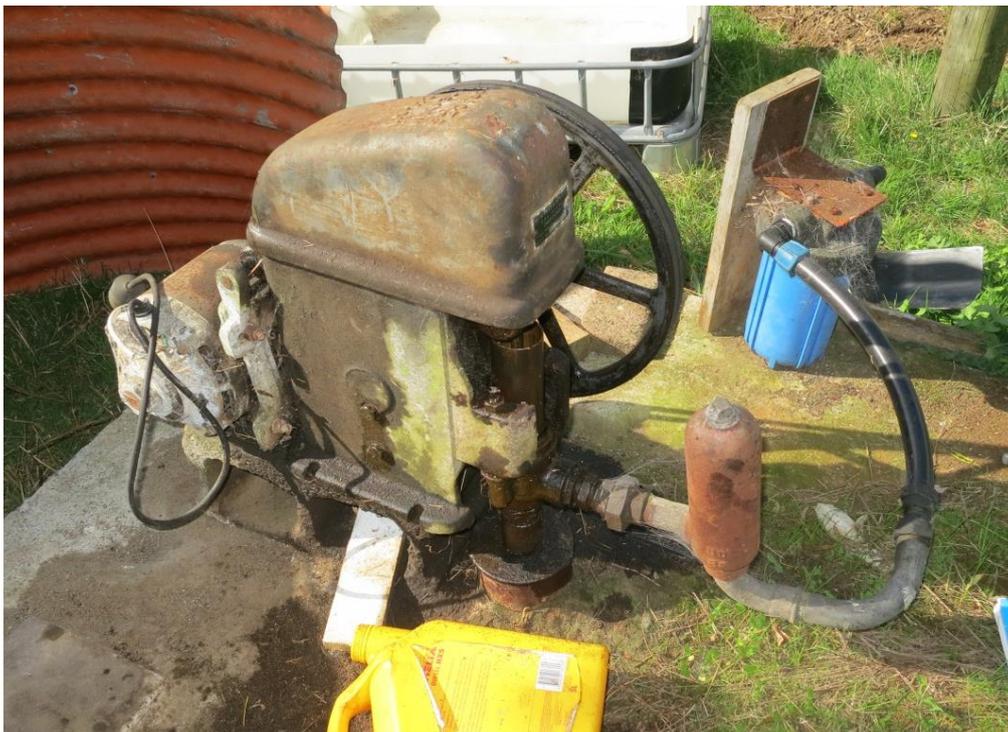
Figure A 1.54 Well 69_2082.

Pump comments: Old surface pump that has not been in use much over the past years.

Sampling comments: Water quality sample was taken right at the bore after detaching the pipe there. Owner forced pump to run for 75 minutes before sample was taken. Assumed to be well purged prior to sampling.

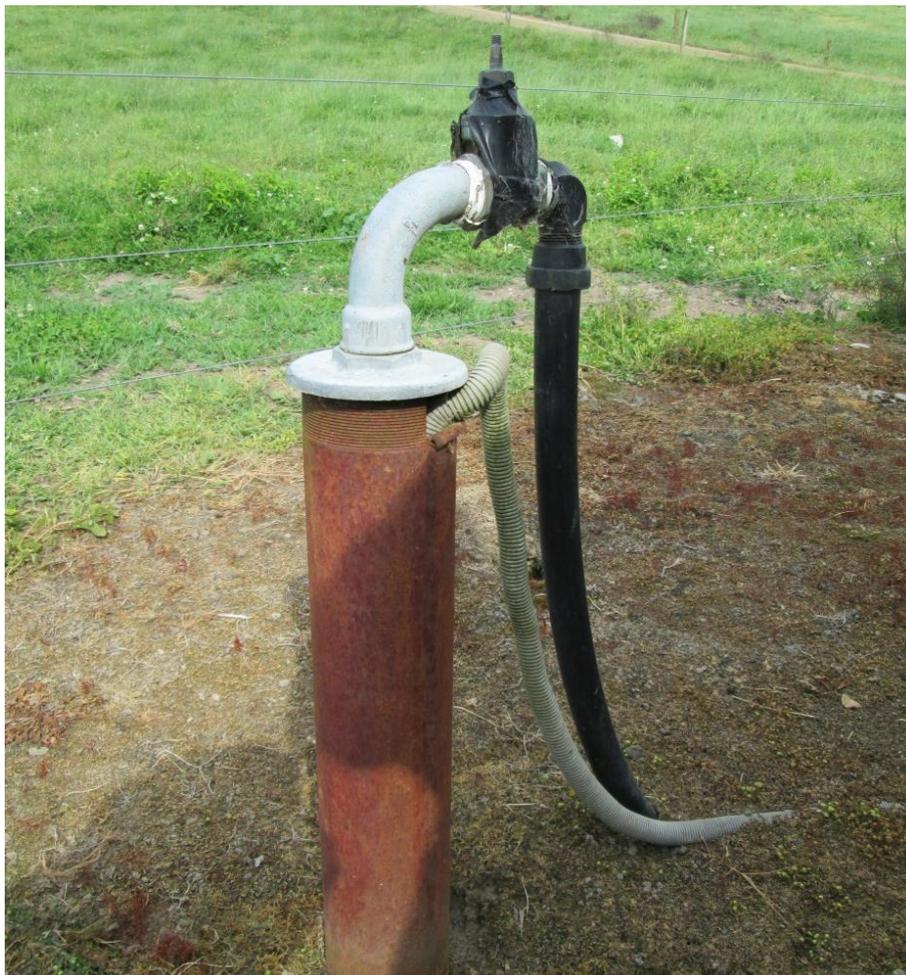
Figure A 1.58 Well 72_5289.

Access comments: Bore is next to cowshed. Gravel road, easy but steep access. Four wheel drive is recommended if rain preceded visit or is expected.

Pump comments: Submersible that pumps water into plastic storage tank next to cowshed.

Sampling comments: Pipe was detached before entering the plastic tank to get a water quality sample. Assumed to be well purged prior to sampling.

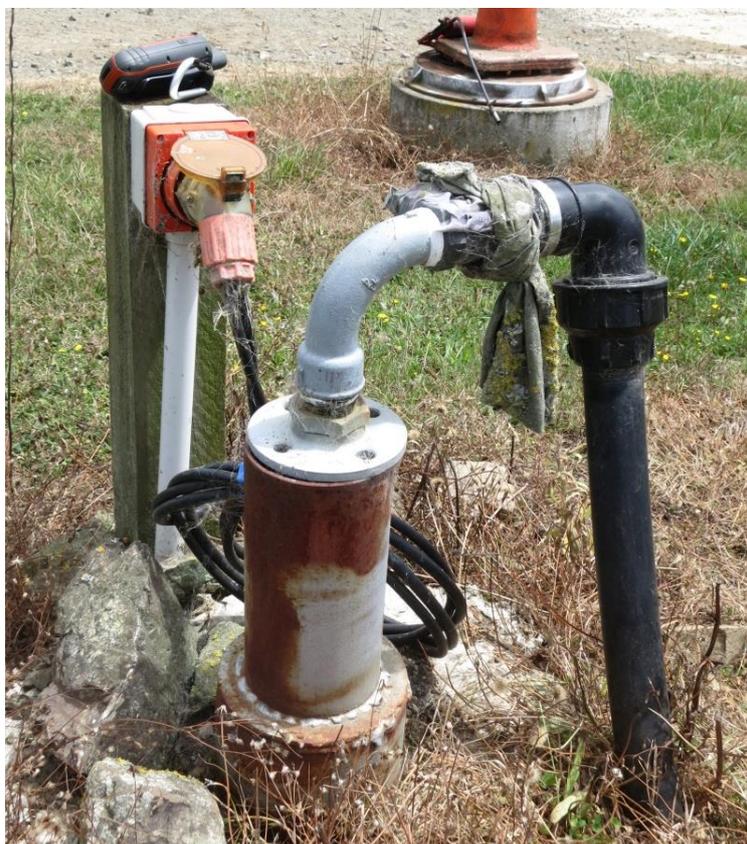
Figure A 1.60 Well 72_5490.

Access comments: Bore is next to cowshed. Gravel road. If rain preceded visit or is expected then four wheel drive is recommended to obtain access to the plastic storage tank.

Pump comments: Submersible that pumps water into plastic storage tank about 150 m east of bore.

Sampling comments: Water quality sample taken where water feeds into plastic storage tank. Assumed to be well purged prior to sampling.

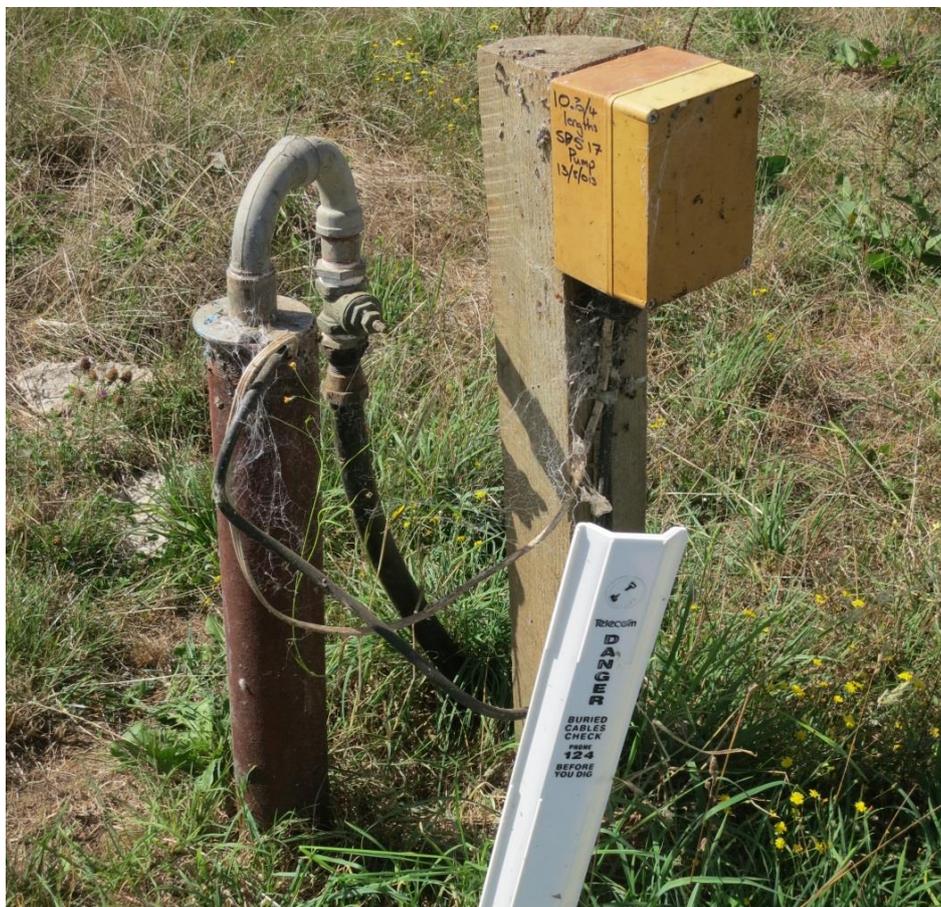
Figure A 1.64 Well 72_4788.

Access comments: Bore is 900 m northeast from 727 Old Te Kuiti Rd on a hill on the northern side of the road. Access through a gate up a paddock. Four wheel drive is recommended.

Sampling comments: Water quality sample was taken where water feeds into plastic tank at 900 m distance from the bore. Assumed to be well purged prior to sampling.

Additional comments: Water level could maybe be measured with a smaller water level indicator.

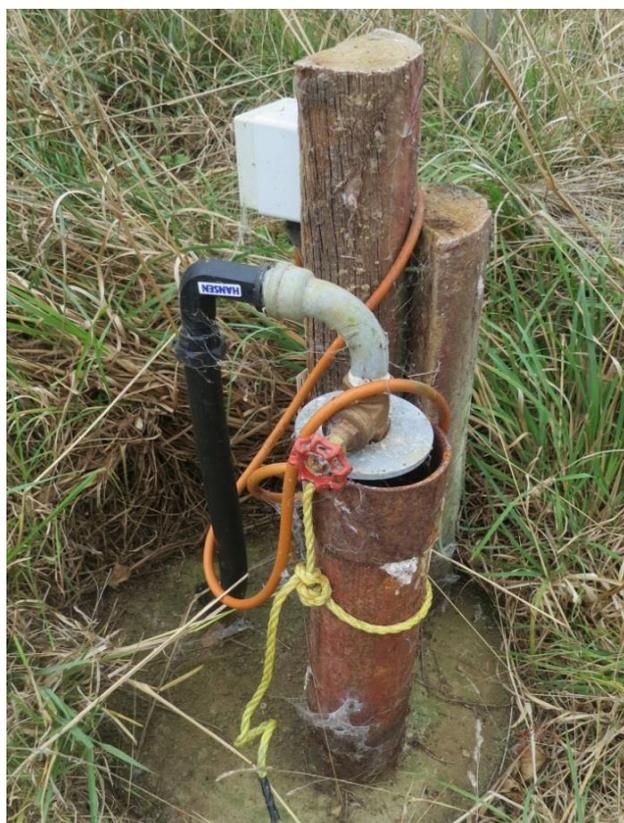
Figure A 1.68 Well 72_2732.

Access comments: Drive up gravel driveway at 75A Saulbrey Rd. Bore is 70 m southeast of house near a shed. Four wheel drive is recommended.

Sampling comments: Opened tap at pressure tank in order to drain tank and to force pump to run. Water quality sample taken at tap on pressure tank. Assumed to be well purged prior to sampling.

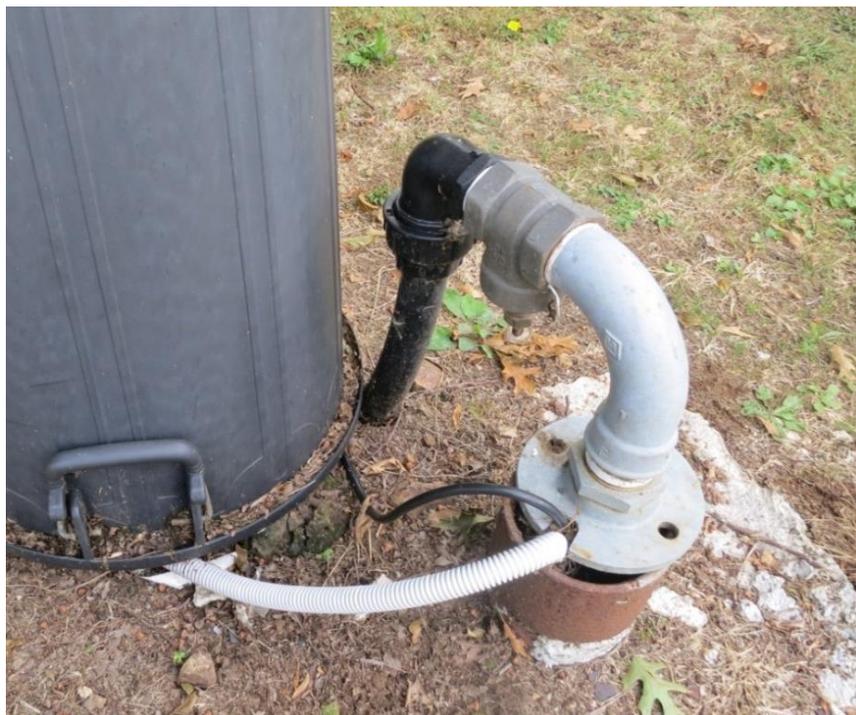
Figure A 1.72 Well 72_5433.

Access comments: Bore is next to house at 2091 State Highway 31. Steep gravel road. Four wheel drive recommended in wet conditions.

Pump comments: Submersible pump that feeds water into concrete storage tank next to it.

Sampling comments: Water quality and age samples were taken at about 3 m distance from bore after detaching pipe. Assumed to be well purged prior to sampling. Float switch can be forced down easily to force pump to run.

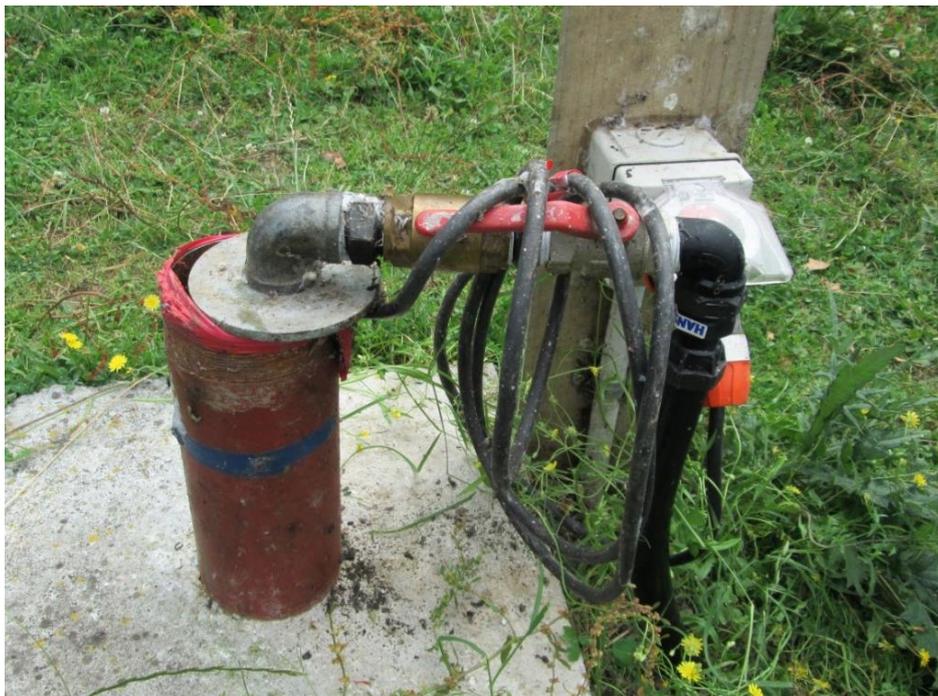
Figure A 1.82 Well 72_5569.

Pump comments: Submersible that pumps water into a concrete storage tank nearby.

Sampling comments: Water quality sample taken where water enters the concrete storage tank. Assumed to be well purged prior to sampling.

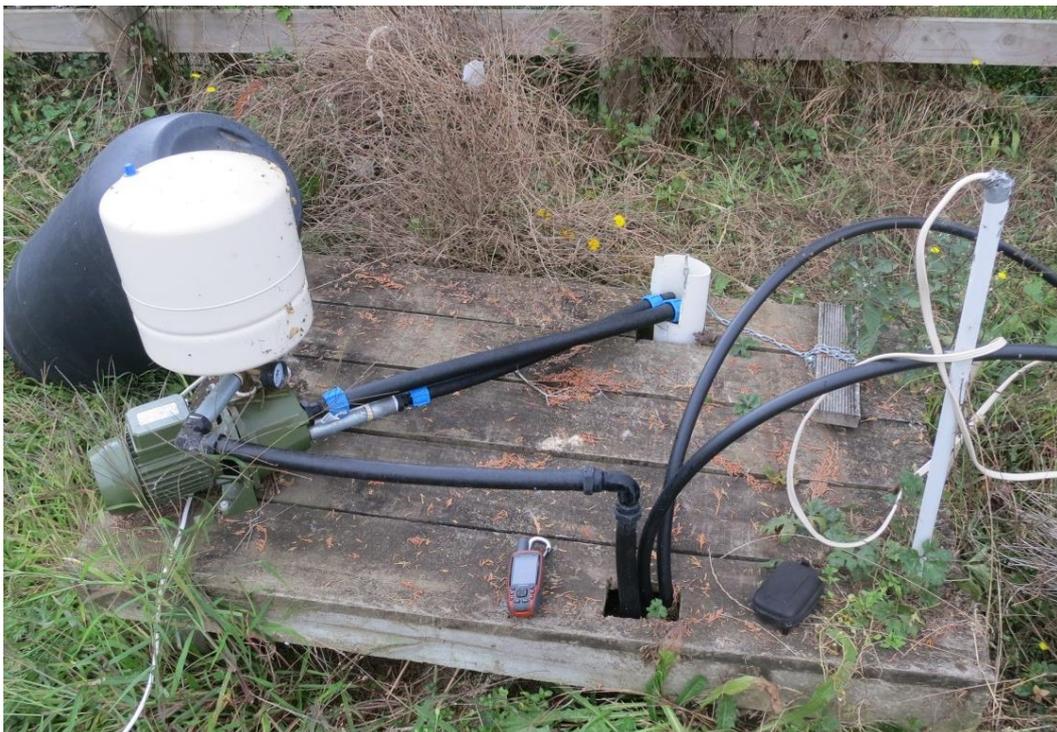
Figure A 1.84 Well 72_6180.

Pump comments: Surface pump that feeds water into a storage tank nearby.

Sampling comments: Water quality sample taken where water enters the concrete storage tank by pulling out the pipe. Assumed to be well purged prior to sampling.

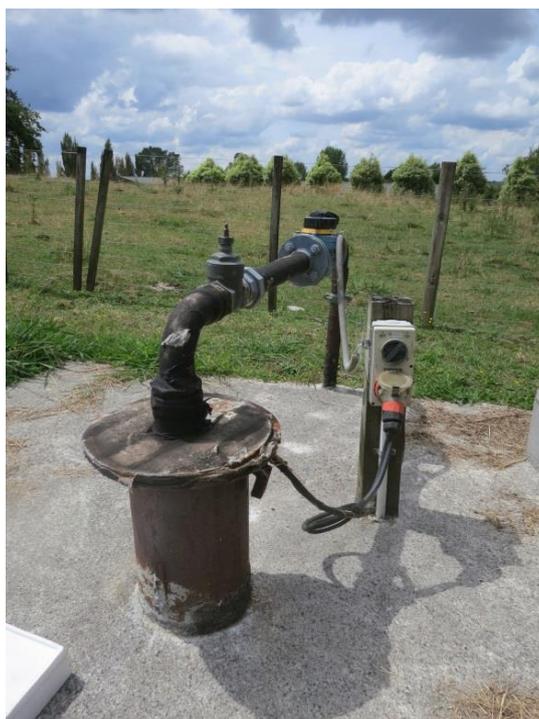
Figure A 1.86 Well 72_2915.

Access comments: From Te Kuiti drive south along State Highway 3 and turn onto gravel road at a picnic area 300 m north of Johnston Rd. After 150 m turn right and go through a gate, drive up paddock to top of the hill. Four wheel drive is recommended.

Additional comments: Bore not in use at present, but Waitomo DC turns the pump on every day for about 10 minutes to clean the bore.

Sampling comments: Water quality sample taken at tap right at the bore. Assumed to be well purged prior to sampling.

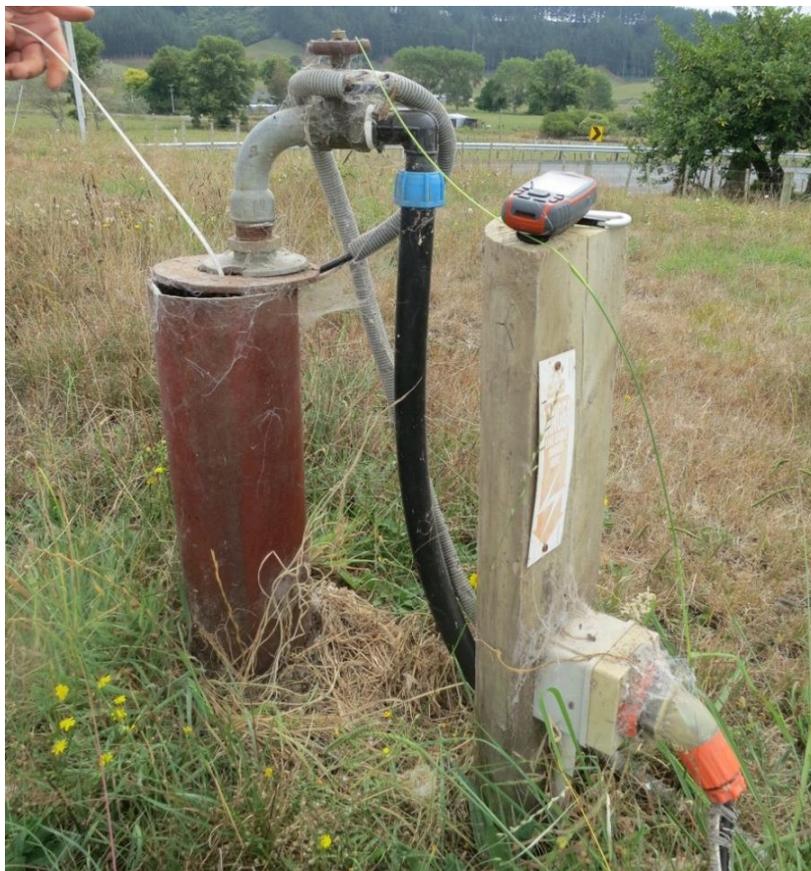
Figure A 1.88 Well 72_4759.

Location comments: The bore located key number for this bore may be wrong. It seems that 72_4759 was another bore at 412 Kawhia Rd. This bore apparently collapsed and the owner contracted Barham United Welldrillers to drill a new bore at 422 Kawhia Rd as a replacement (which is the bore that was sampled for water chemistry and had a hydraulic test completed). The driller supplied us with the following information about this replacement bore: Depth: 90 m, Screen: 32.5 – 90 m, Casing diameter: 150 mm, Casing Depth: 32.5 m, Screen diameter: 100 mm, Static WL: 18 m. The replacement bore and the bore 72_4759 are only about 370 m apart and are at approximately the same elevation. Since we do not have any information on lithology for the replacement bore, we have used the lithological log from 72_4759 for the interpretation of the hydraulic test conducted at the replacement bore (see hydraulic testing appendices) in combination with the details supplied by the drillers (presented in the well details for 72_4759 in Appendix 3).

The recovery data analysis for well 72_4759 is presented in Figure A 3.14, which results in a transmissivity estimate of $T = 0.56 \text{ m}^2/\text{day}$. For conversion to hydraulic conductivity, the screen length has been used $b = 57.5 \text{ m}$. As such, $K = 0.01 \text{ m/day}$ or $K = 1.1 \times 10^{-7} \text{ m/sec}$. This is consistent with theoretical values for fractured hard rock (8×10^{-9} to $3 \times 10^{-4} \text{ m/sec}$), indicating as expected that water is drawn from fractured mudstone.

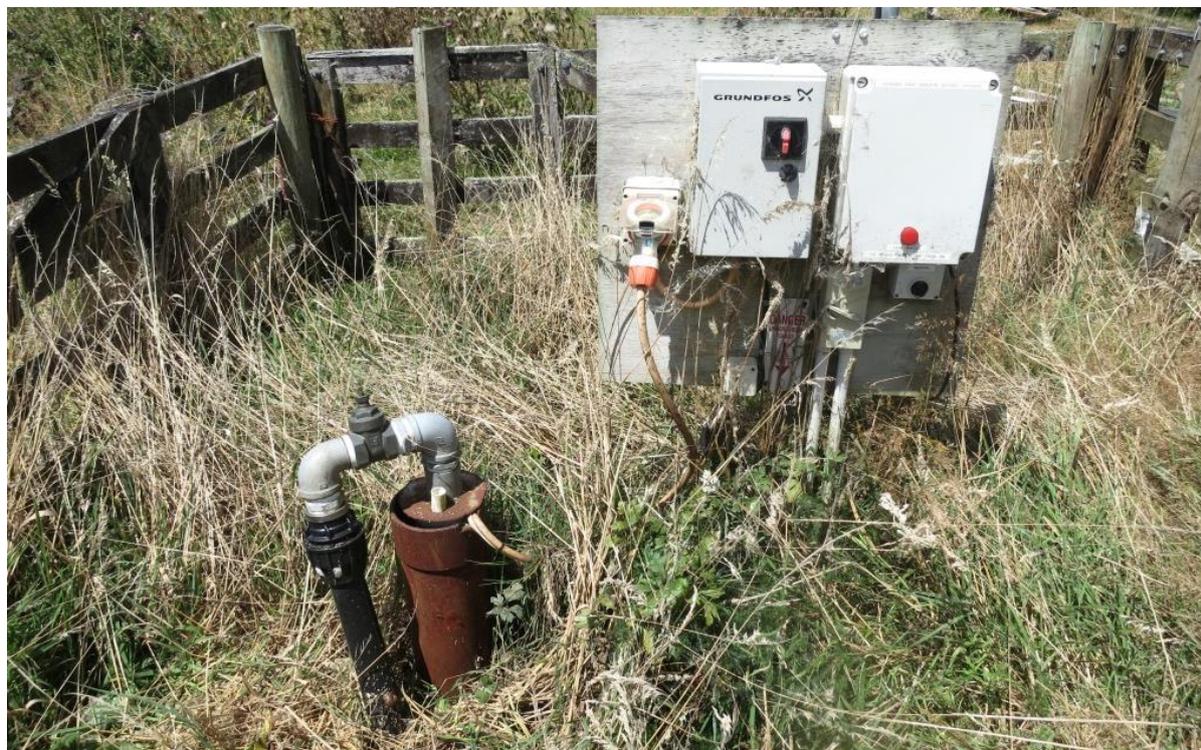
Figure A 1.92 Well 72_5503.

NZTM E (new)	NZTM N (new)	Altitude (m ASL)	Correct Bore	Pump
1797331	5753564	244 (GPS)	Most likely, but WRC coordinates 670 m off	Submersible pump, pump rate ~ 8820 L/h
Bore Depth	Screen_from	Screen_to	Geology	Lithological log
50	32	50	Basement rock	Fractured Greywacke
Access to WT	Water Table	Water sampling	Slug test	Pump test
Yes	11.887 m BGL (static, 22/04/15)	Done, 17/02/15	No	Completed, 22/04/15

The recovery data analysis for well 72_5503 is presented in Figure A 3.12, which results in a transmissivity estimate of $T = 3.29 \text{ m}^2/\text{day}$. For conversion to hydraulic conductivity, the screen length has been used $b = 18 \text{ m}$. As such, $K = 0.18 \text{ m/day}$ or $K = 2.1 \times 10^{-6} \text{ m/sec}$. This is consistent with theoretical values for fractured hard rock (8×10^{-9} to $3 \times 10^{-4} \text{ m/sec}$), indicating as expected that water is drawn from fractured greywacke.

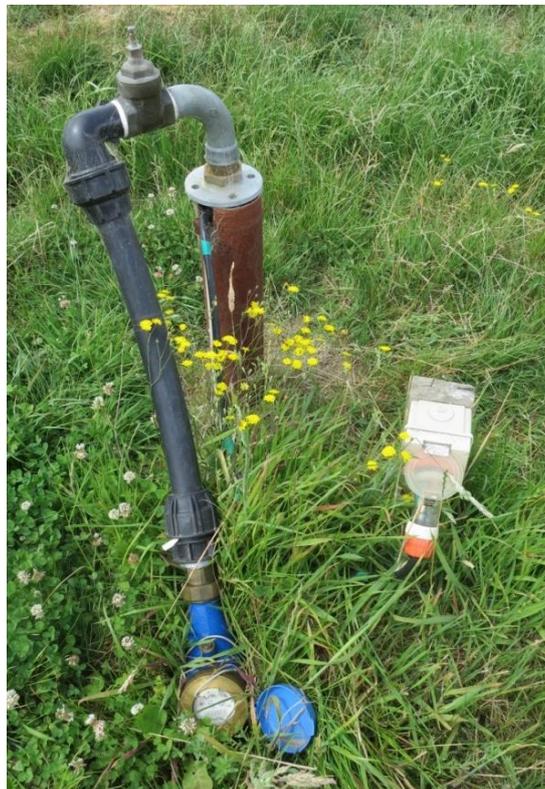
Figure A 1.100 Well 72_5009.

Sampling comments: Water quality sample taken at tap inside cowshed. Age samples were taken right at bore after detaching pipe. Assumed to be well purged prior to sampling.

Additional comments: A pump test was completed using the owner's submersible pump. The farm manager forgot to turn the pump off the evening before the pump test and therefore the water level was not quite static at the start of the test. The pump rate increased and decreased during the test time due to the farm workers using the wash down hose in the cowshed. This variable pump rate was accounted for during hydraulic testing.

The recovery data analysis for well 72_5009 is presented in Figure A 3.20, which results in a transmissivity estimate of $T = 2.79 \text{ m}^2/\text{day}$. For conversion to hydraulic conductivity, the screen length has been used $b = 12.5 \text{ m}$. As such, $K = 0.22 \text{ m/day}$ or $K = 2.6 \times 10^{-6} \text{ m/sec}$. The screen here spans mainly pumice, with a portion of 'rhyolite' (interpreted as Pakaumanu ignimbrite). Compared to theoretical values, this is consistent with the expected fractured igneous rock and fine, medium or coarse sand (8×10^{-9} to 3×10^{-4} , 2×10^{-7} to 2×10^{-4} , 9×10^{-7} to 5×10^{-4} , 9×10^{-7} to $6 \times 10^{-3} \text{ m/sec}$).
