FARM ENVIRONMENT PLAN (FEP)
BRIEN FARM
140 MORRISON ROAD, PUKEKAWA

Version 1	Draft FEP prepared to determine likely information requirements and associated costs	August 2016

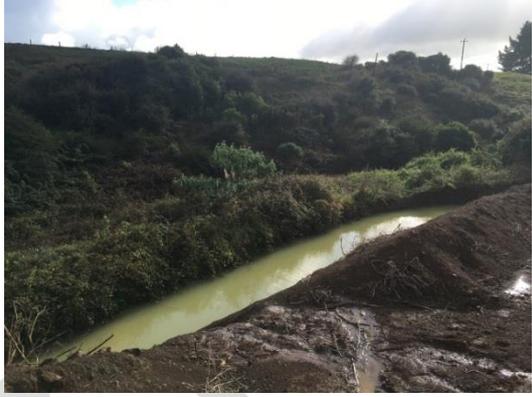
Sediment Trap	Dimensions (m) (Length x Width x Depth)	Volume (m³)	Photograph
A	20 x 2 x 2	80

Priority	Time Frame	GPS Ordinates	Co-	Date Completed
Observation	Site is moderate in slope and appropriately contoured, with banded channels directing all runoff to a sediment trap at lowest point					
Recommendation	No recommendations for sediment control required.					
Observation	A stream runs to the north of this site, traversing retired pastoral land.					
Recommendation	It is recommended that if stock are to be grazed on the pastoral land to the north of this site, then the stream should be fenced off to prevent their access with a minimum 1m setback as slope is less than 15 degrees.	Low	If needed			
Observation	Existing vegetation in excess of 5m bounds stream to the north but is comprised of blackberry and long grasses.					
Recommendation	No recommendations

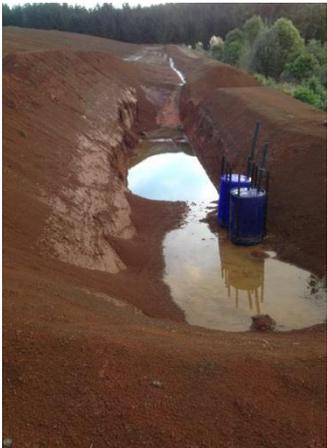
<p>G</p>	<p>16 x 1.5 x 1.5</p>	<p>36</p>

Recommendation	No recommendations				
Observation	Extensive established riparian planting to the south of the LMU exists (>10ha). To the north of the site there is a small area of riparian planting between sediment traps G and J. The remainder of the northern boundary is in pasture, with eucalyptus trees planted along the boundary line.				
Recommendation					
Observation	Control of runoff to the west of the site exists, although disperses into paddock at lowest point. Runoff is derived from sediment trap P of MARS03 and also from site TOWN02.				
Recommendation	Sediment trap to be developed in north western corner of LMU BRIE02.	High			
Observation	Three minor breaches in the bund on the southern margin of the site were observed, please refer to LMU Map for locations.				
Recommendation	Recontour bund on southern margin to rectify breaches.	High			-37.322707, 175.005152

LMU REFERENCE	RECOMMENDATION	DATE TO BE ACTIONED
BRIE01/02	If stock are to be grazed adjoining stream then fencing to ensure stock exclusion is required.	Low Priority
BRIE02/03	Sediment trap to be created in the north western corner, to the west of sediment trap J. Size is to be calculated based upon contributing catchment and in accordance with Industry Guidelines.	High Priority
BRIE02/04	Recontour channel and repair minor breaches in bund on southern margin.	Medium Priority
BRIE03/01	Repair breach in bund on northern margin and ensure that all runoff is channelled to sediment trap K.	High Priority
BRIE05/01	Recontour channel and bund along the north western margin of site to repair minor breaches in bund.	Low Priority

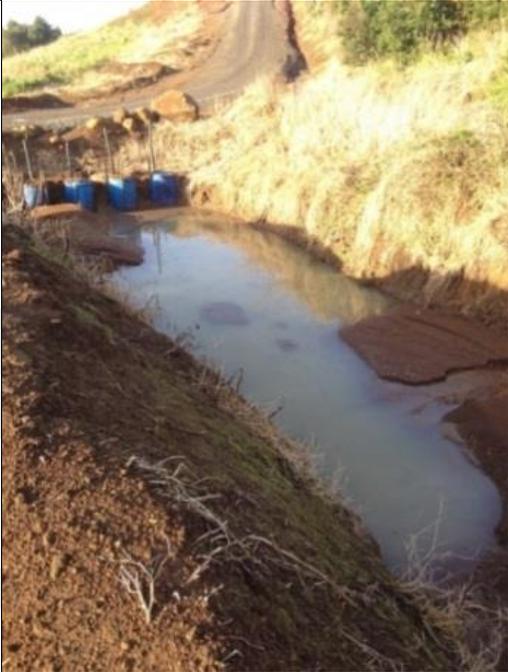
Sediment Trap	Dimensions (m) (Length x Width x Depth)	Volume (m ³)	Photograph
N

Observation	Erosion and sediment controls are well positioned and maintained. Three large sediment traps are located at the base of the paddock. All runoff channelled, banded and directed to sediment traps.				
Recommendation	No further recommendations for erosion and sediment control beyond routine maintenance.				
Observation	Existing well established riparian planting in excess of 5m on the eastern margin protecting adjoining watercourse (See Figure 11).				
Recommendation	No recommendations.
