KEY STAKEHOLDER PREFERRED OUTCOMES FROM STAGES I, II, III & IV
Mid-Waikato Bed Degradation Investigations Stages III & IV - EW Contract No. AM20004/05-30

- Appendix G

Options to Manage Bed Degradation

G3 – Six Engineered Options for High Priority Sites at Risk from Predicted Future Bed Degradation

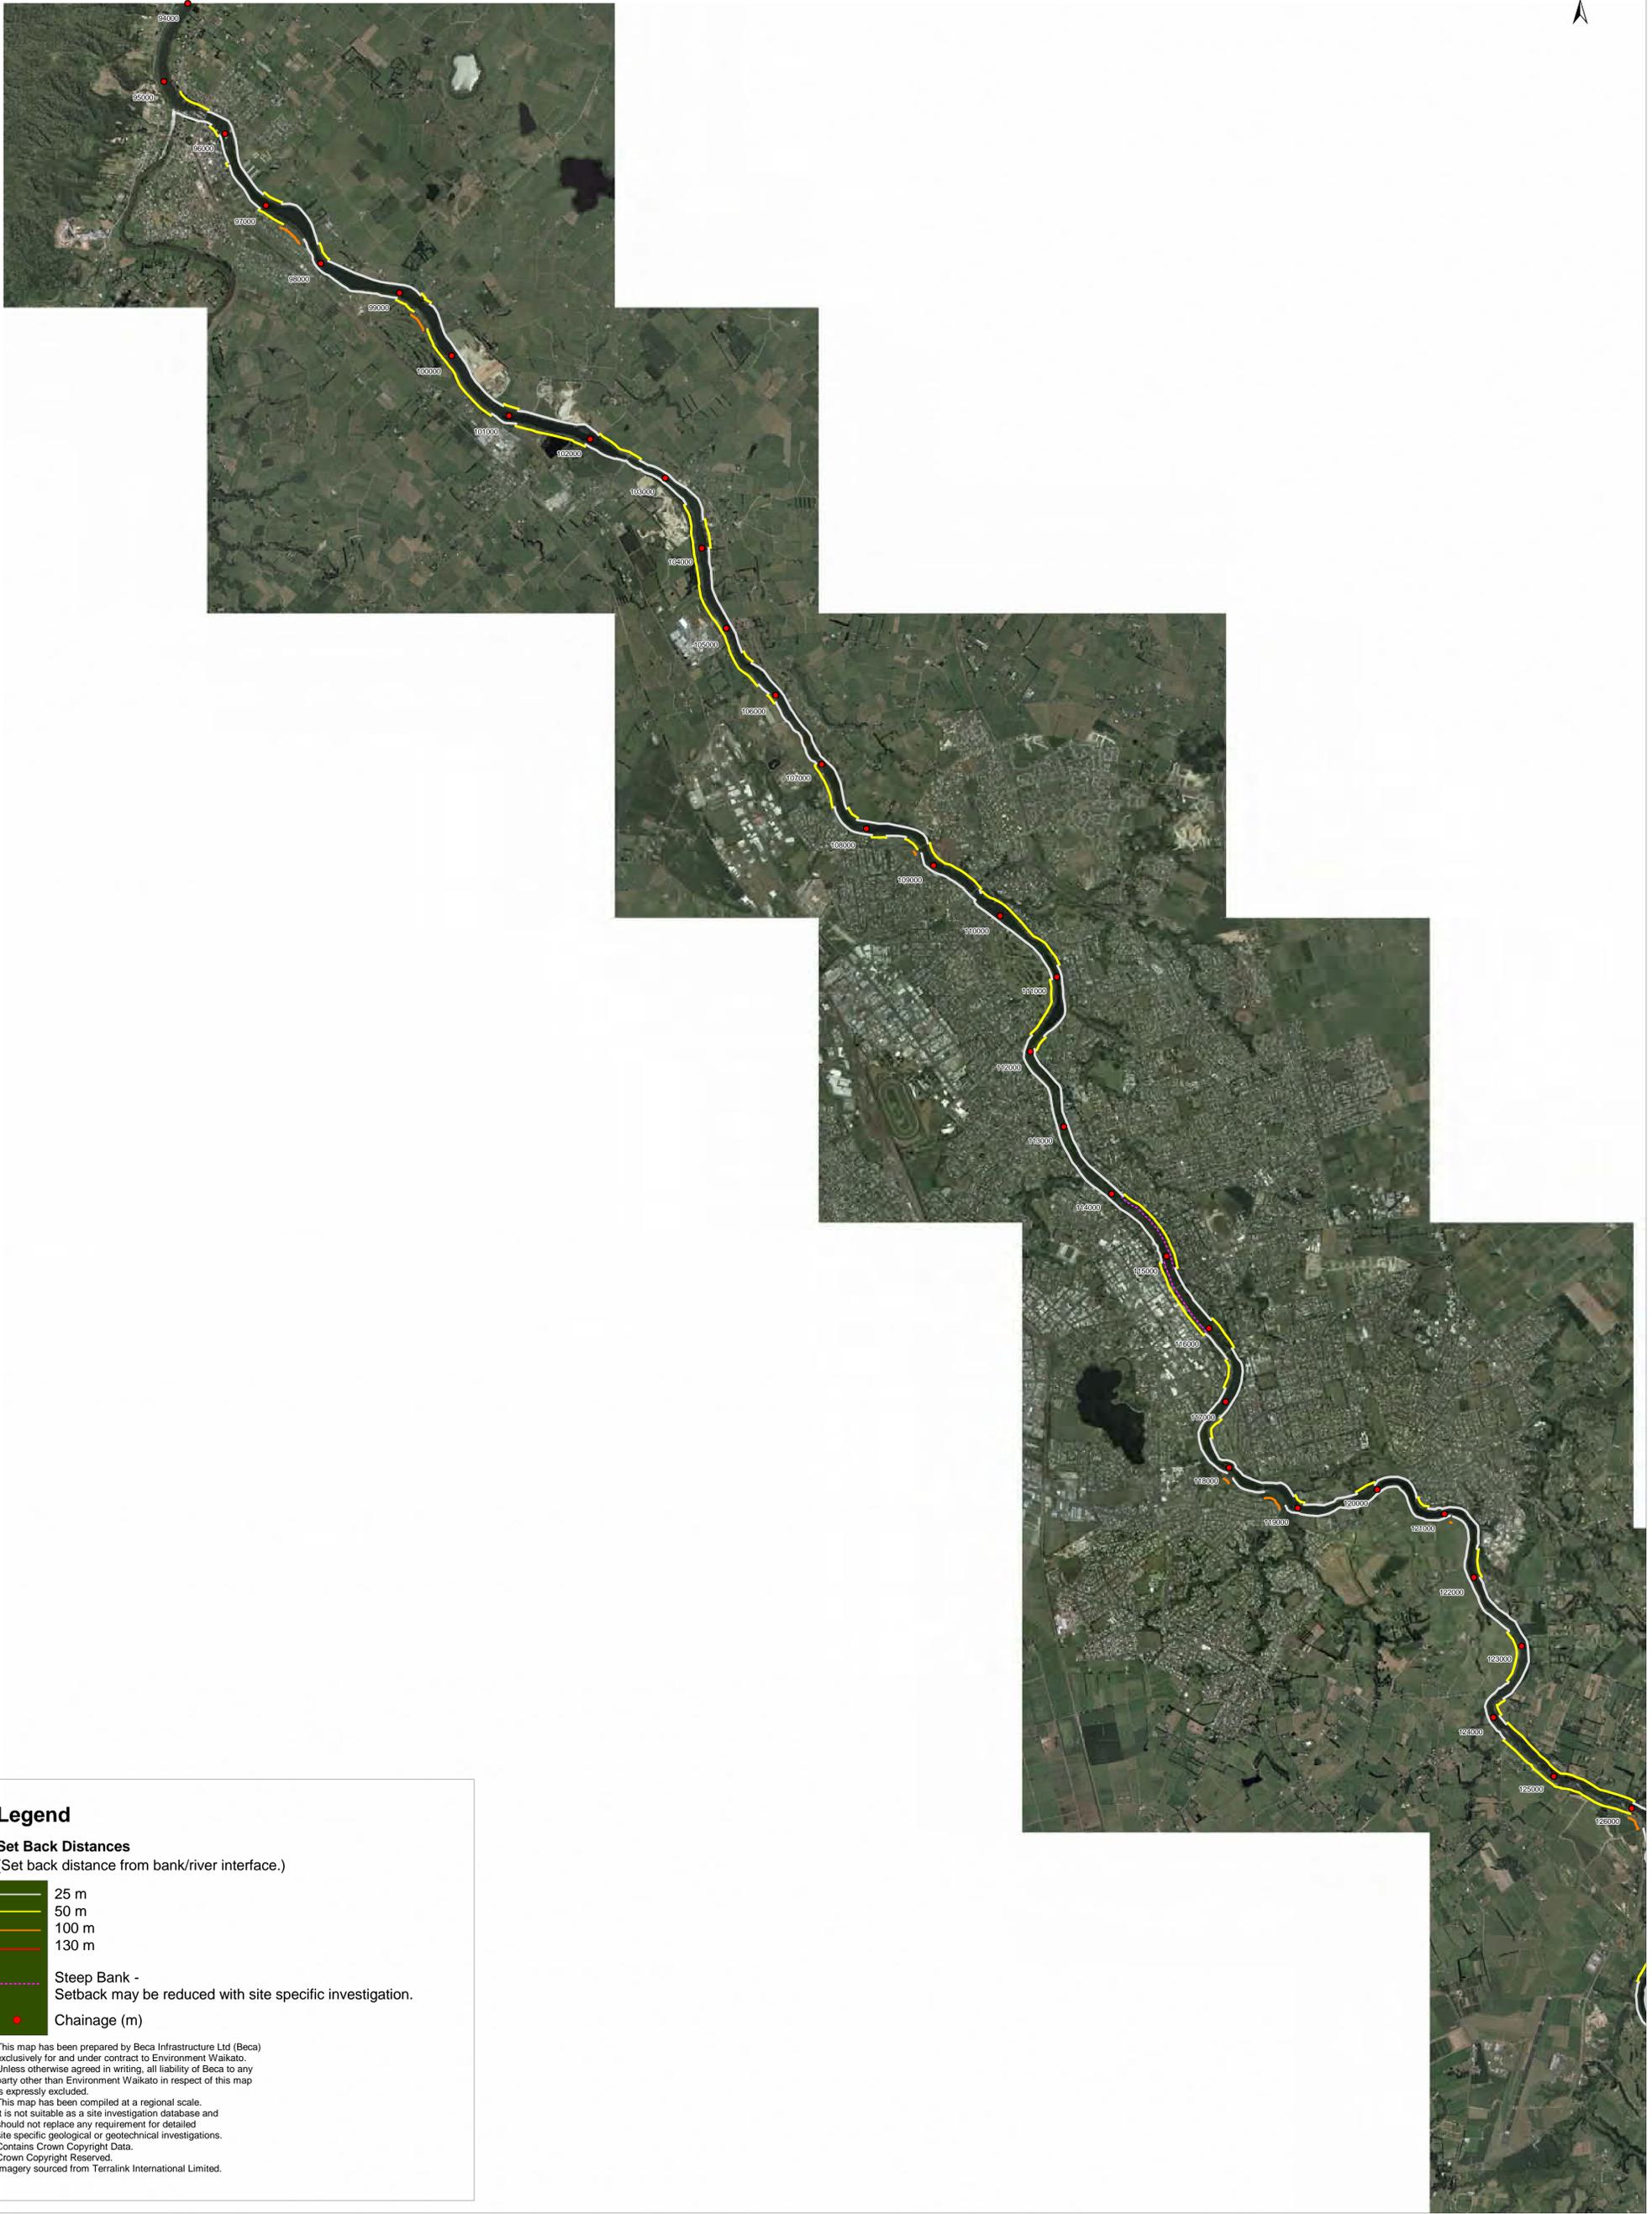
Set Back Distances
(Set back distance from bank/river interface.)

- 25 m
- 50 m
- 100 m
- 130 m
- Steep Bank -
Setback may be reduced with site specific investigation.
- Chainage (m)

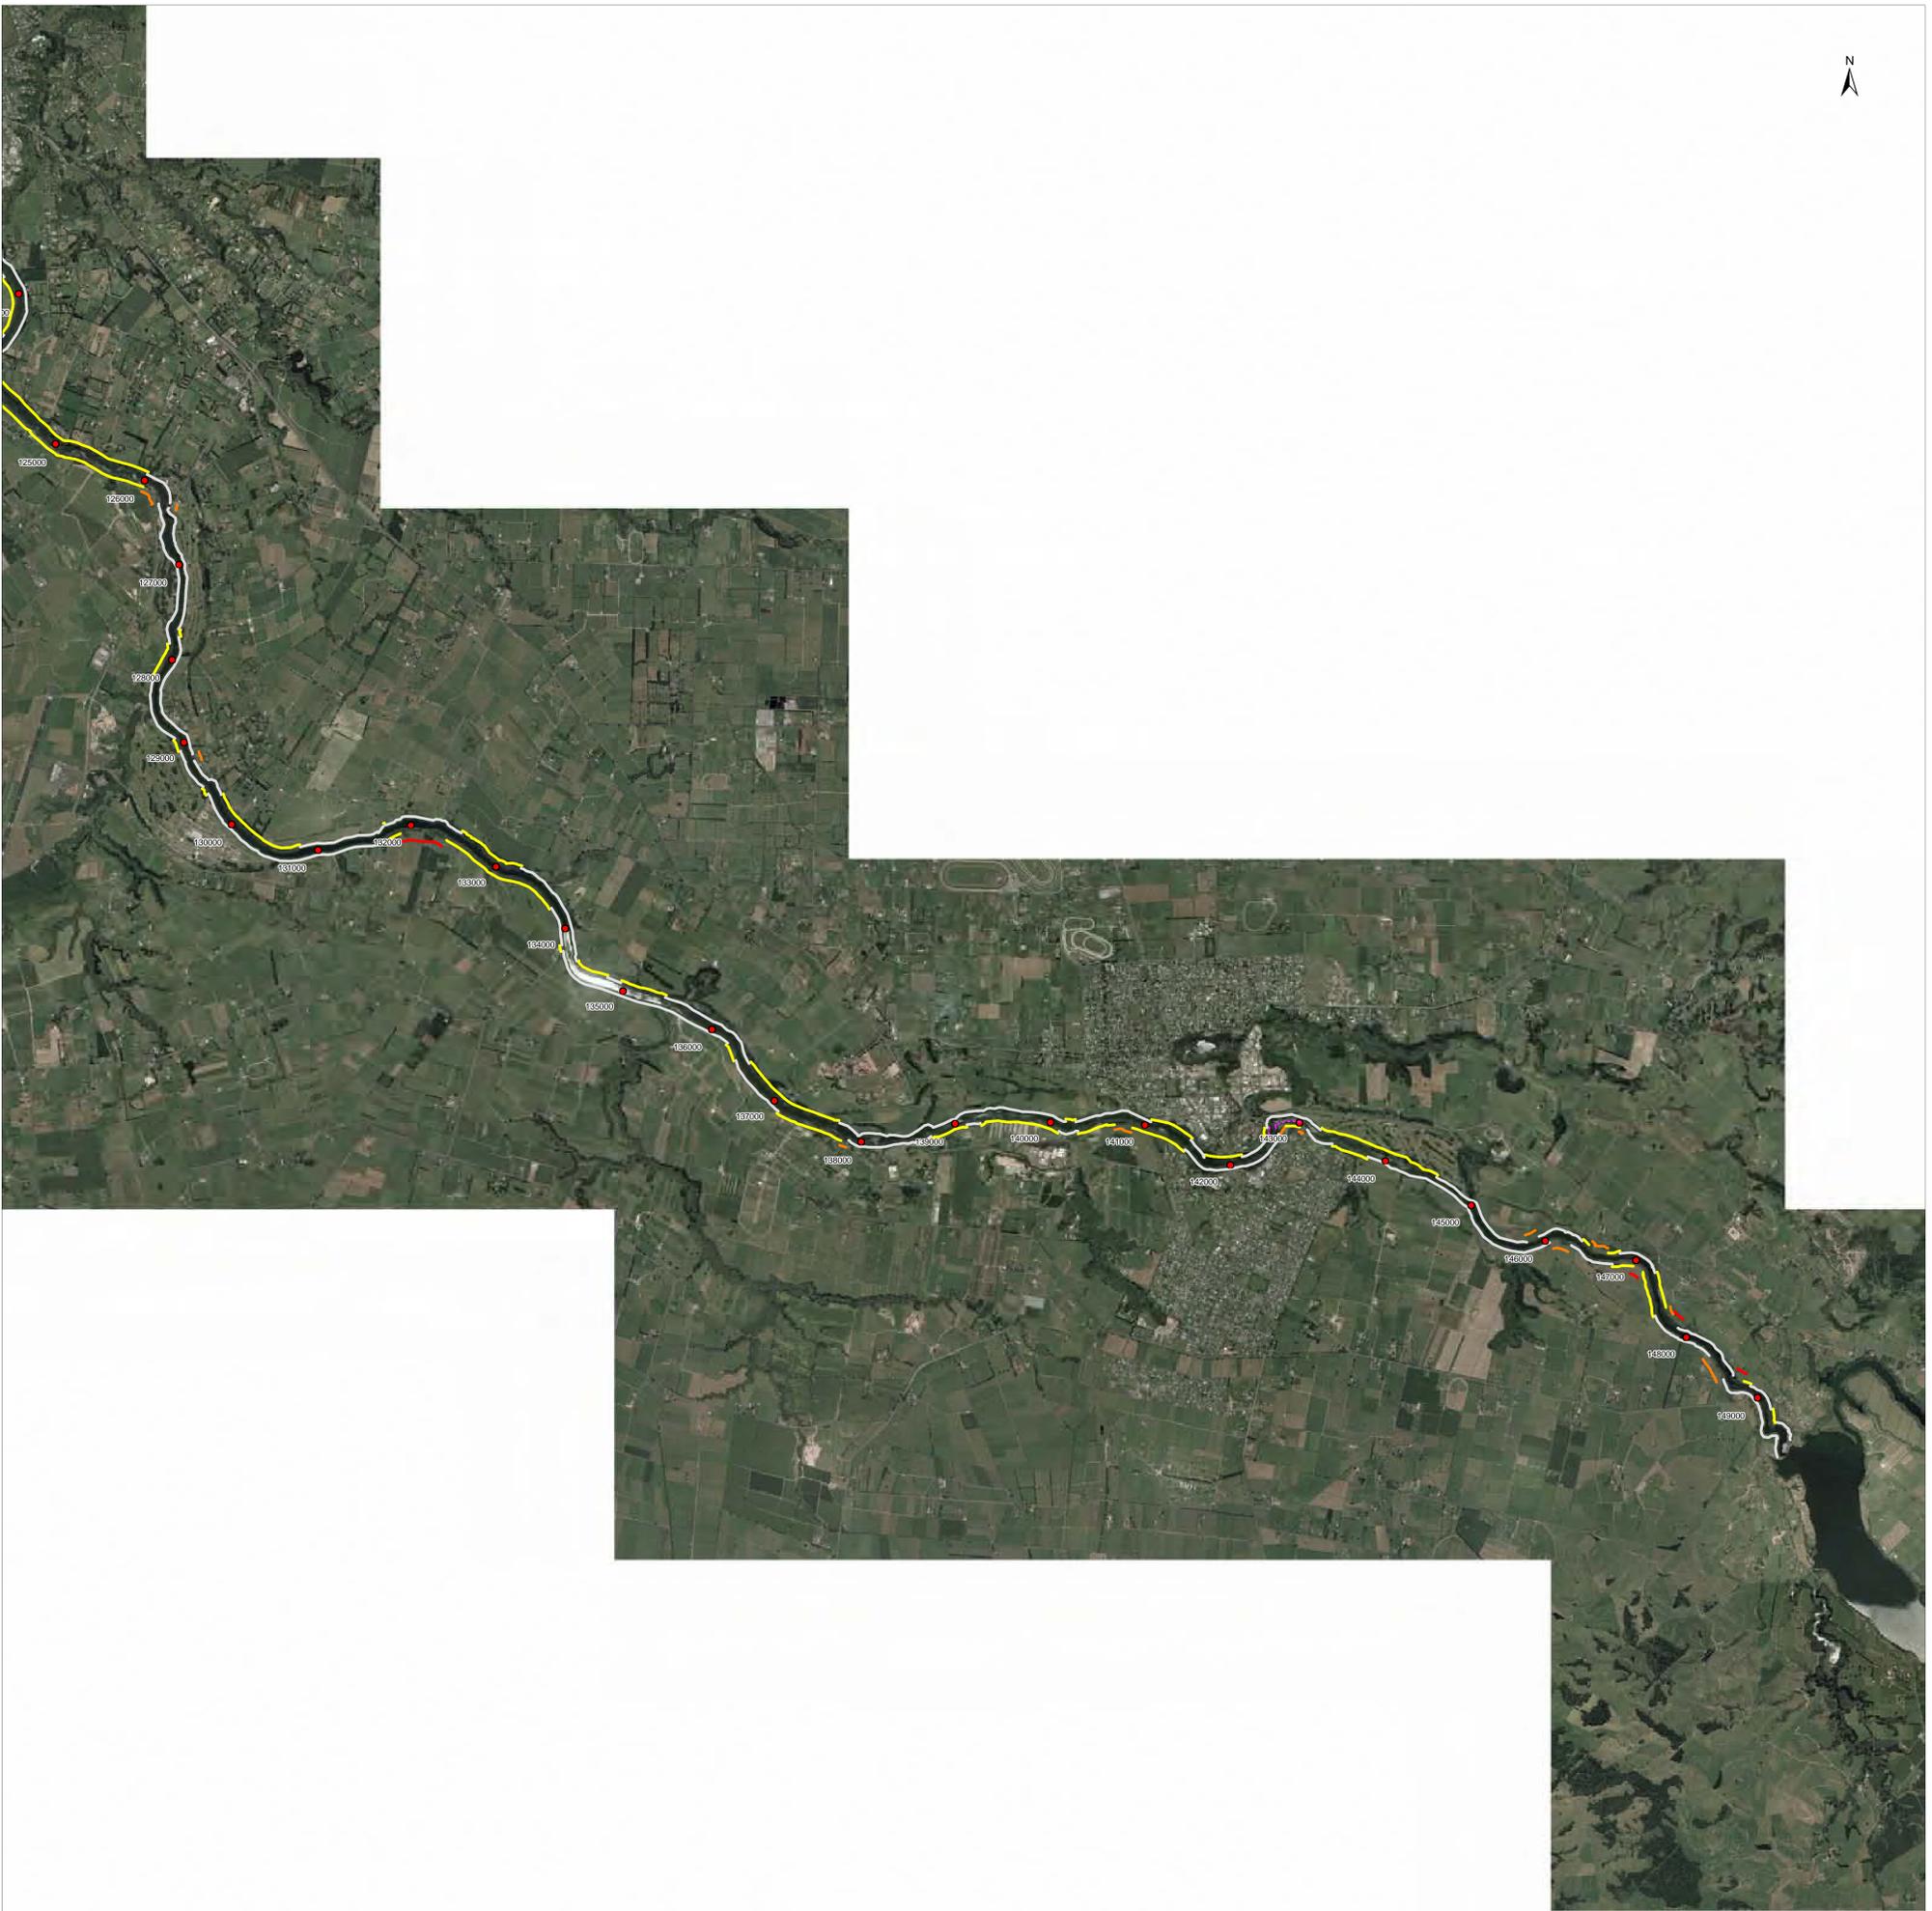
Set Back Distances
(Set back distance from bank/river interface.)

Steep Bank -
Setback may be reduced with site specific investigation.

This map has been compiled at a regional scale. It is not suitable as a site investigation database and should not replace any requirement for detailed site specific geological or geotechnical investigations.
